NHTSA Investigation

NHTSA Concerns

Toyota Action Plan

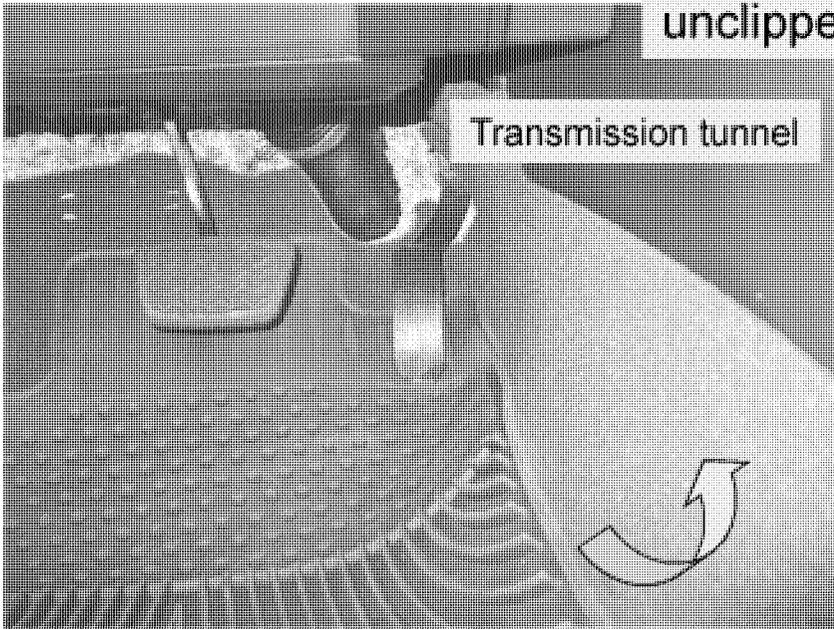
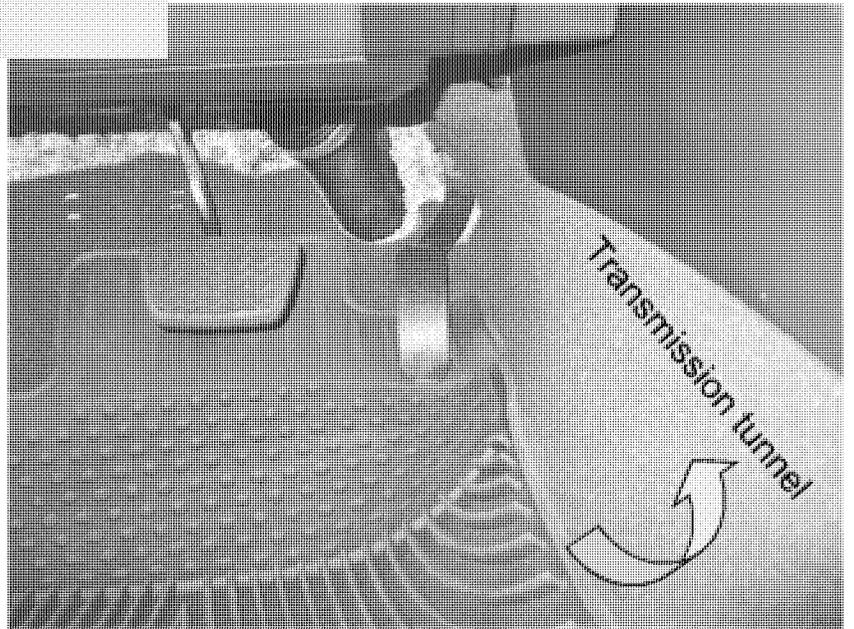
Avalon with unclipped mat

- No ridge on AWM
- Footwell may impede forward movement of AWM
- Tunnel interference
- 1 in scope VOQ
