U.S. Department
of Transportation
**National Highway
Traffic Safety
Administration**

DOT HS 812 112

Crashworthiness Research of Prototype Hydrogen Fuel Cell Vehicles: Task Order 7 Project Report

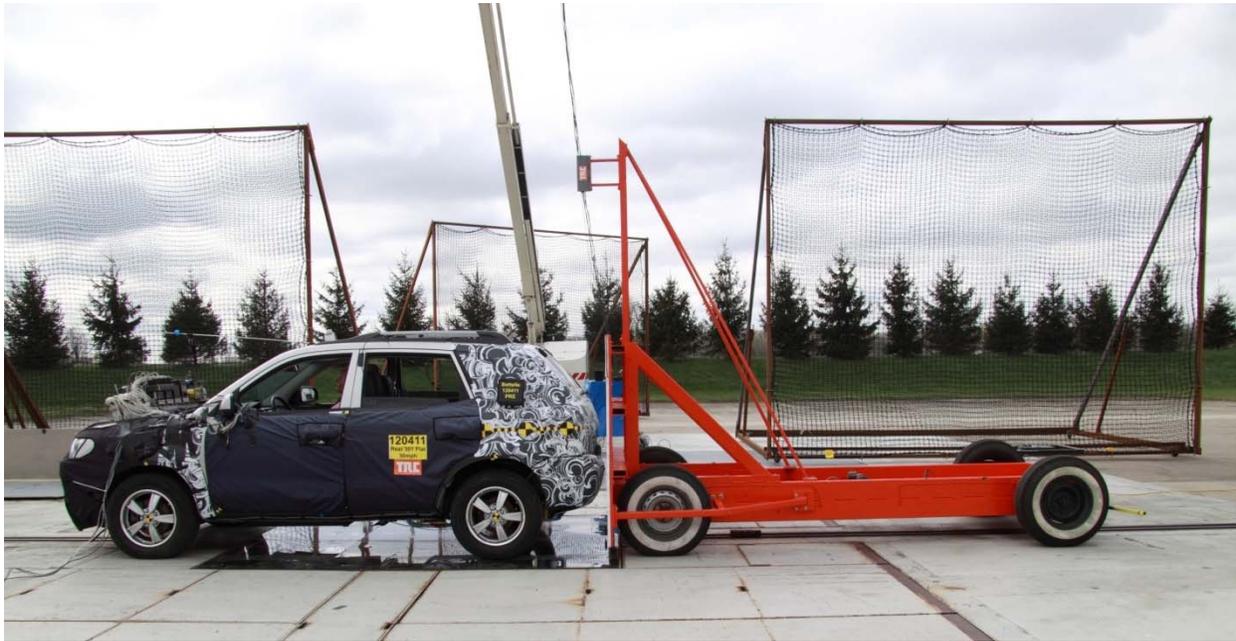
The rear-impact crash, with the billboard barrier according to FMVSS No. 303, pushed the rear bumper into the rear container, collapsing the components of the fuel system together. Containers showed surface damage, but the pressure boundary remained intact. The fuel system for the rear impact had been pressurized with helium to 35 bar (508 psi). This pressure, 10 percent of the container's service pressure, was selected to allow greater circumferential deformation, and greater potential for container damage. The structure of the vehicle protected the fuel system from the side-impact crash (conducted with the moving deformable barrier according to FMVSS No. 214). The fuel system was shaken during the impact, but suffered no observable or measurable damage. The fuel system for the side crash had been pressurized to 350 bar (5,076 psi) with a mixture of 80 percent helium and 20 percent nitrogen. One hundred percent of the service pressure was selected for the crash directed at the end of the container because full pressure proved to be the worst case in longitudinal impacts under extreme conditions in Task Order 1. A mixture of nitrogen and helium was used because it met the experimental requirements for leak detection and was significantly less expensive than pure helium. A helium sensor, provided by the National Renewable Energy Laboratory, which was mounted near the container, detected a trace amount of helium at the moment of impact. The sensor in the passenger compartment detected no helium. After the crash, both detectors were tested, and both detectors were found to be working correctly.

Figure ES-1. The rear crash was patterned after FMVSS No. 303, a “billboard” barrier at nominal 30 mph. The nets for containing debris in the event of a container rupture are visible behind the vehicle. The fuel system was pressurized to 35 bar (508psi) with helium.

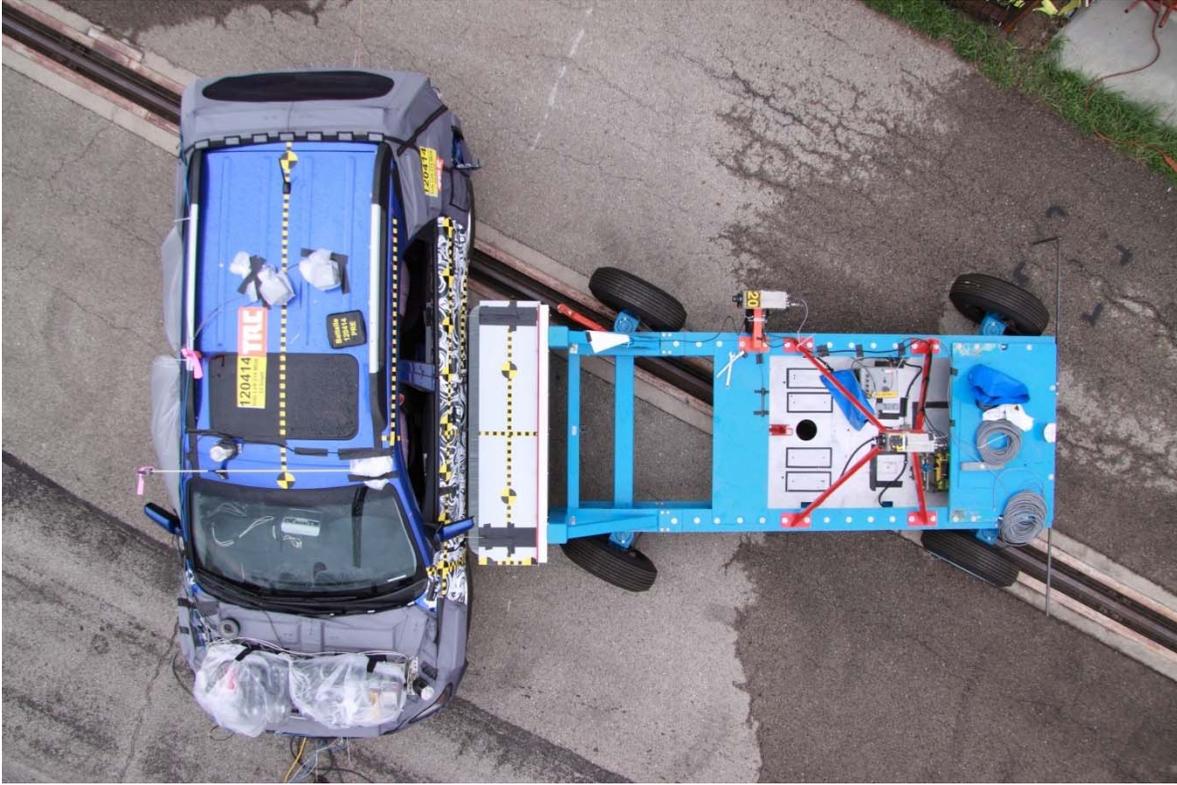
Figure ES-2. The side crash was patterned after FMVSS No. 301, which is identical to the dynamic impact in FMVSS No. 214. The moving deformable barrier's longitudinal axis is at an angle of 27 degrees to its direction of travel at nominally 33.5 mph. The fuel system was pressurized to 350 bar (5,076psi) with 80 percent helium and 20 percent nitrogen.

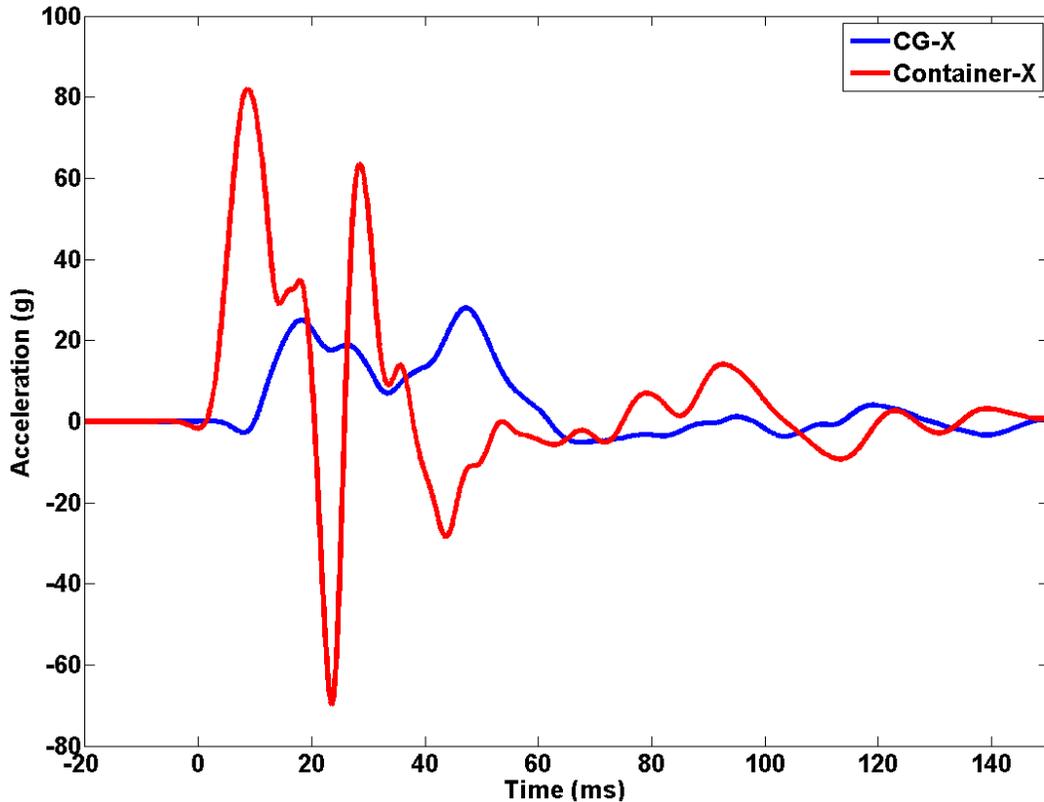
The accelerations experienced by the containers in the rear crash were dominated by direct contact. Figure 3-9 compares the x-axis acceleration pulses for the rear container and the vehicle CG for the rear crash. The blue curve is the x-direction acceleration of the vehicle's CG, and the red curve is the x-direction acceleration of the rear container—passenger side accelerometer. The rear container, which is located just beneath the rear bumper, experienced the impact roughly 8 ms sooner than the CG of the vehicle. This is apparent by the red curve rising well before the blue curve. The peak accelerations experienced by the container were also roughly four times higher than the acceleration experienced by the vehicle's CG. This is caused for two reasons, the smaller mass of the containers relative to the entire vehicle, and the direct contact of the billboard on the rear container.

Figure 3-9. X-direction acceleration pulses for the vehicle CG and the rear container (passenger side accelerometer) for the rear crash. The rear container acceleration (red) is substantially higher than the vehicle's CG acceleration (blue).

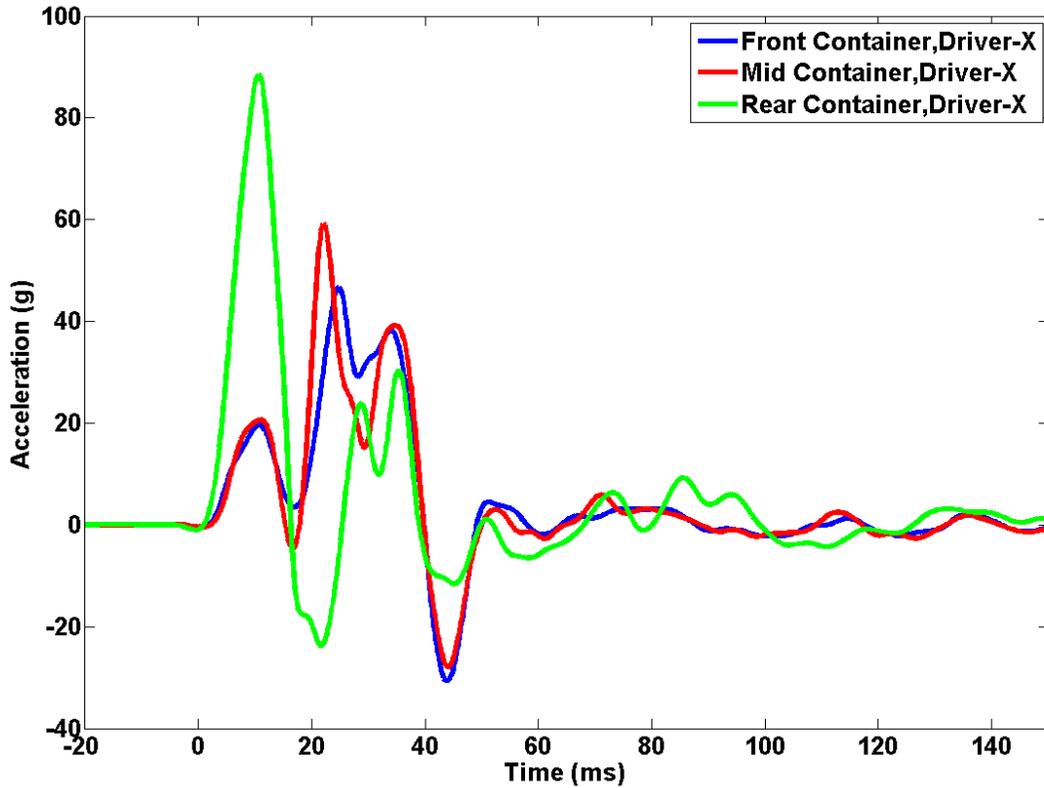
The peak acceleration experienced by the rear container was approximately 50 percent higher than the peak accelerations experienced by the other two containers. Figure 3-10 compares the x-axis accelerations of all three containers. The initial acceleration of the rear container, shown as the first peak by the green line, was substantially larger than the accelerations of the other two containers. At around 20 ms after the impact, the rear container experienced a negative x-acceleration, while the middle and front containers experienced a positive x-acceleration. This is a result of the rear container pushing a suspension cross member into the middle container. As a result, both the middle container and the front container, which are strapped into the same mounting frame, were pushed forwards. This corroborated with the high-speed pit camera views.

Figure 3-10. X-direction acceleration pulses for the front, middle, and rear containers, driver side accelerometers in the rear crash. The negative acceleration of the rear container (green) coincides with the largest accelerations for the middle (red) and front (blue) containers, which indicates contact between the rear and middle containers.

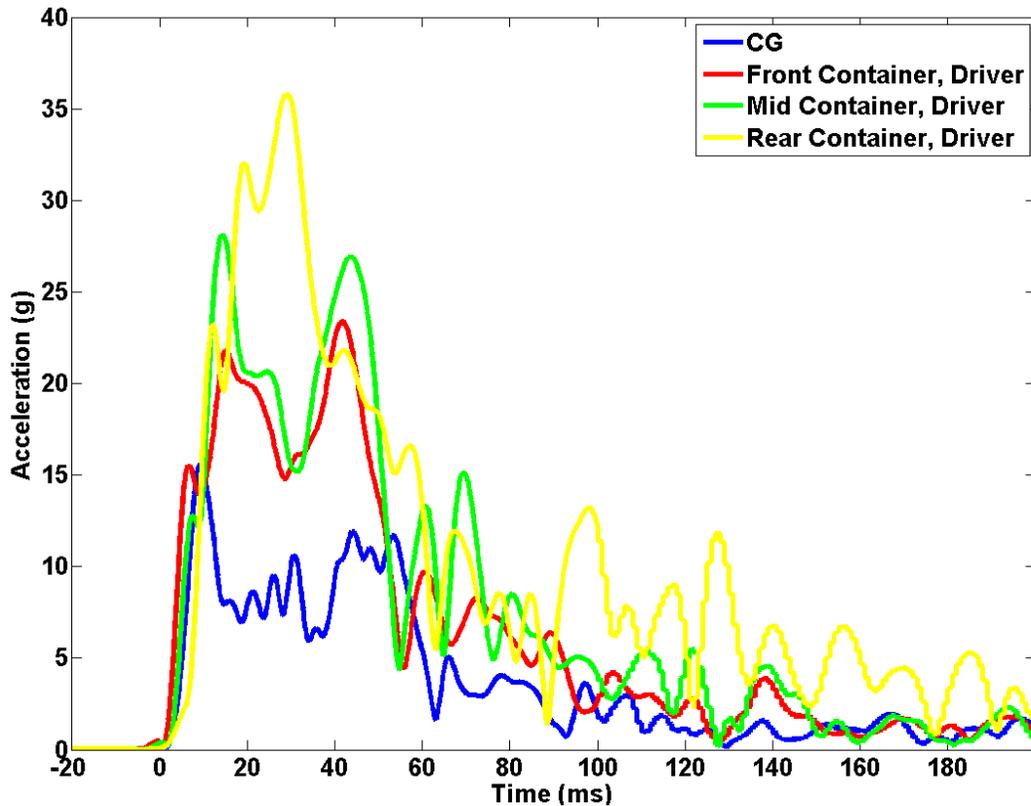
In the side crash, the container accelerations were one and a half to two times the vehicle CG acceleration. Figure 3-11 compares the resultant accelerations of the three containers to the vehicle CG resultant. From the figure the peak accelerations are greater the farther the container is located from the CG. This is in part due to the back end of the vehicle swinging around as a result of the impact. Based on the lack of visible damage to the containers and the relatively comparable acceleration levels, the side impact was less severe, to the fuel system, than the rear impact.

Figure 3-11. Resultant accelerations in the side crash for the vehicle CG (blue) and the driver side accelerations of the front (red), middle (green) and rear (yellow) containers. The peak accelerations are greater on containers farther from the CG.

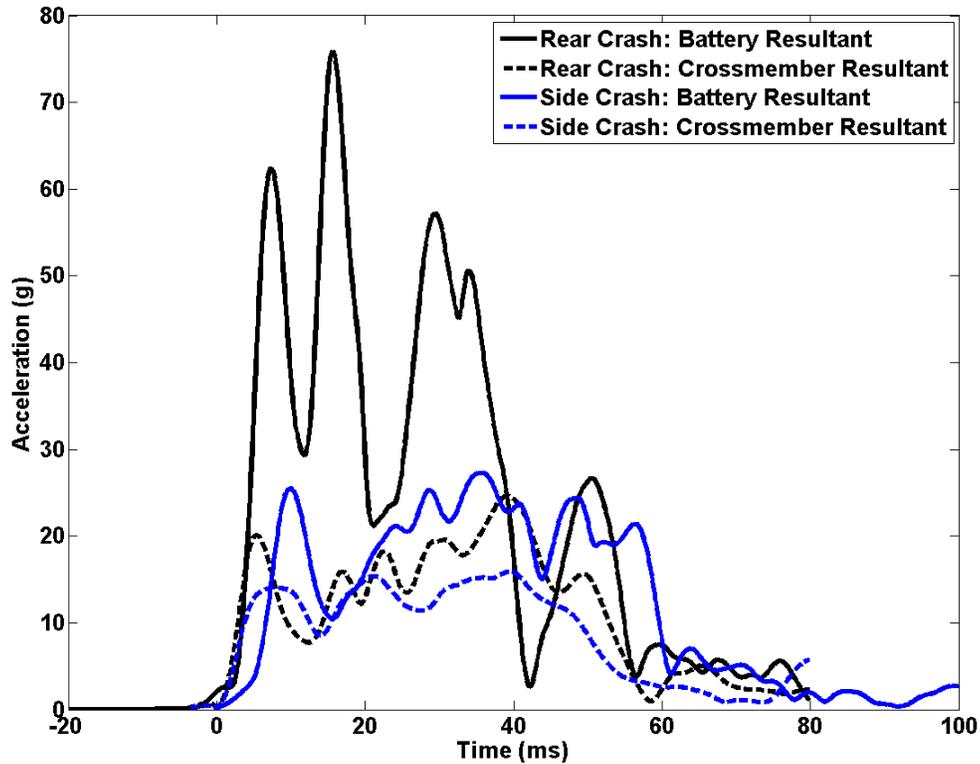
Figure 3-12 shows the remains of the fan assembly following the rear crash. The accelerometers on the passenger side of the compartment recorded a direct impact, which is consistent with the fan assembly being crushed into the battery housing. The original battery housing had vent holes by the fan, but its internal components could easily have been arranged so that cells were unlikely to be punctured by fragments from the fan. The battery housing itself was intact. The resultant acceleration, shown in Figure 3-14, on the driver side of the battery housing was sustained above 20 g for a 50 ms crash pulse and reached a peak of 76 g. The rear crash battery resultant acceleration is much higher than the side crash battery resultant. This is due to the impact from the fan being crushed against the housing in the rear crash.

Figure 3-14. Resultant accelerations of the driver side battery accelerometers and the cross member accelerations for both the rear and side impacts. The cross member acceleration is representative of the acceleration that was applied to the base of the battery housing.

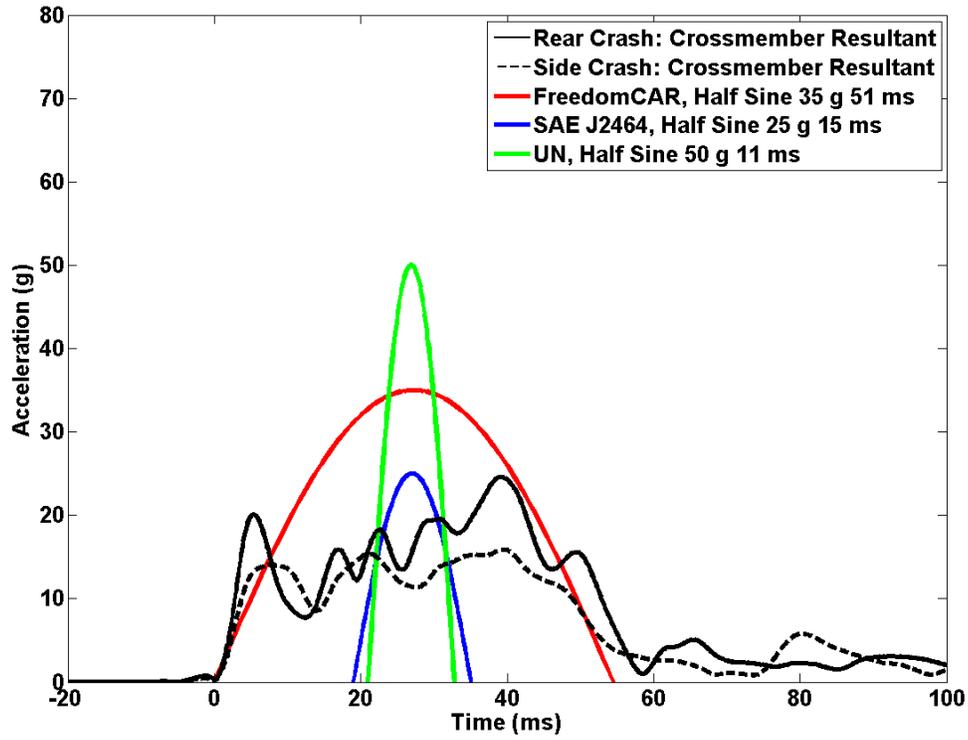
These three idealized pulses are overlaid on the actual crash pulses measured on the driver side of the battery housing in Figure 3-15. These standardized pulses would be applied to the base of a battery under test. The accelerations experienced by the vehicle cross member are representative of the accelerations experienced at the base of the battery housing. The SAE and UN abuse standards call for shocks that are shorter in duration than the pulses in these crashes. The FreedomCAR standard appears to adequately envelope the rear and side crash pulses. A crash test is a single impact (although a crash on the highway may have secondary impacts), and the SAE and UN standards call for repeated impacts. Even so, a component within a battery pack designed to withstand the peak amplitude of one of the standards may fail when subjected to a crash pulse of the amplitude measured here.

Figure 3-15. Time histories of the rear and side crash acceleration resultants compared with the three lithium battery abuse standards. These two actual crash pulses are a longer duration than the SAE and UN pulses.

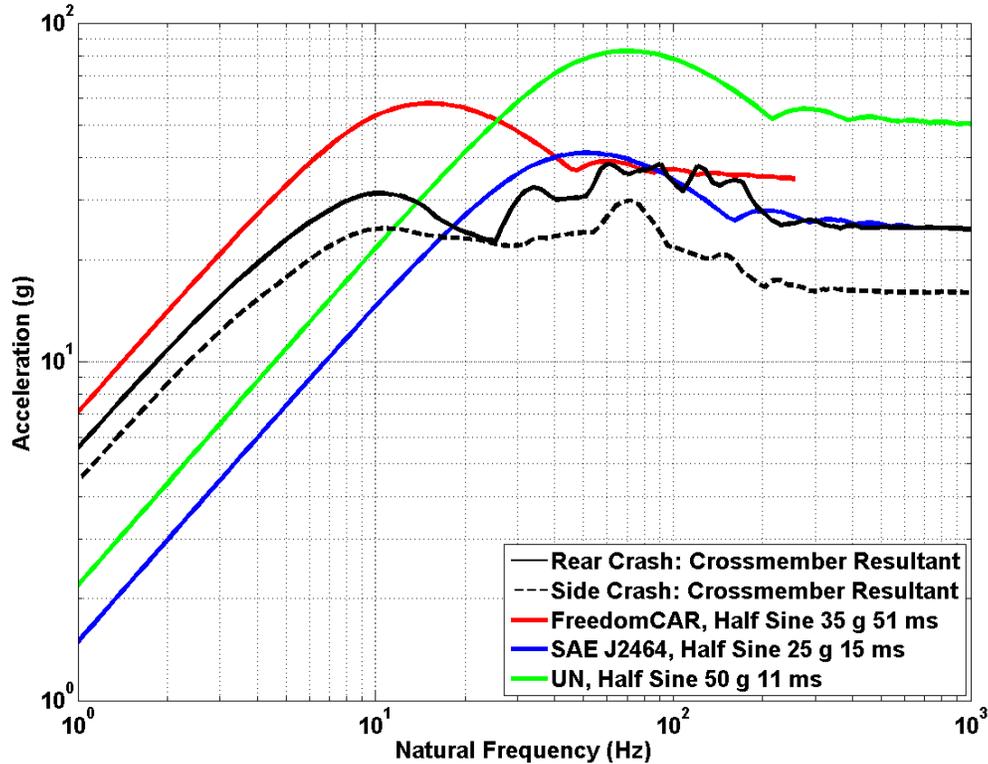
The same comparison can be made in the frequency domain. Figure 3-16 shows a shock response spectrum analysis performed on both the side and rear battery resultant accelerations and the three abuse test shock standards. The cross member impacts are fairly well enveloped by the FreedomCAR response spectrum. Typically, in shock response analysis, the accelerations are measured at the base of the object or near a mounting location. As a result the cross member resultants were analyzed in the shock response spectrum, since the cross member acceleration would be a good approximation of the shock input at the base of the battery. The SAE and UN abuse standards do not capture the low frequency responses experienced in the test crashes.

Figure 3-16. Shock response spectrum analysis on the housing for the high-voltage battery in both the rear and side crashes. The shock response spectrums for the three lithium battery abuse standards have been superimposed for reference. The FreedomCAR SRS adequately envelopes the side and rear crashes. The SAE and UN standards are insufficient to capture the lower frequency response of these two crashes.

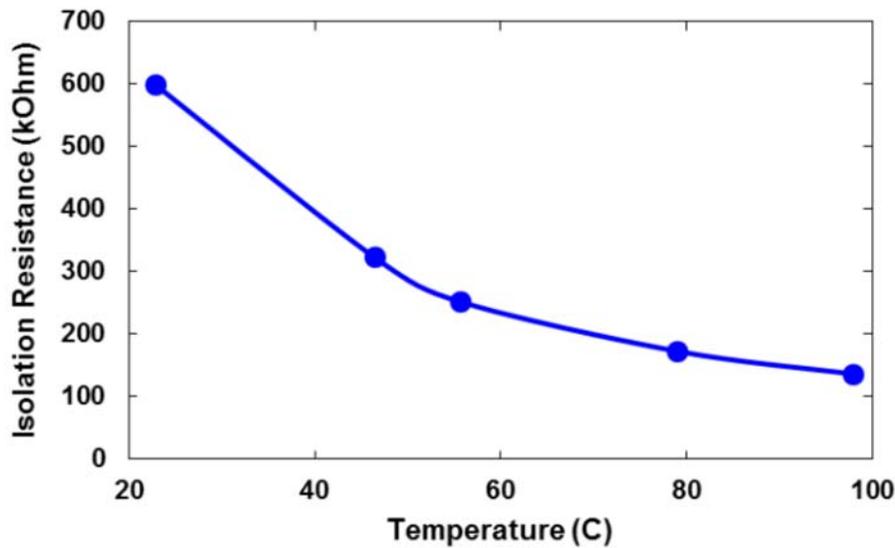
Figure 4-1. The resistivity of Glystantin decreases with increasing temperature. Data from Task Order 4.

The isolation between the fuel cell and the chassis depends on the conductivity of the coolant if the coolant is not electrically isolated from the chassis. Fresh deionized water has a low conductivity and gives good isolation. As coolant ages, either by sitting or by running, the water gradually gathers impurities that increase its conductivity. A fuel cell with aged, ionized (conductive) coolant is not as well isolated from the chassis unless the vehicle utilizes an ion exchange resin filter to maintain low coolant conductivity. Because the measurement of isolation depends on the quality of the coolant, the coolant must be specified for a measurement to be meaningful.

Testing would be more complete and more realistic with the fuel cell active and current circulating. This would provide realistic thermal conditions and allow isolation measurements to be performed with a voltmeter, as is done for other high-voltage sources. With the fuel cell inactive, a testing device such as a safety analyzer would be necessary for isolation measurements. As part of the Electrical Isolation Task Order 4, testing showed the effective isolation resistance of a sample of Glysantin decreased approximately by a factor of four when temperature was increased from 25° C to 100° C, as shown in Figure 4-1. Thus, temperature of the vehicle will significantly affect fuel cell isolation. If the fuel cell cannot be active due to the inability to use hydrogen, temperature correction factors for different types of coolant will need to be developed.
