U.S. Department
of Transportation

National Highway
Traffic Safety
Administration

NHTSA Toyota Pre-Crash EDR Field Inspections
During March – August 2010

February 2011

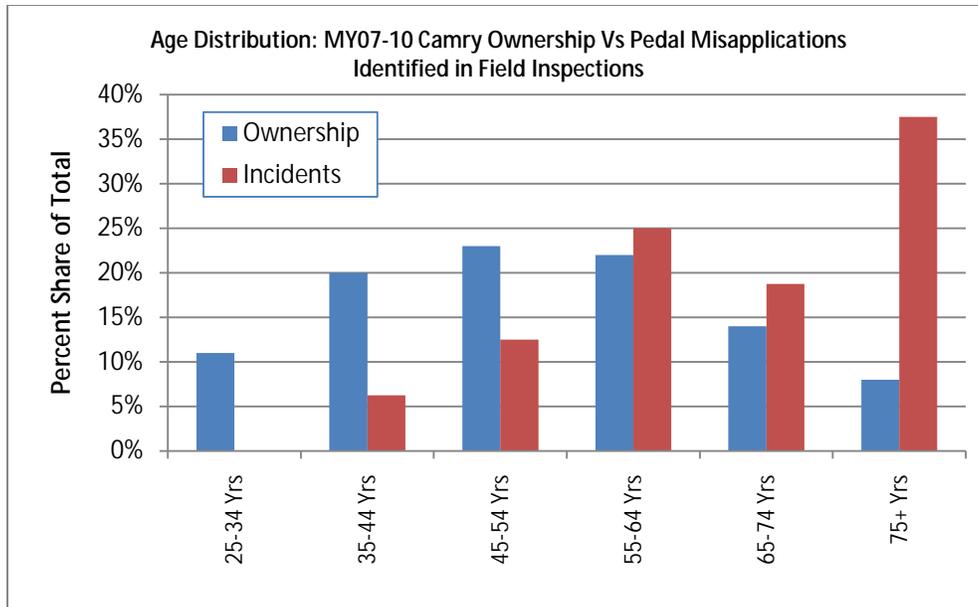
Figure 5: Camry Age Distribution: Ownership Vs Pedal Misapplication Incidents

Pedal misapplication incidents were disproportionately experienced by older drivers, with thirty one (79%) involving drivers 55 years or older at the time of incident. Twenty-four (62%) of drivers were 65 years or older at the time of incident. A comparison of Camry ownership by age group to driver ages for the 16 pedal misapplication incidents for this model is displayed in Figure xx below.

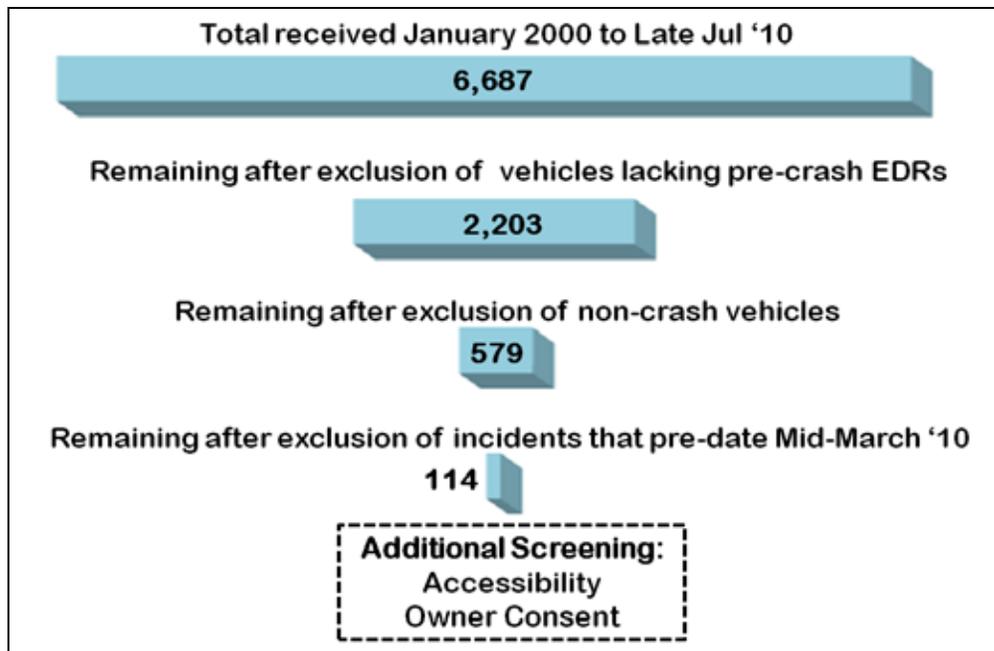
Figure 6: UA VOQ Traffic Compared to Field Inspection Screening

Questions have been posed concerning the relatively small number of field inspections (58 total, 27 of which were prompted by VOQs) as compared to the thousands of consumer complaints received reporting UA in Toyota vehicles. The objective of the field inspection program was to examine incidents where UA was reported in Toyota vehicles and pre-crash EDR data was likely to be available so as to better rule out driver influence when searching for a vehicle-based safety defect. As noted earlier, several criteria were employed to identify incidents that represented the most effective use of finite resources. The influence of these criteria on the complaint screening process is illustrated in Figure x.

No UA condition code exists in ODI’s VOQ database. However, it is possible to identify likely UA incidents with a keyword search based on the VOQ narrative. While the results of this search are broad and include some non-UA complaints, the search does capture a majority of likely UA VOQs. Applying these search terms to over 426,000 VOQs received from January 2000 to the end of July 2010, 6,687 VOQs were identified. Because the field inspection program focused on obtaining pre-crash EDR data, VOQs associated with vehicles lacking this capability were screened out. This left 2,203 VOQs meeting the UA keyword criteria in pre-crash EDR-equipped Toyota vehicles. In order to trigger a pre-crash EDR to capture data, a crash had to occur. Screening out non-crash VOQs reduced the available pool to 579 potential vehicles. VOQs concerning incidents that occurred on or after mid-March were selected from that group in order to obtain the freshest possible evidence. Some exceptions²¹ to this practice exist but they were, by and large unique. Screening out incidents occurring prior to mid- March reduced the available pool to 114 VOQs.
