# Takata Inflator Rupture Root Cause Summary Report

Submitted by:  
**Orbital ATK for the Independent Testing Coalition**

Submitted to:  
**National Highway Traffic Safety Administration**

**September 2016**

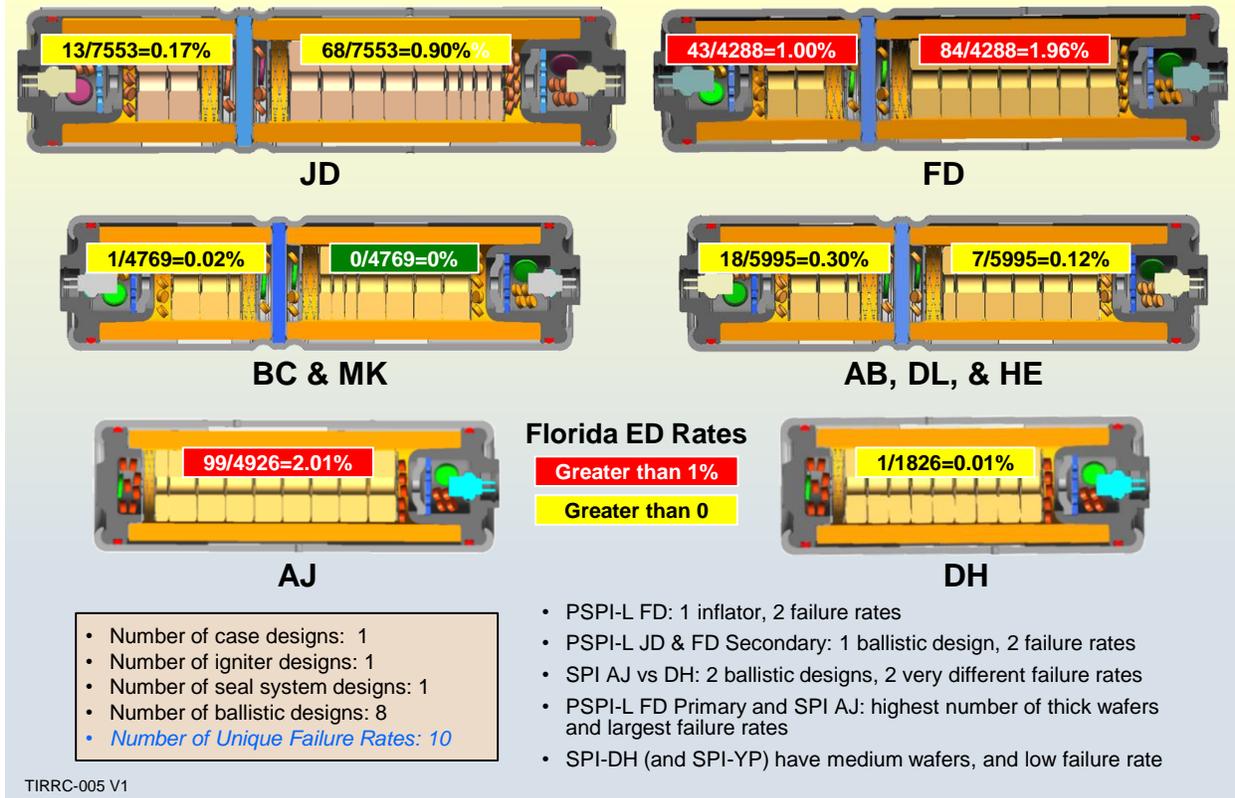
**Figure 4. Summary of Similarities and Differences for Passenger Inflators.**

*These summaries guide where more detailed engineering analysis and testing will be most likely to identify root causes and contributors. The rupture rate on field return tests is shown for each inflator chamber superimposed on that chamber.*

Analysis of the passenger branch showed a common case design, seal system design and igniter design with eight unique ballistic designs. Since the main hardware designs are the same but ballistic designs are different, this suggests a focus on ballistic differences will help to understand differences in energetic disassembly (ED), or rupture rate. This analysis shows that designs that superficially appear similar can be quite different in the ED rate. Detailed analysis is yielding insights on these differences. Each of these points is a clue in understanding the root cause.

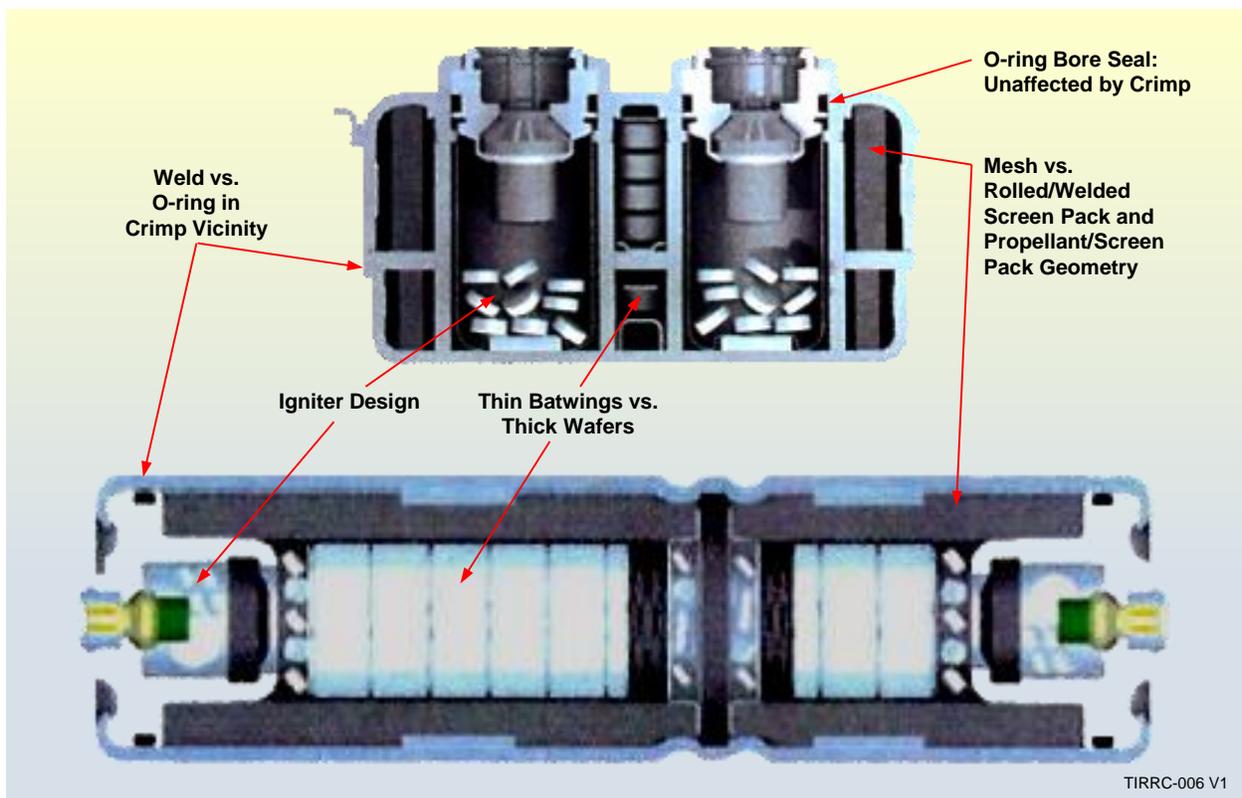
**Figure 5. Comparison and Contrast of Major Design Differences in Takata Driver and Passenger Dual Chamber Inflators.**

Detailed design analysis and comparison was also done for the driver branch of inflators. This allowed us to examine the driver and passenger designs for similarities and differences (Figure 5) that could account for the order of magnitude higher passenger-branch failure rate. Key differences include: 2004 propellant geometry, igniter closure seal design, igniter design and screen pack design.

*While functionally similar (see Figure 7), understanding these differences is relevant to understanding differences in ED rates.*

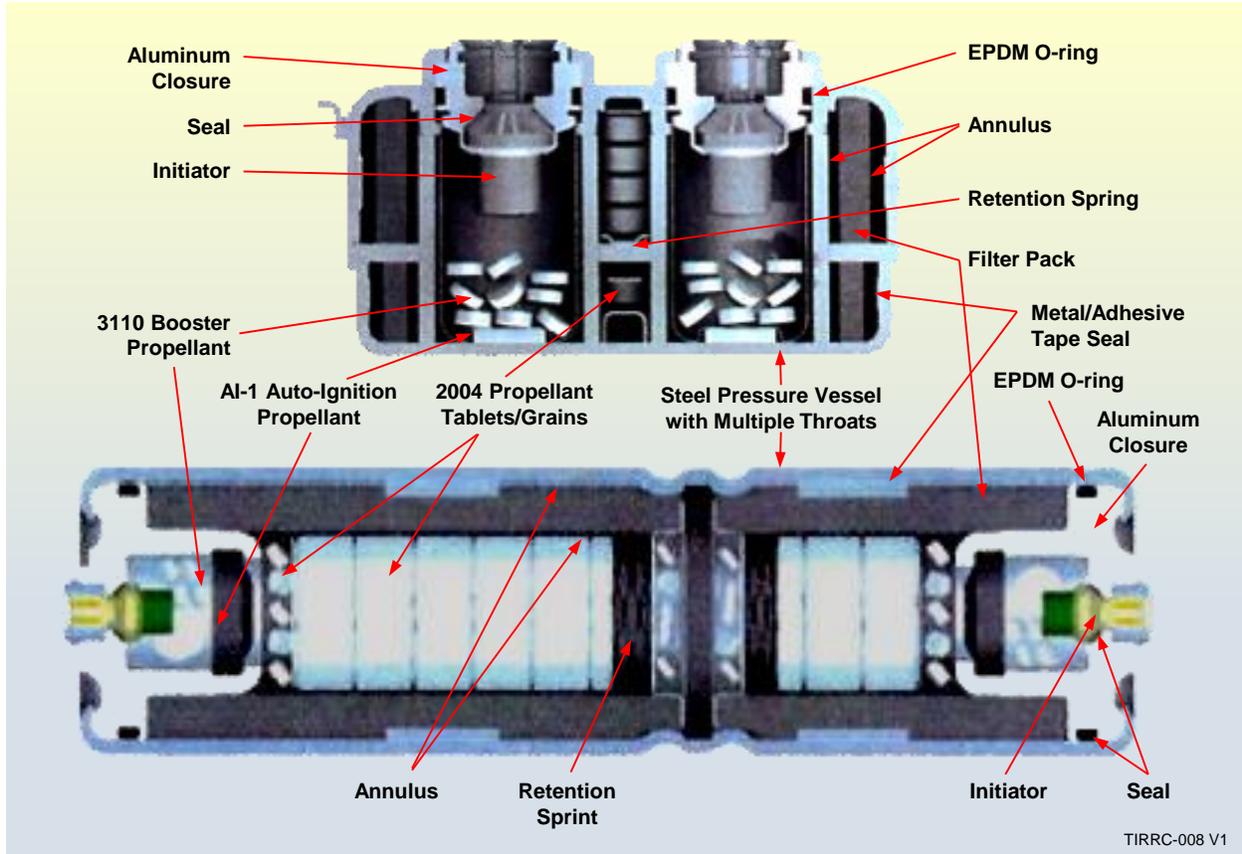
**Figure 7. Similarities in Operating Features of Takata Driver and Passenger Inflators.**

*While there are certain differences (Figure 5), there are many similarities in propellants, materials and designs for the inflators under recall. These similarities allow conclusions regarding both designs to be reached on several key parameters.*
