**UNITED STATES DEPARTMENT OF TRANSPORTATION
NATIONAL HIGHWAY TRAFFIC SAFETY ADMINISTRATION**
1200 New Jersey Avenue SE
Washington, D.C. 20590

EA15-001
Air Bag Inflator Rupture

**REPORT OF TK HOLDINGS INC. PURSUANT TO PARAGRAPH 33.a
OF THE NOVEMBER 3, 2015 CONSENT ORDER**

June 30, 2016

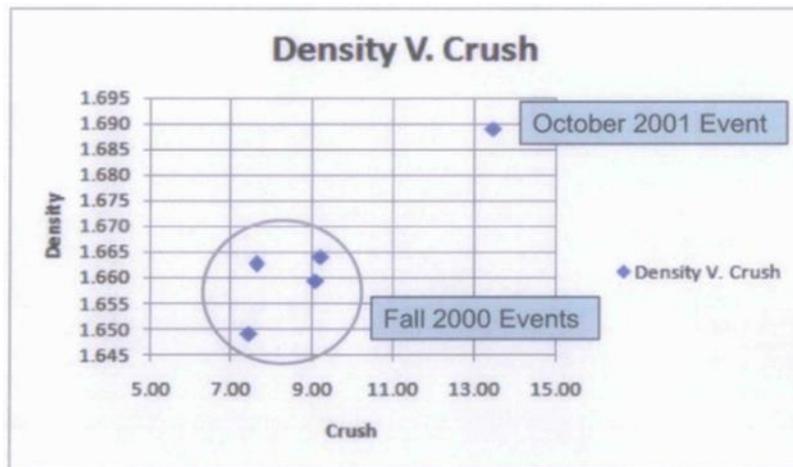
Third, after testing other inflators from the Event 0 lot, Takata found that the density and other wafer characteristics were excellent—consistent with the best 25 percent of all lots Takata had measured—and above specification. Moreover, ballistics tests on five inflators from the Event 0 lot confirmed no evidence of aggressive characteristics. Propellant characteristics from the Events 1-4 lots, by comparison, exhibited poor density, extreme ballistic variability, and poor propellant performance (see comparison below).

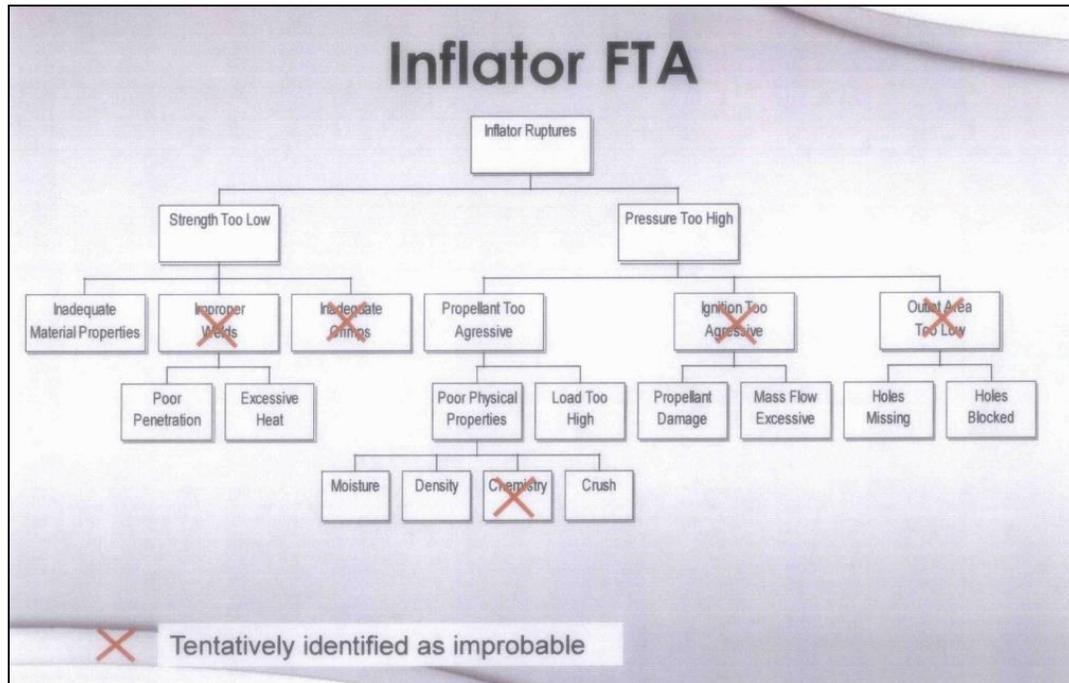
Fault Tree Analysis as of July 31, 2007

The FTA again showed the remaining potential causes as either insufficient cap structural strength or overly aggressive propellant during deployment, which could result from poor physical properties or too high of a load.

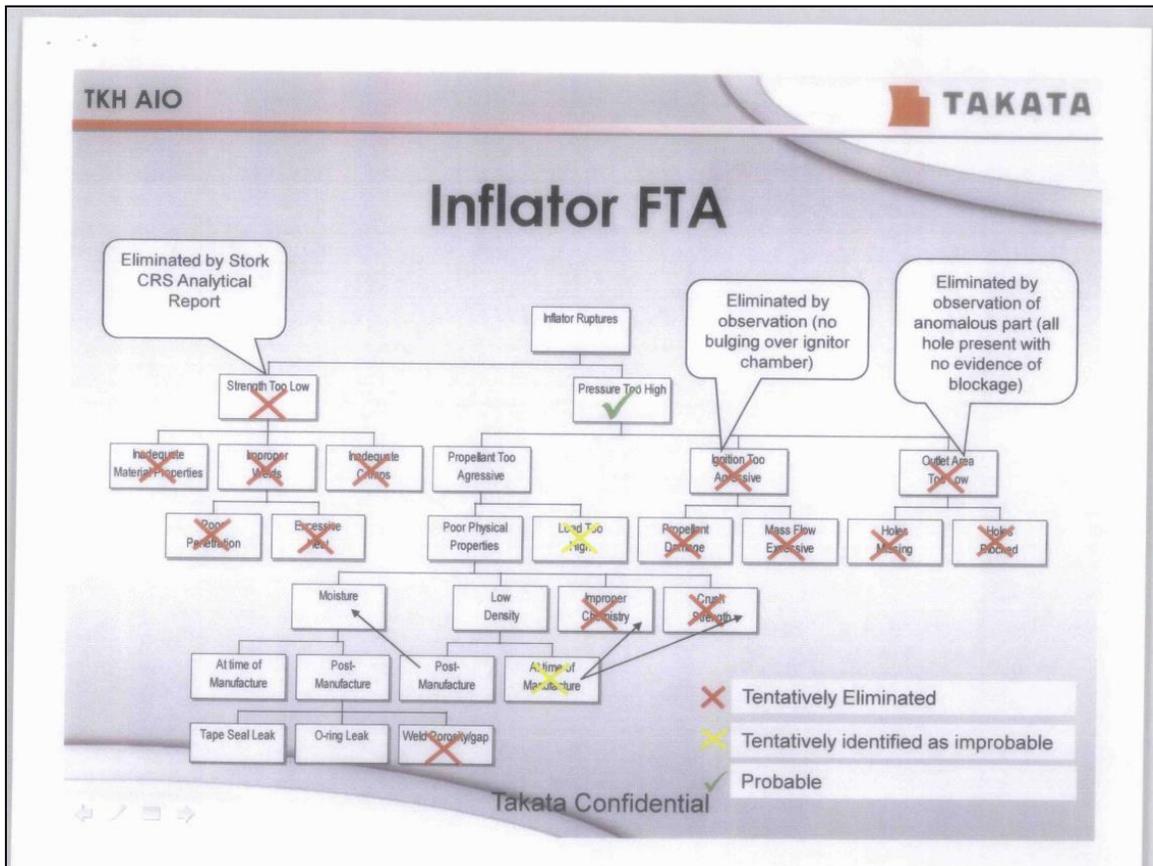
Fault Tree Analysis as of Aug 20, 2007

During the August 2007 briefing, Takata presented the chemical/metallurgical analysis conducted by an outside research organization of a fractured piece from an event inflator. The analysis concluded—based on the absence of material defects and the inflator’s conformance with specification—that the part fractured because it “experienced force . . . that exceeded its load-bearing ability.” Based on the analysis from the outside research organization, Takata tentatively eliminated the strength of the cap as being a possible cause of the rupture and identified the probable root cause as excessive burning pressure:

As the above chart shows, at that time, Takata identified low density as a potential root cause of the aggressive propellant. Takata stated that the most likely cause of the low density was degradation of the propellant through moisture intrusion occurring after the production of the propellant. At this point, Takata had “tentatively concluded” that the low density at the time of propellant production was “unlikely” because “wafers 100% inspected for weight and height at propellant manufacturing site eliminates low density wafers.”

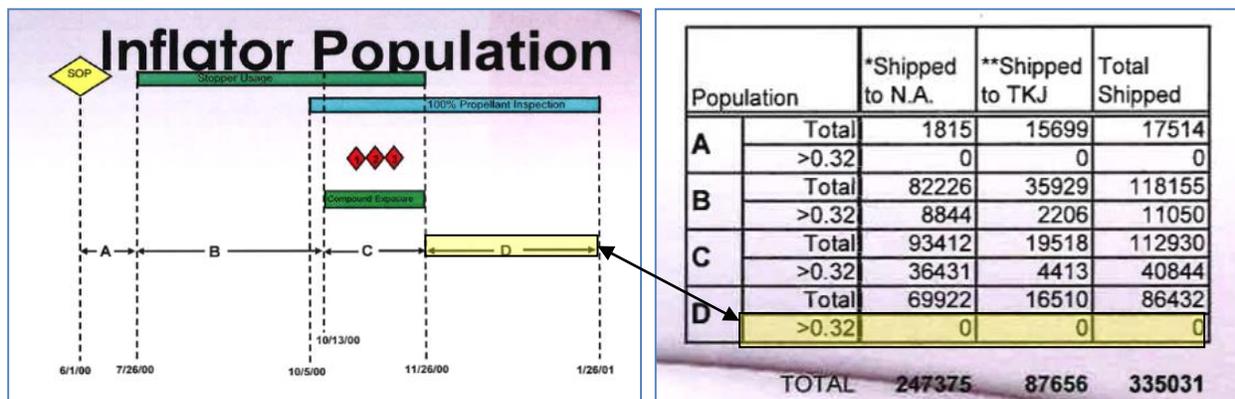
Takata’s moisture hypothesis prior to Event 4 had assumed (i) baseline moisture at 0.08 wt. percent when the propellant was manufactured, (ii) moisture increase of approximately 0.04 wt. percent during the 100-percent inspection period, and (iii) potential moisture increase of up to 0.25 wt. percent during the stopper application/tape seal period. Under these calculations, Takata surmised that inflators manufactured during the stopper application period alone, or more likely, during the combined stopper application and inspection period, could result in a moisture level above 0.32 wt. percent that could degrade the propellant. Takata had not believed, however, that inflators subject only to the 100-percent propellant inspection—like Event 4 and in “D” below—could exceed the 0.32 wt. percent moisture threshold.

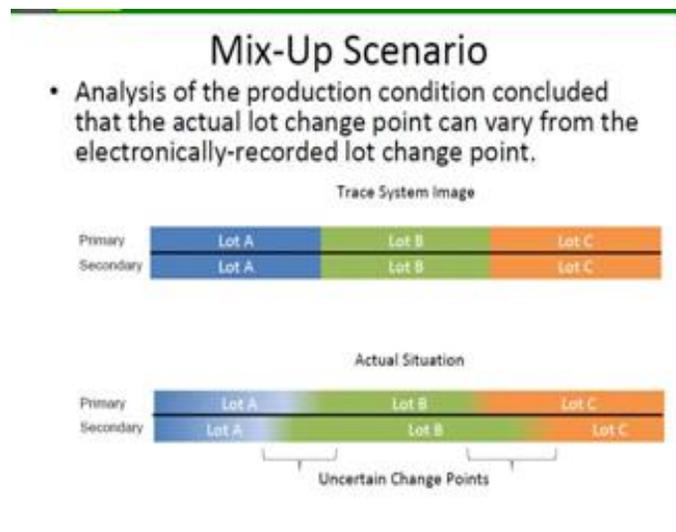
At the meeting, Takata explained the concept of the lot change point, which, in theory, is the moment inflator manufacturing switches from one lot of propellant to another. In Takata’s tracing system, these points appear to be precise and singular. However, in practice, the change points are somewhat imprecise and are not uniform (see below).

One of the potential causes suggested by Takata for the imprecise lot change points involved the fact that the trace system reflects only the propellant in the PSDI’s primary chamber, which may have differed from the propellant in the

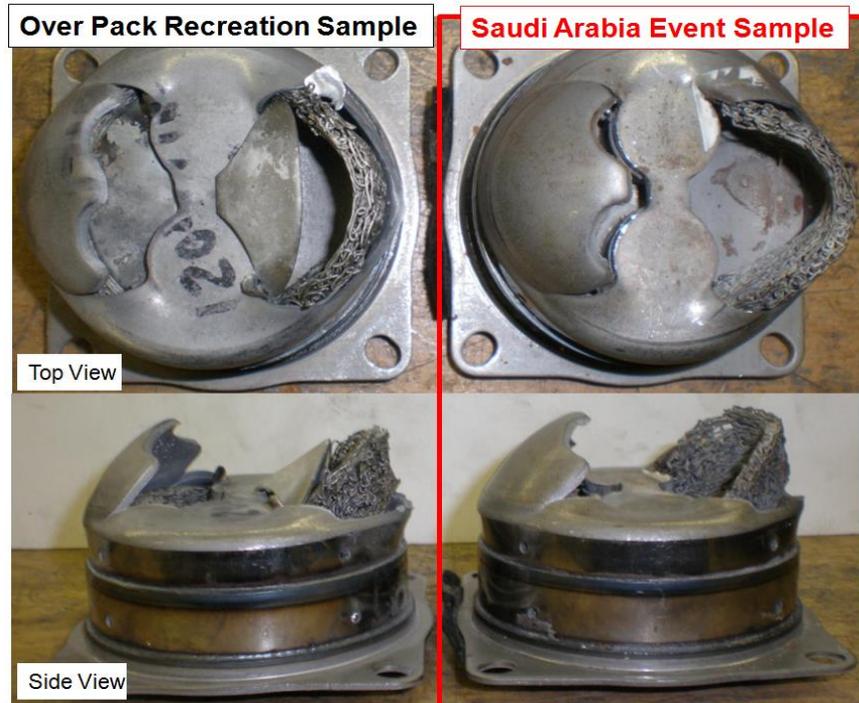
During the April 2012 meeting, Takata presented a hypothesis that the rupture resulted from a propellant overload. Takata hypothesized that, in the event an extra batwing wafer (five as opposed to four) was inserted into the disk press, the overpack would cause the propellant to crush and break. This breakage would increase the surface area of the propellant and the eventual burn rate, possibly leading to excessive internal pressure and rupture. While the propellant manufacturing line had a batwing height check to make sure extra propellant was not loaded during the time the event inflator was manufactured, Takata surmised that the height check might not catch the overpack when a batwing was broken. Takata tested its hypothesis by overpacking a secondary chamber of a sample PSDI inflator with an extra batwing and then deploying the inflator. The result was similar to that seen in the Saudi Arabia event (see photos, below). Takata concluded that the overpack hypothesis should be further analyzed. Takata also determined that the effect of Saudi Arabia's extremely hot environment warranted additional consideration and proposed testing the hypothesis by conducting heat cycle aging tests for both the propellant and the inflator.

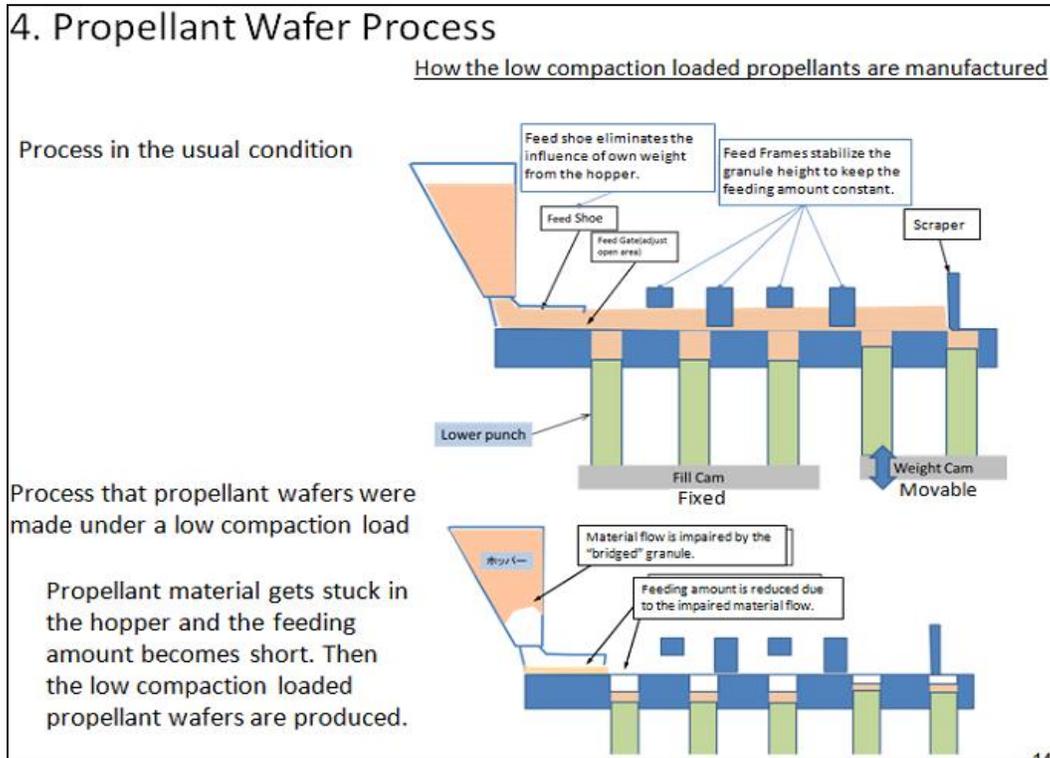
Takata explained how low compaction load propellant for PSPI and SPI inflators could have been manufactured. If an improper amount of propellant granules was loaded into the press, a "bridge" would be created that essentially clogged the flow of propellant and resulted in a decreased feed of propellant (see depiction, below). The compaction load during pressing varied based on the amount of propellant. Thus, the hypothesis was that decreased feed caused by the clog resulted in propellant lots with low compaction load.

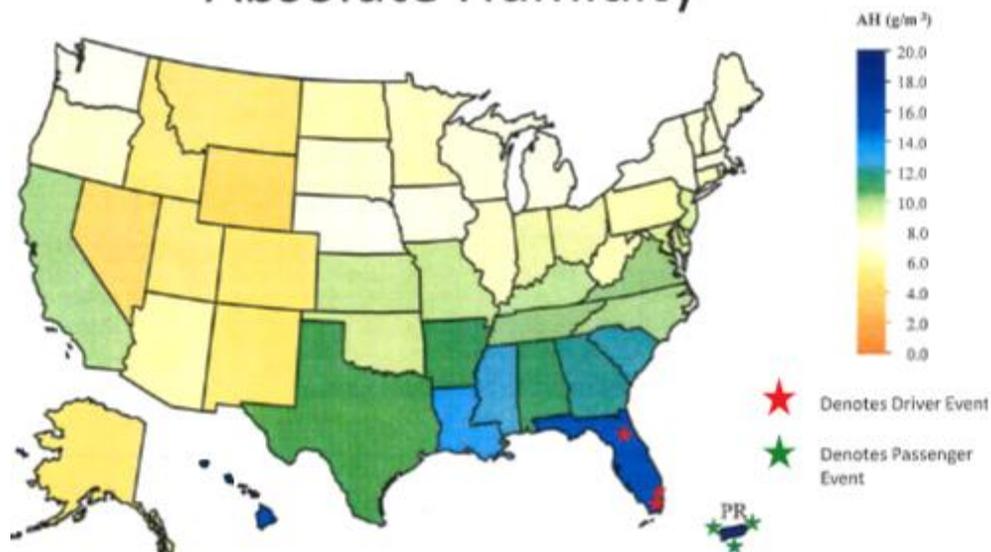
Beta Incident Location and Absolute Humidity

On May 20, 2014, Takata met with NHTSA regarding the six Beta Events that it was aware of at that time. Takata told NHTSA that its “tentative conclusion” was that the Beta Events “reflect a combination of long-term exposure to [HAH] environment[s], and processing issues that may have influenced aging stability.” In support of this “tentative conclusion,” Takata pointed to the location of the Beta Events that had occurred thus far.

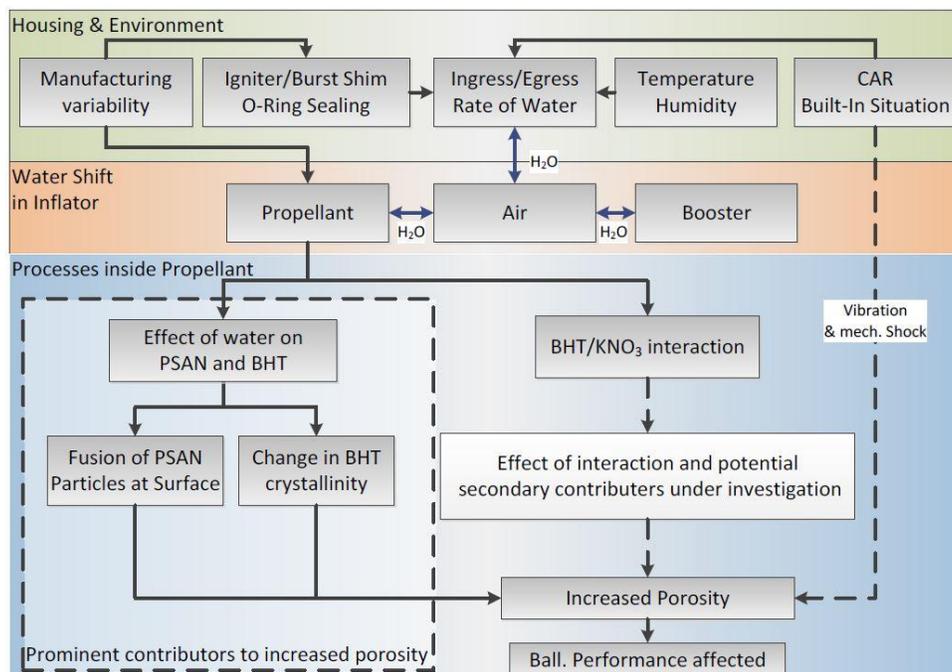
Fraunhofer’s February 2015 Fault Tree Analysis

In February 2015, Fraunhofer issued a final, summary report of its then-current findings regarding the root cause(s) of inflator ruptures. Fraunhofer’s overall fault tree analysis is depicted below.⁵¹

As the fault tree analysis shows, Fraunhofer's investigations pointed to increased porosity in the propellant wafers, which, in turn, causes the propellant to perform more aggressively.

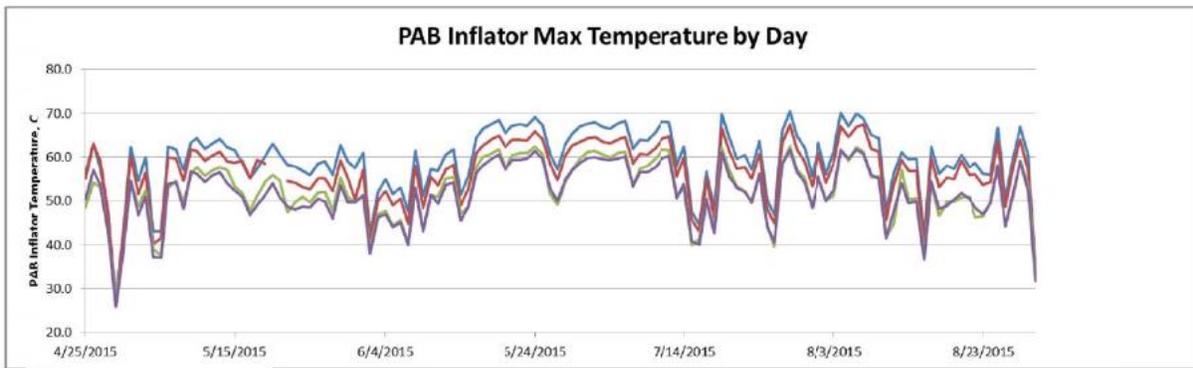
On September 29, 2015, Takata updated its vehicle manufacturer customers on the state of its investigation. The root cause statement provided at the March 2015 update to vehicle manufacturers remained unchanged, and Takata provided additional data and explanation of the potential for ingress and movement of moisture and effects upon the propellant. First, Takata stated that its in-vehicle testing had not shown a correlation between the inflator’s rupture rate and the humidity in the vehicle or moisture content inside the inflator. Rather, of all of the measurements taken, “the passenger inflator max temperature has the strongest correlation to the field outcome.” On this point, Takata found that the maximum temperature varies between vehicles in a small but “potentially critically important” way. The chart below shows the interior temperatures of different vehicles in Miami over a period of months.

As can be seen, only in certain vehicle types does the interior temperature regularly rise above 60°C. This fact appears to be significant, Takata observed, because rupture rates appear to increase as the maximum passenger airbag temperature rises above 60°C, as show below:

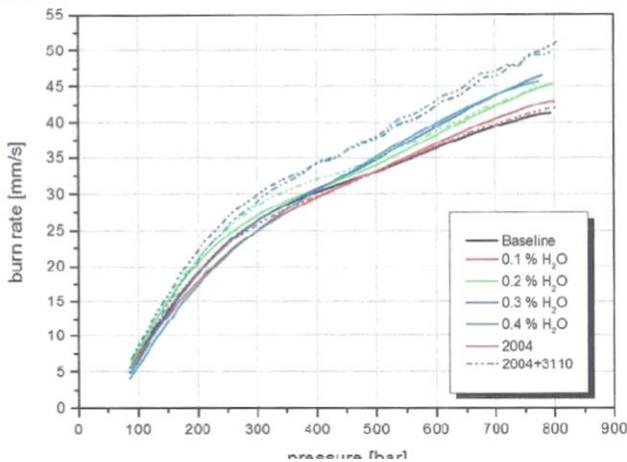
Artificial cycling tests

The report also discussed testing regarding the difference in burning characteristics between field returns and propellant put through artificial cycling tests conducted by Fraunhofer intended to recreate porous burning. As can be seen in the Fraunhofer chart below on the left, increased moisture due to artificial cycling results in a roughly uniform increase in burning rate across the entire range of pressures. The Fraunhofer chart on the right, by comparison, shows what is seen in the field: a highly non-uniform increase in burning rates that is exhibited only in the high pressure ranges.

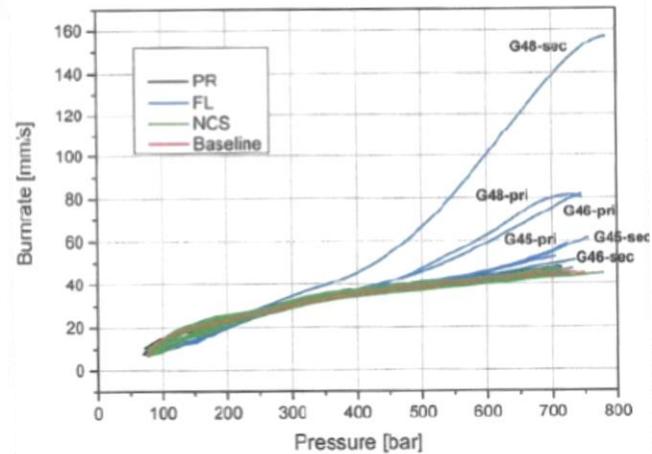
Field return testing

Takata noted that this effect can also be seen in the internal chamber pressure within an inflator. The internal pressure of an inflator increases steadily and predictably with increasing propellant degradation due to increased moisture and temperature cycling during validation testing. Conversely, the results of the field returns do not follow the same characteristic.

In sum, Takata concluded that vehicle manufacturer validation tests do not degrade the propellant in the same manner as observed in the aged field returns. Accordingly, Takata concluded that vehicle manufacturer validation environments are not useful in determining the expected life of the inflators in the field.
