SSC 7LB - 2007 LEXUS ES 350 OPTIONAL ALL WEATHER FLOOR MAT
SAFETY RECALL NOTICE

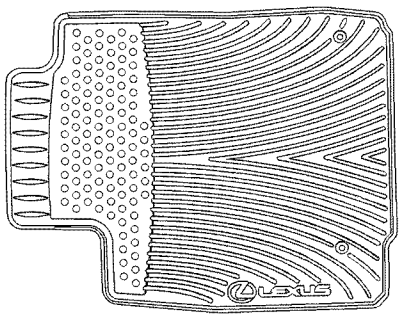
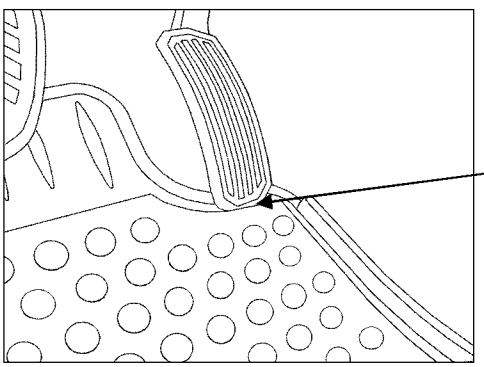
Lexus All Weather Floor Mat Involved in this recall

In recent months, Lexus has received reports regarding the optional Lexus All Weather Floor Mat (please see the diagram for the specific mat involved) slipping forward and interfering with the movement of the accelerator pedal. Lexus has investigated these reports and determined that if the optional Lexus All Weather Floor Mat (either by itself or if it is placed on top of the existing carpeted floor mat) is **not secured by the retaining hooks** and the mat moves forward, it may interfere with the accelerator pedal from returning to the idle position. If this condition occurs, in the worst case, it may increase the possibility of a crash.

If the Lexus All Weather Floor Mat is not **secured by the retaining hooks (clips)** and the mat moves forward, it may interfere with the accelerator pedal.

Lexus is currently developing an improved driver's seating position All Weather Floor Mat. We will send another notification when the improved driver's seating position All Weather Floor Mat is available. The original driver's seating position All Weather Floor Mat will be exchanged for an improved one at that time.

Until the improved driver's seating position All Weather Floor Mat is ready, we request your assistance in regularly verifying the floor mat is properly secured using the retaining hooks (clips) provided. Good times to check are after filling your vehicle's tank with gasoline, after a carwash and/or vehicle interior cleaning, when another driver is about to drive the vehicle, etc. More than one floor mat should never be used in the driver's seating position, as the vehicle is designed to accommodate only one floor mat at a time.
