2020 SAE Government Industry Meeting

Status of NHTSA's Roof Ejection Mitigation Research

Aloke Prasad, NHTSA

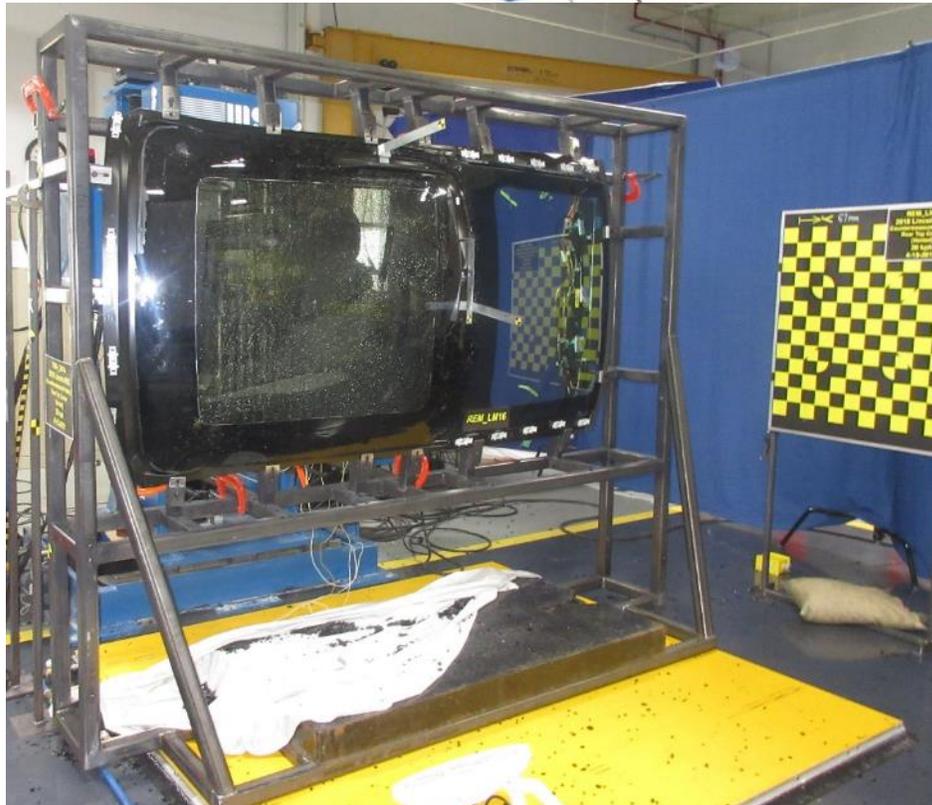
Test Setup

- FMVSS No. 226 Impactor
- Featureless headform (40 lbs. [18kg])
- Displacement, speed from Linear Pot (LVDT)
- Accelerometer on the ram

Linear Variable Differential Transformer (LVDT)

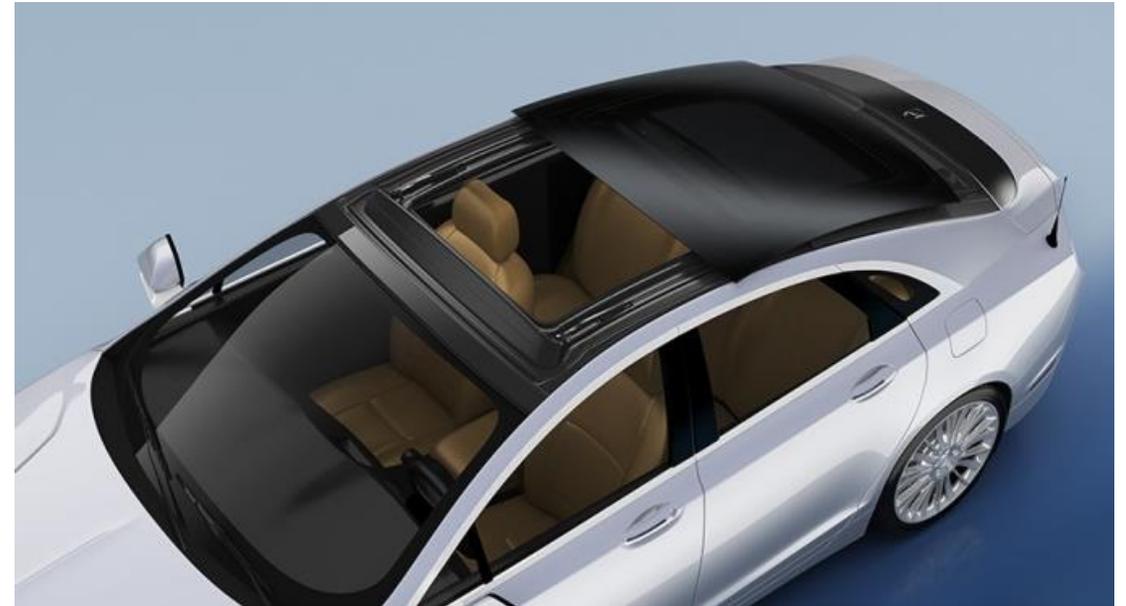
Lincoln MKZ

- Large panoramic design
- Outer slider type (opens to outside)
- ProTec 2[®] (PET) film
- Attached to rails at front and back
- Production and countermeasure panels

PET = polyethylene terephthalate

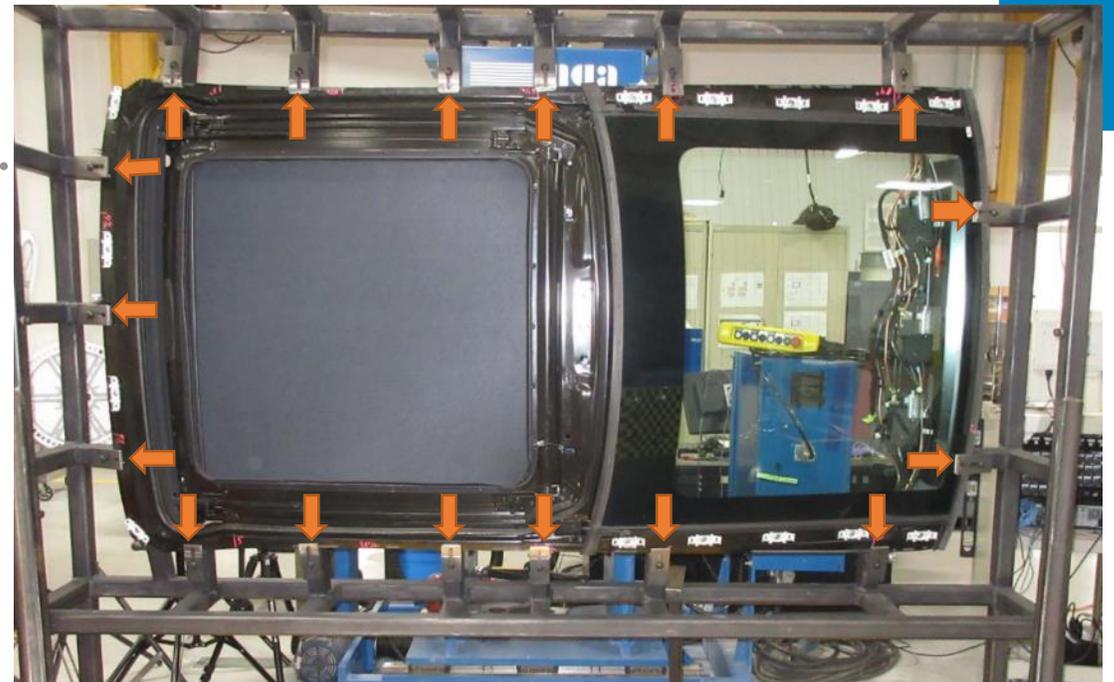
Test Setup

- Custom made frame – module attached to frame using 17 sliding brackets (shown with arrows)

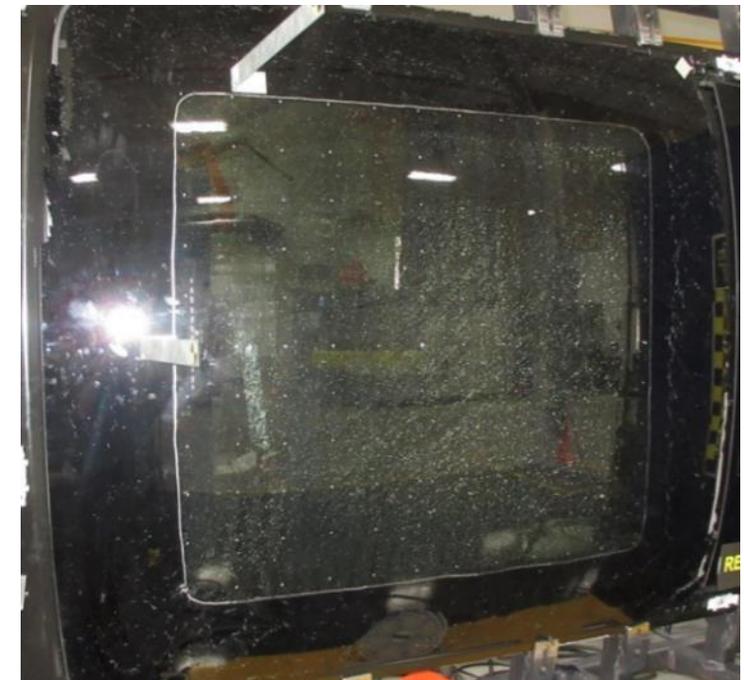
- Glass pre-broken on one side (outside)
 - Punched once in corner– glass fractured all the way across
- Brackets with targets for photographic analysis attached at inner glue line (near frit line) – measure edge excursions

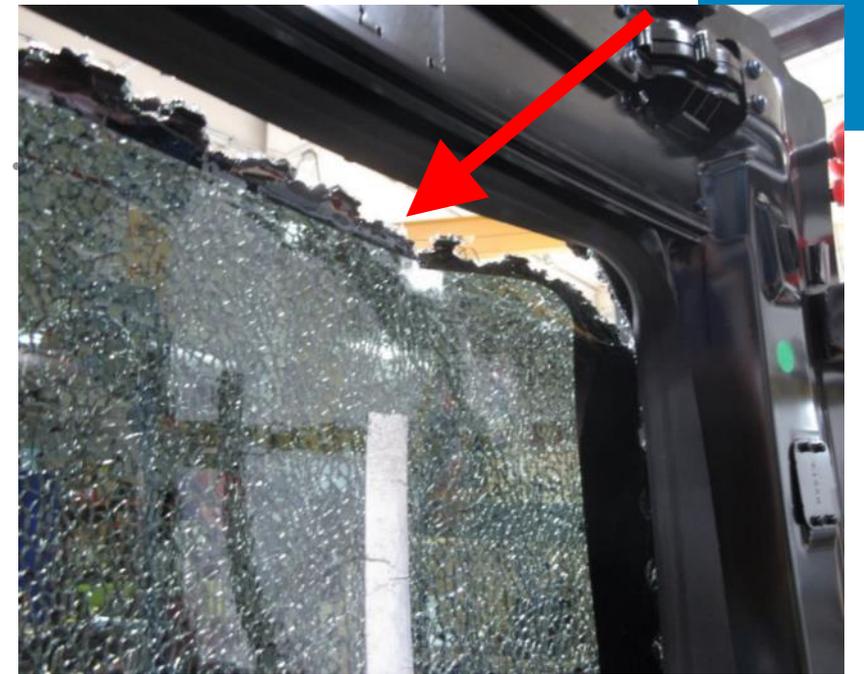
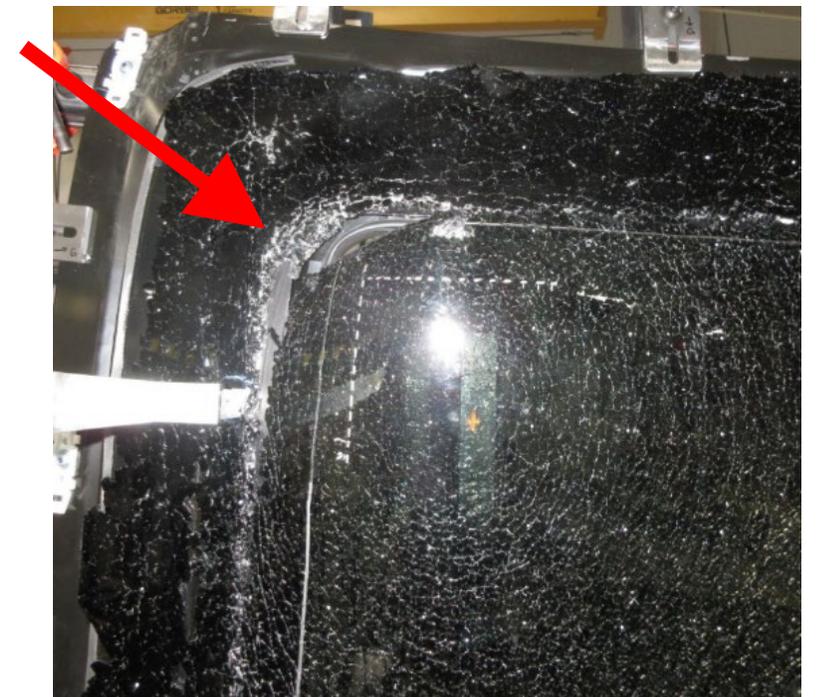
Plastic Film Tear

Production panel- Front corner – 16 km/h

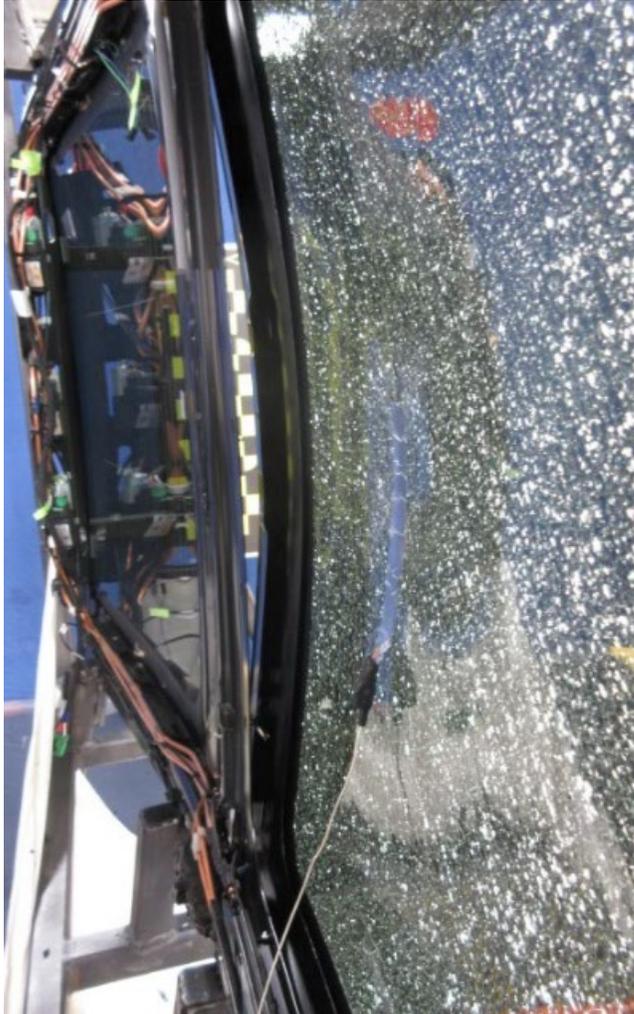
Some bending of steel frame

- 4 inch ball did not pass through

Rear edge – mid @ 20 km/h

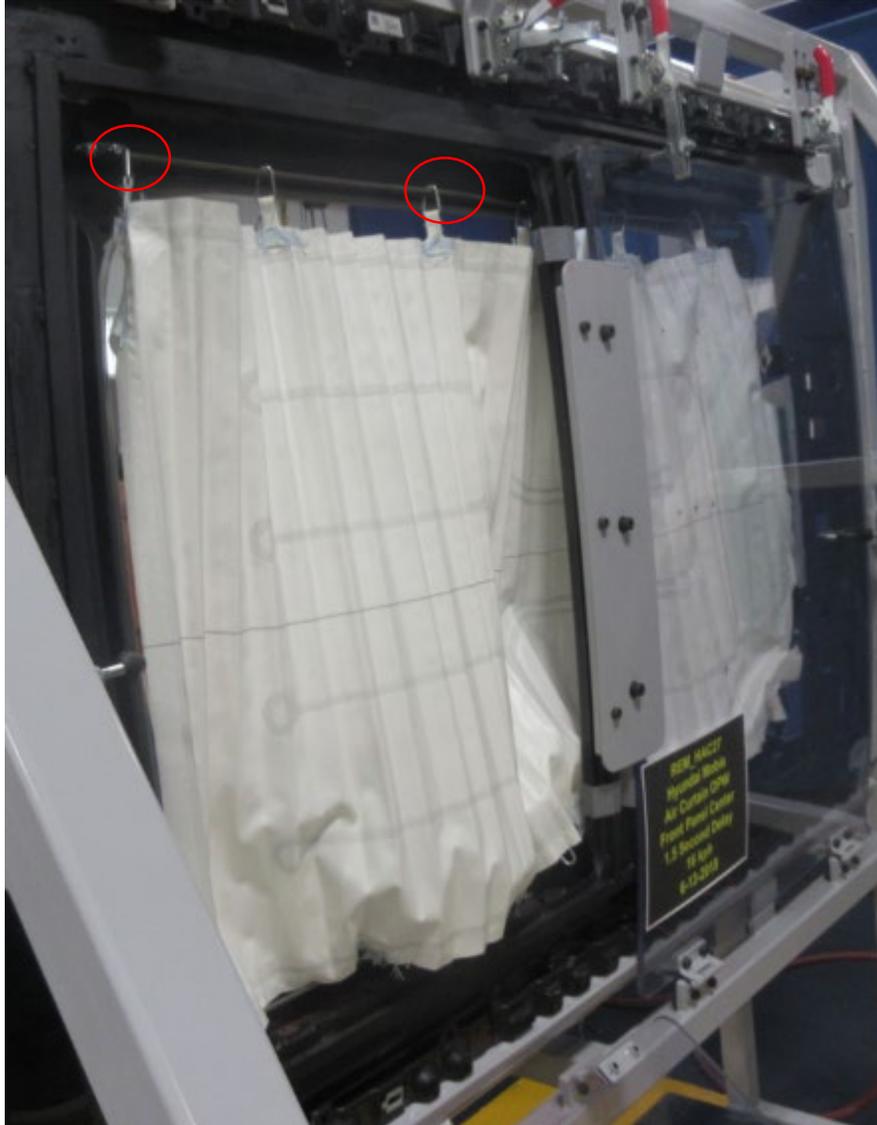
Curtain Air Bag Module Assembly

- Guide rods mounted along lateral edges
 - 2 nuts per end
 - Bolt to prevent turning
- Guide rings on both sides hold bag to module along guide rods

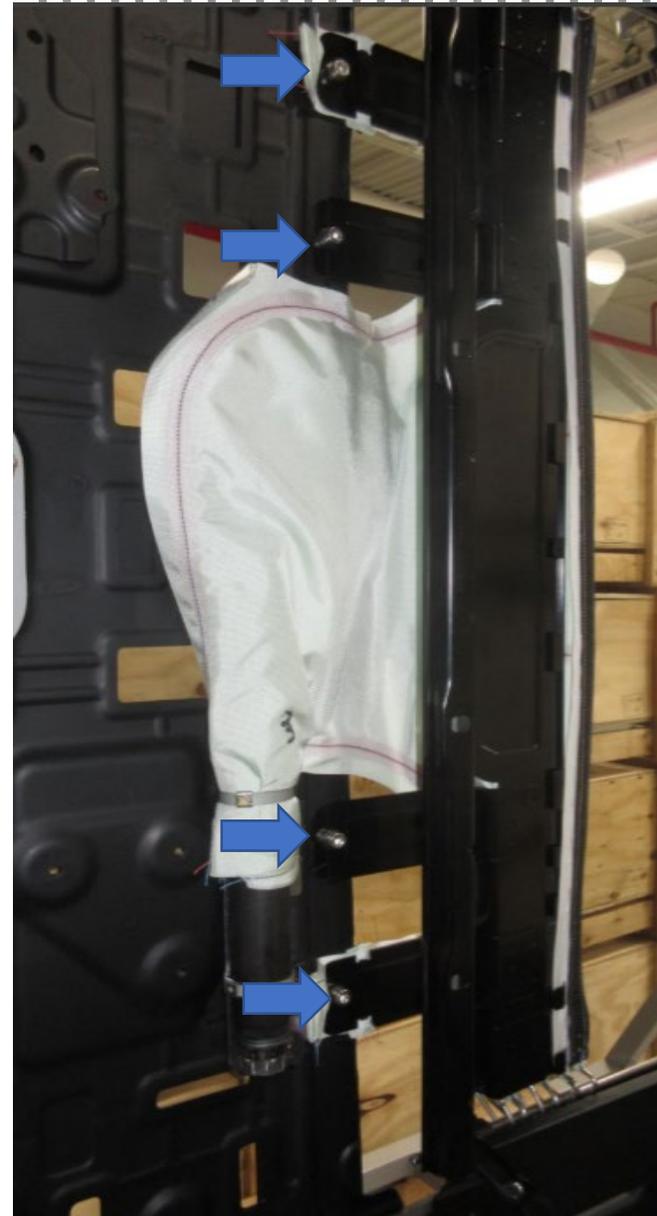
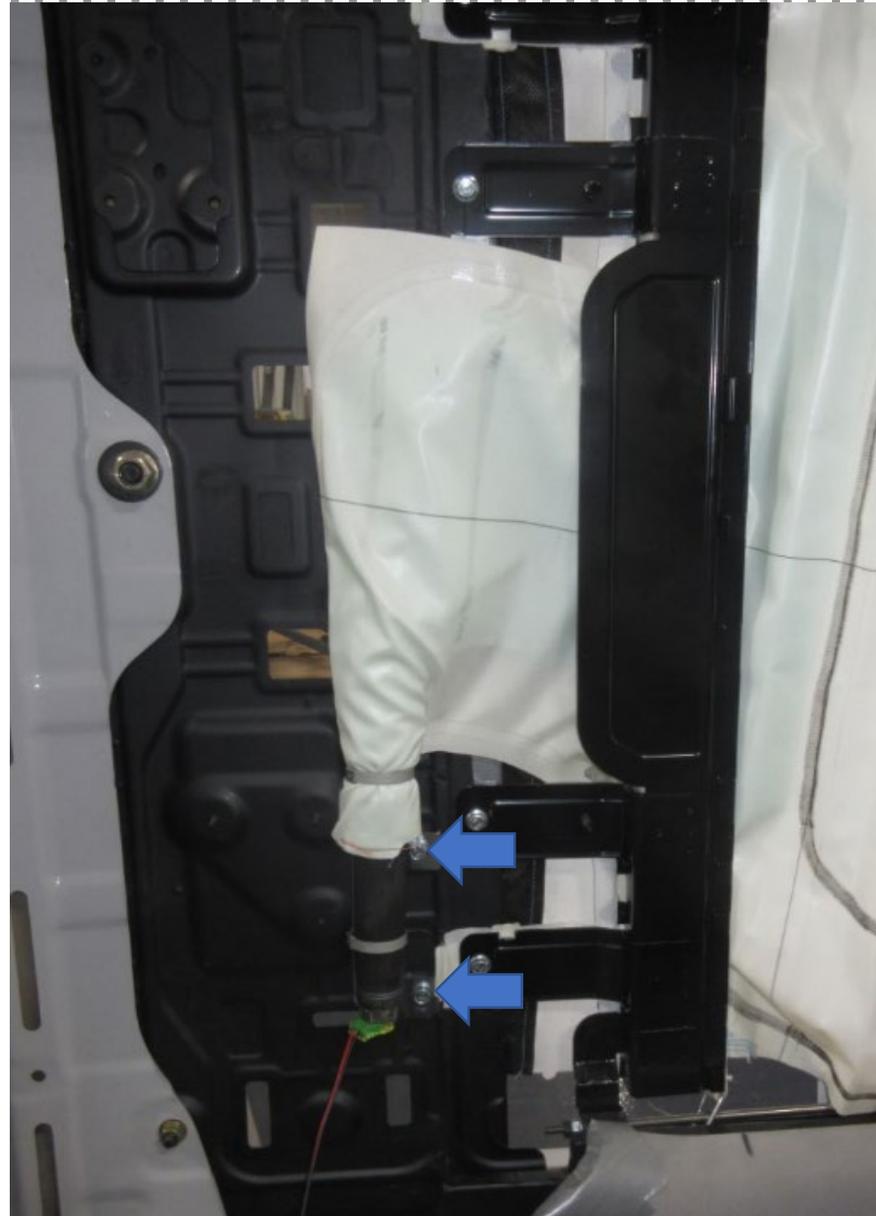
Curtain Air Bag Module Assembly

- Air bag mounted on rear of module at six locations, four on interior, two on exterior
- Inflator secured at two locations

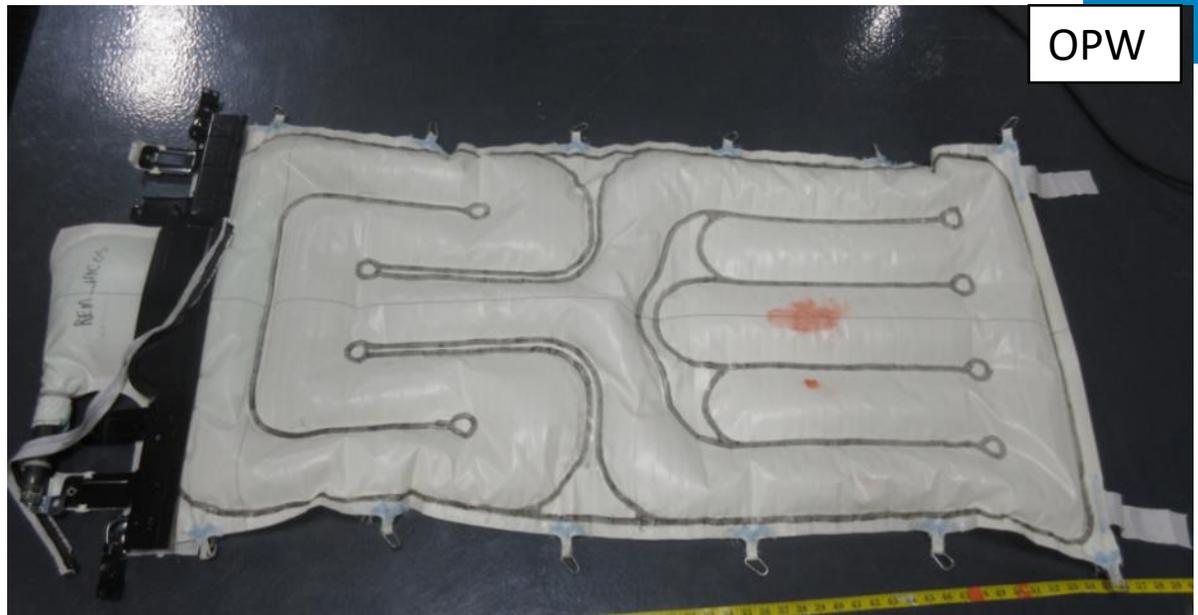
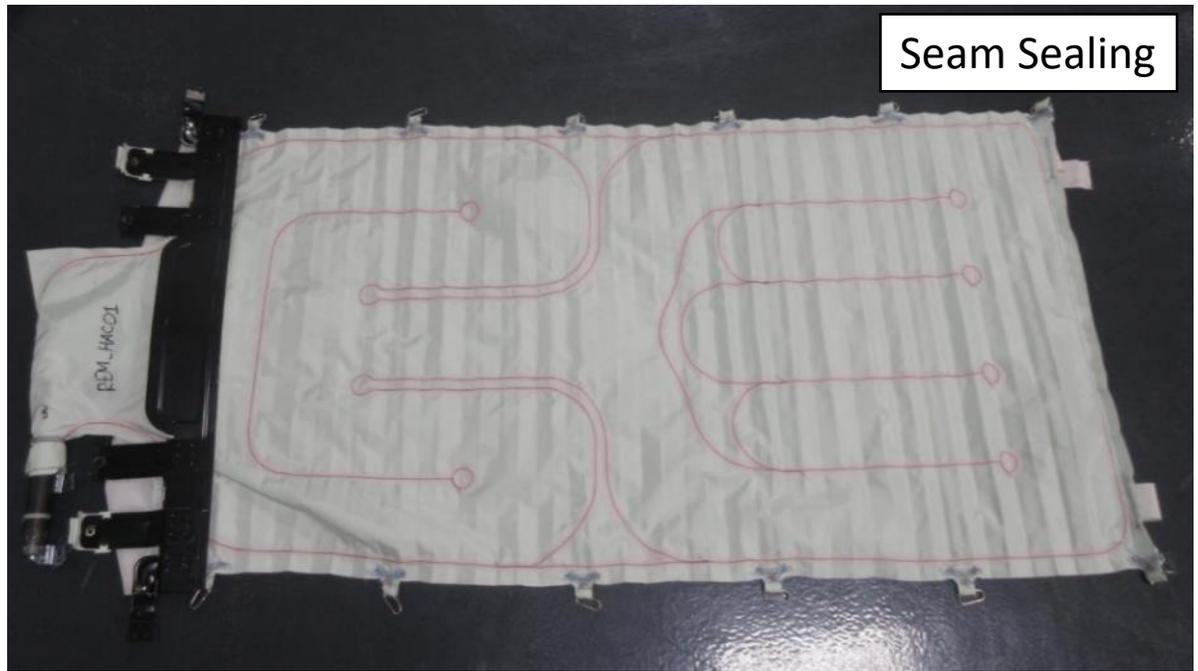
Curtain Air Bag Types

- Curtain types
 - One Panel Woven (OPW)
 - 30 bags
 - Seam Sealing (SS)
 - 15 bags
 - Same inflator and chamber layout

- Differences between the two:
 - Material
 - Fabric in OPW sealed by plastic film material, woven together at seam

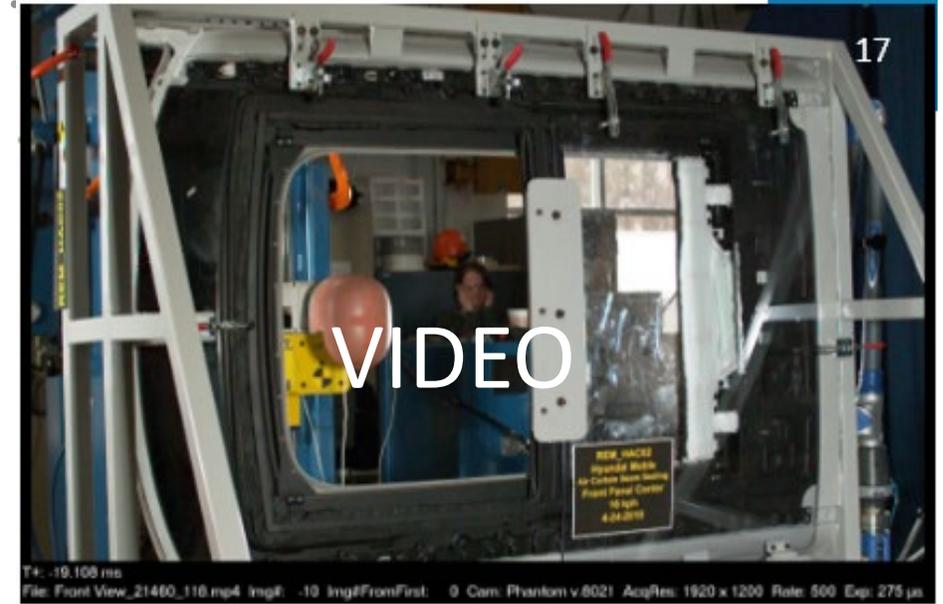
- Open bag across daylight opening
 - Assumed successful deployment
 - Full automatic deployment found to not be reliable – 2 trials
 - 6 Impact Locations
 - Front Corner, Front Edge – Mid, Center, 2/3 Lateral Edge, Rear Edge – Mid, Rear Corner
- 3 speeds
 - 14 km/h, 16 km/h, 20 km/h
- Plexiglass positioning
 - Front panel impacts – front plexiglass down, rear up – “moveable panel”
 - Rear panel impacts – front and rear plexiglass down
 - Plexiglass is zero plane for excursion measurements

Some rear panel targets eliminated per FMVSS No. 226 procedure

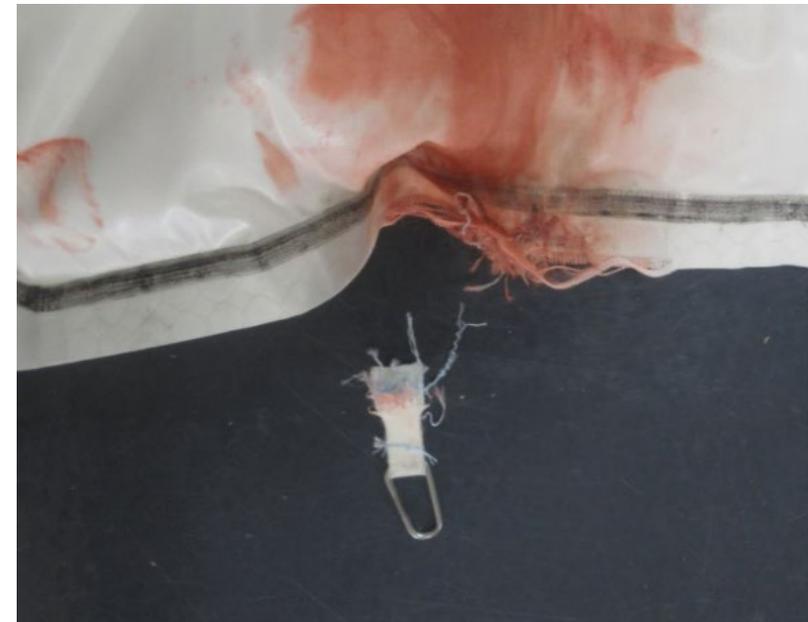
Failure Modes

- Ripping at stitching of guide ring
 - When headform impacted near stitching
 - Full and partial ripping
 - Headform still contained
