Subject: Special Service Campaign (SSC) 7LB (Safety Recall)
Lexus ES 350 All Weather Floor Mat Accessory for 2007 and Early 2008 Model Year Vehicles

Special Service Campaign (SSC) – 7LB (Safety Recall) Q&A
Lexus ES 350 All Weather Floor Mat Accessory for 2007 and Early 2008 Model Year Vehicles

SSC 7LB – LEXUS ES 350 ALL WEATHER FLOOR MAT ACCESSORY SAFETY RECALL NOTICE FOR 2007 AND EARLY 2008 MODEL YEAR VEHICLES

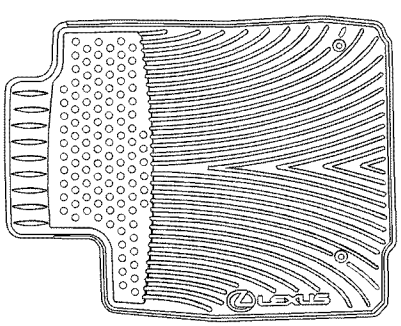
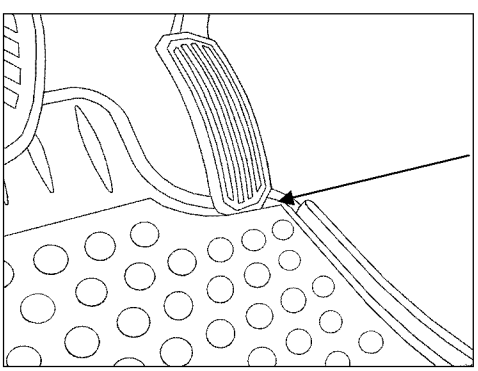
Lexus ES 350 All Weather Floor Mat Involved in this recall

If the Lexus ES 350 All Weather Floor Mat is not **secured by the retaining hooks (clips)** and the mat moves forward, it may interfere with the accelerator

Until the replacement All Weather Floor Mat for the driver's seating position is ready, we request your assistance in helping customers to verify the floor mat is properly secured using the retaining hooks (clips) provided. If the mat is properly secured, it will not interfere with the accelerator pedal. More than one floor mat should ***never*** be used in the driver's seating position, as the retaining hooks (clips) are designed to accommodate only one floor mat at a time.

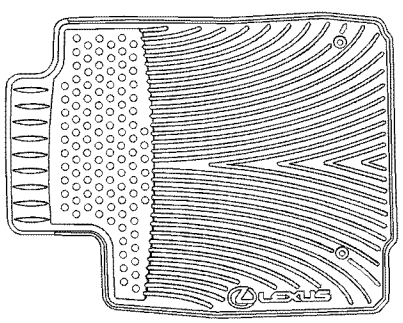
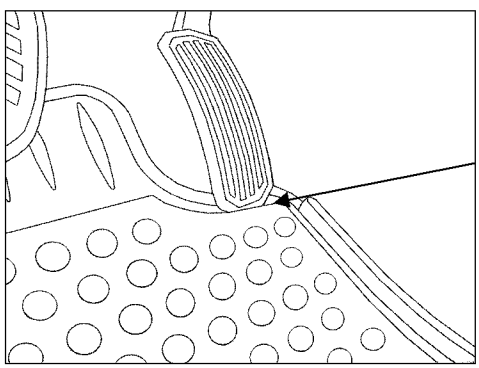
Lexus ES 350 All Weather Floor Mat Involved in this recall

If the Lexus ES 350 All Weather Floor Mat is not **secured by the retaining hooks (clips)** and the mat moves forward, it may interfere with the accelerator pedal.

Until the new driver's seating position Lexus ES 350 All Weather Floor Mat is ready, we request your assistance in regularly verifying the floor mat is properly secured using the retaining hooks (clips) provided. If the mat is properly secured, it will not interfere with the accelerator pedal. Good times to check are after filling your vehicle's tank with gasoline, after a carwash and/or vehicle interior cleaning, when another driver is about to drive
