<b>Condition Title</b>	<b>Dealer Code</b>
MIL ON - DTC P0351, P0301 - Wire Harness	19063
MIL ON P0121 and loss of engine power - wire harness	12145
MIL ON P035#: Vehicle ran rough.	31062
Vehicle intermittently stalls - engine wire harness	47025

T3 Id	Vin	L/O Date	Opened Date	Mileage	Dtc Code	Dealer Code	Region
TA080930360	JTDBL40E29J [REDACTED]	2/5/2008	2-Apr-08	151	P0351,P0352,P0353,P0354	31062	NYR

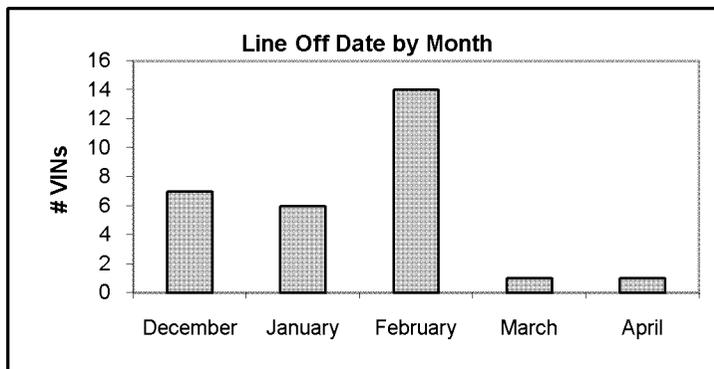
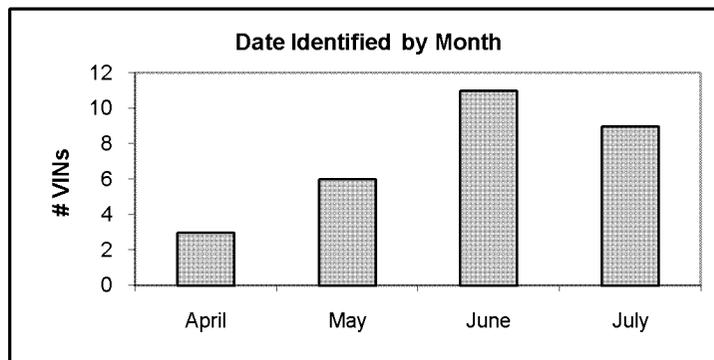
L/O Date by Month	Month
7	December
6	January
14	February

1	March
1	April

Vin	L/O Date	Date Identified
JTDBL40E29J	2/5/2008	4/2/08
JTDBL40E99J	12/18/2007	4/22/08
JTDBL40E299	12/25/2007	4/25/08
JTDBL40E199	2/22/2008	5/7/08
JTDBL40E89J	2/28/2008	5/8/08
JTDBL40E39J	12/20/2007	5/14/08
JTDBL40E399	1/18/2008	5/15/08
JTDBL40E999	1/11/2008	5/16/08
JTDBL40EX9J	1/30/2008	5/30/08
JTDBL40E399	1/29/2008	6/2/08
JTDBL40E999	2/18/2008	6/3/08
JTDBL40E799	1/10/2008	6/11/08
JTDBL40E69J	2/18/2008	6/12/08
JTDBL40E79J	12/18/2007	6/13/08
JTDBL40E799	2/28/2008	6/14/08
JTDBL40E29J	2/8/2008	6/17/08
JTDBL40E199	12/22/2007	6/19/08
JTDBL40E59J	3/31/2008	6/23/08
JTDBL40E79J	2/23/2008	6/27/08
JTDBL40E999	4/1/2008	6/30/08
JTDBL40E999	1/26/2008	7/1/08
JTDBL40E59J	2/26/2008	7/1/08
JTDBL40E999	2/7/2008	7/3/08
JTDBL40E999	2/26/2008	7/3/08
JTDBL40EX99	12/22/2007	7/8/08
JTDBL40E99J	12/20/2007	7/9/08
JTDBL40E999	2/26/2008	7/9/08
JTDBL40E899	2/27/2008	7/10/08
JTDBL40E999	2/7/2008	7/11/08
