SSC 7LB – LEXUS ES 350 ALL WEATHER FLOOR MAT ACCESSORY
SAFETY RECALL NOTICE FOR 2007 AND EARLY 2008 MODEL YEAR VEHICLES

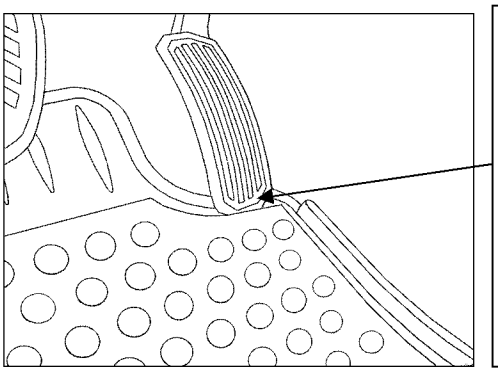
If the Lexus ES 350 All Weather Floor Mat is not **secured by the retaining hooks (clips)** and the mat moves forward, it may interfere with the accelerator pedal

Until the new driver's seating position Lexus ES 350 All Weather Floor Mat is ready, we request your assistance in regularly verifying the floor mat is properly secured using the retaining hooks (clips) provided. If the mat is properly secured, it will not interfere with the accelerator pedal. Good times to check are after filling your vehicle's tank with gasoline, after a carwash and/or vehicle interior cleaning, when another driver is about to drive the vehicle, etc. More than one floor mat should ***never*** be used in the driver's seating position, as the retaining hooks (clips) are designed to accommodate only one floor mat at a time. Please refer to the floor mat section of your Owner's Manual for further information regarding the retaining hooks (clips).
