SSC 7LB – LEXUS ES 350 ALL WEATHER FLOOR MAT ACCESSORY
SAFETY RECALL NOTICE FOR 2007 AND EARLY 2008 MODEL YEAR VEHICLES

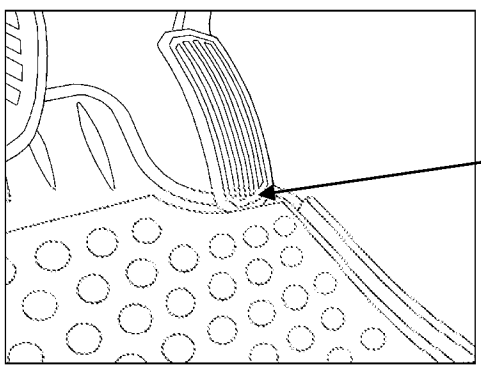
If the Lexus ES 350 All Weather Floor Mat is not **secured by the retaining hooks (clips)** and the mat moves forward, it may interfere with the accelerator pedal.

Until the new driver's seating position Lexus ES 350 All Weather Floor Mat is ready, we request your assistance in regularly verifying the floor mat is properly secured using the retaining hooks (clips) provided. If the mat is properly secured, it will not interfere with the accelerator pedal. Good times to check are after filling your vehicle's tank with gasoline, after a carwash and/or vehicle interior cleaning, when another driver is about to drive the vehicle, etc. More than one floor mat should ***never*** be used in the driver's seating position, as the retaining hooks (clips) are designed to accommodate only one floor mat at a time. Please refer to the floor mat section of your Owner's Manual for further information regarding the retaining hooks (clips).
