U.S. Department  
of Transportation  
**National Highway  
Traffic Safety  
Administration**

DOT HS 811 816

# **Post-Crash Hydrogen Leakage Limits and Fire Safety Research**

| 9. Performing Organization Name and Address<br>Battelle Memorial Institute<br>505 King Avenue<br>Columbus, OH 43201 | | | | 10. Work Unit No. (TRAIS) | |

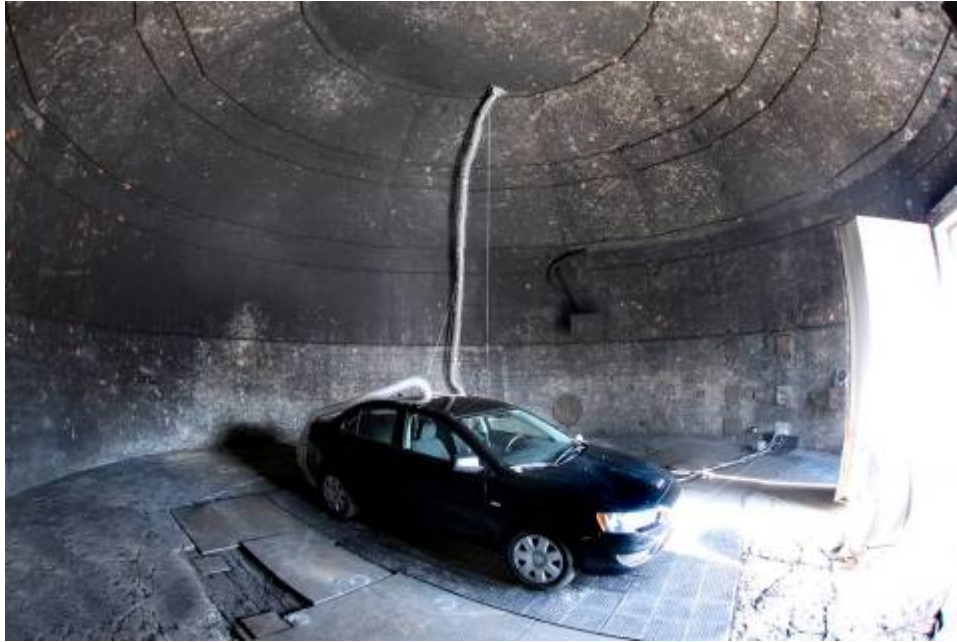
**Test Facility.** Tests were conducted at the Battelle High Energy Research Laboratory Area (HERLA) inside JS-10, a 42-ft diameter, steel-reinforced concrete, domed chamber capable of containing the blast from up to 50 lbs of TNT explosive or the equivalent energy of other flammable materials, including hydrogen and CNG. Conducting tests inside this large blast containment chamber precluded the influence of variable meteorological conditions, which could affect the dispersion and ignition properties of the hydrogen. Factors such as ventilation, temperature, and relative humidity were recorded during the testing (quiescent and within a controllable range). JS-10, shown in Figure I-1, is large enough to accommodate a vehicle and allows leak and ignition-fire tests to be conducted with flammable hydrogen-air mixtures.

**Figure I-1. JS-10 blast chamber/dome used for indoor testing of leak rates with car.**

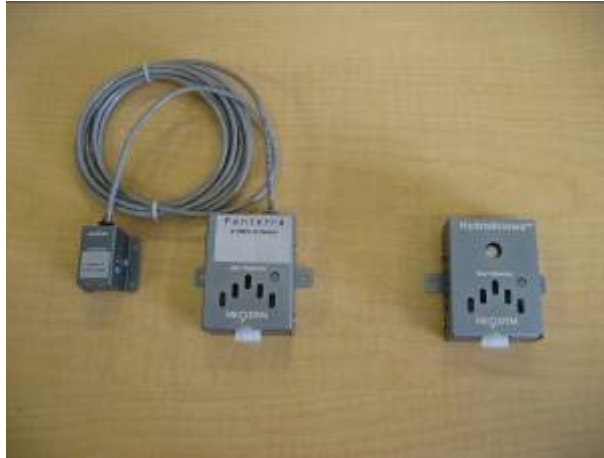
Neodym HydroKnowz sensors equipped with alarms were the second type of sensor. These sensors were placed on the ceiling in the blast chamber and in the control room to monitor the presence of hydrogen during testing in order to safeguard against the accumulation of potentially dangerous (flammable) hydrogen in either location while personnel were present. These sensors have higher resolutions, but can measure only up to 4 percent hydrogen concentrations. The alarms were set to activate when hydrogen concentrations reached 1 percent (10,000 ppm) in air. Figure I-2 shows the two sensor types in their respective housings.

**Figure I-2. Neodym Panterra (left) and HydroKnowz (right) sensors.**

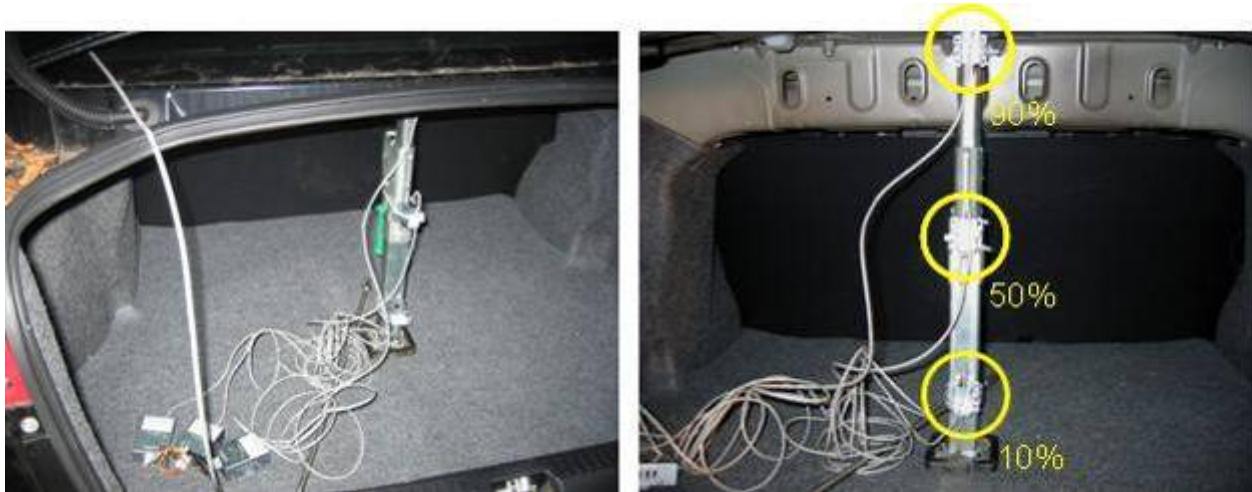
Trunk compartment sensors were located approximately 155 in. back from the sensor reference point, Figure I-3. Sensors were mounted along a vertical pole that extended from the trunk bottom inside surface to the top inside surface, covering a vertical dimension of approximately 32 in. This sensor array was positioned above the spare tire location.

**Figure I-3. Positioning of trunk compartment sensor suite at 10 percent, 50 percent, and 90 percent heights.**

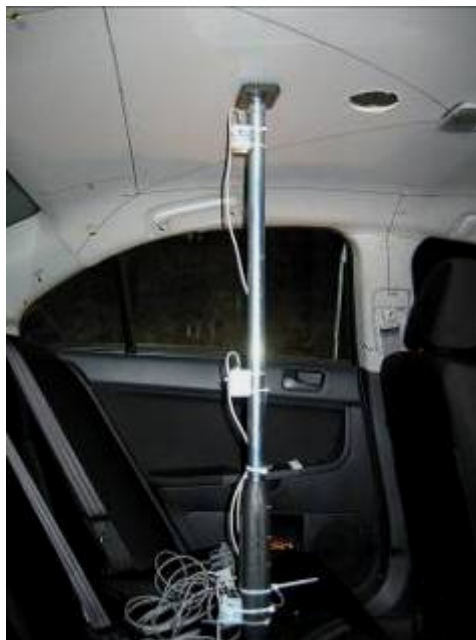
The rear-passenger compartment sensors were mounted in a similar fashion, shown in Figure I-4, and were located approximately 122 in. from the vehicle sensor reference point. The height, approximately 37 in., was defined by the roof liner and the top center of the rear-passenger seat. This arrangement again shown some symmetry for concentration measurements, and approximately represented the locations of an occupant's waist, chest and head.

**Figure I-4. Positioning of rear-passenger compartment sensor suite at 10 percent, 50 percent, and 90 percent heights.**

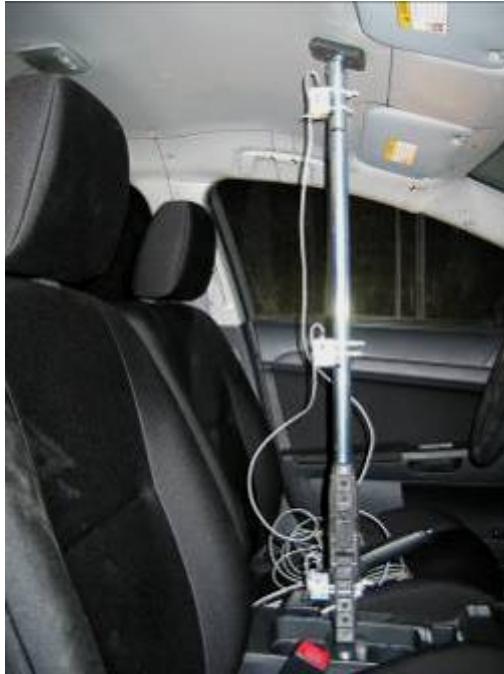
The front passenger compartment sensors were placed approximately 90 in. back from the reference point. The sensors, shown in Figure I-5, were mounted on a pole placed in the front passenger cup-holder console and extended to the roof liner, approximately 34 in.

**Figure I-5. Positioning of front passenger compartment sensor suite at 10 percent, 50 percent, and 90 percent heights.**

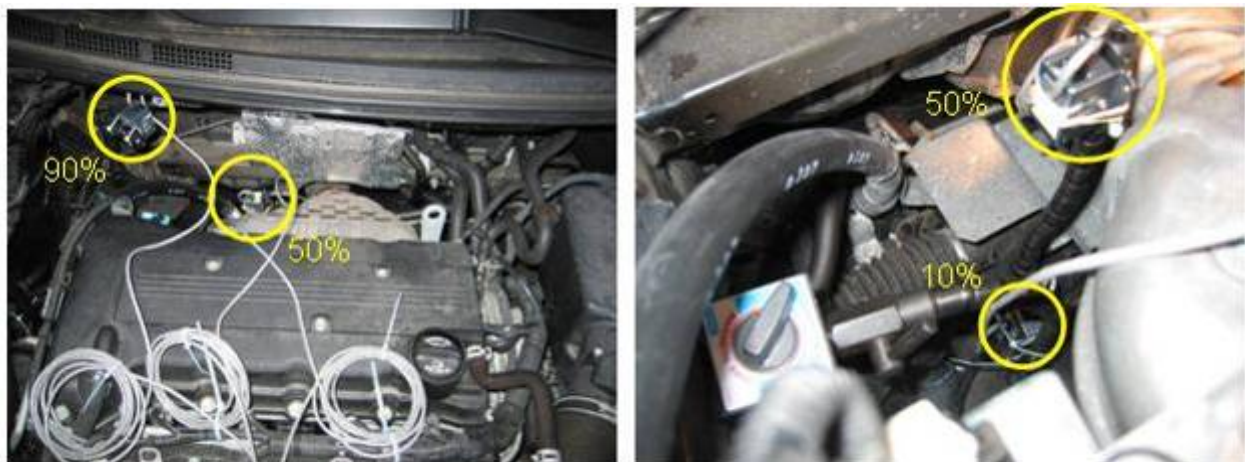
The engine compartment sensors, shown in Figure I-6, were located approximately 44 in. back from the reference point, between the engine and firewall. Magnetic mounting bases with adjustable holders were used to mount sensors at 10 percent, 50 percent, and 90 percent of the total compartment height, approximately 26.5 in. These sensor faces were not vertically in-line with one another due to the free volume restrictions imposed by engine components, tubing, hoses, and fluid reservoirs. These components were left in place and the sensors were positioned around them, keeping potential hydrogen flow paths intact. As with the other suites, each sensor face was oriented downward to promote detection of the rising hydrogen.

**Figure I-6. Positioning of engine compartment sensor suite at 10 percent, 50 percent, and 90 percent heights.**

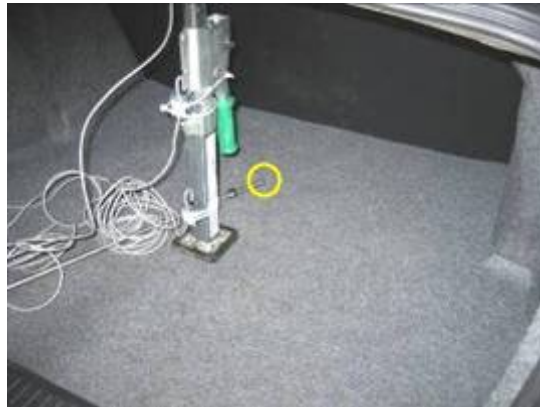
- 1 leak fed directly into the trunk compartment (Figure I-7).

**Figure I-7. Hydrogen leak originating in the trunk.**

Injecting hydrogen directly into these compartments was done to create a *worst-case* scenario by providing the quickest, most direct means for hydrogen to accumulate to potentially combustible mixtures within these compartments.

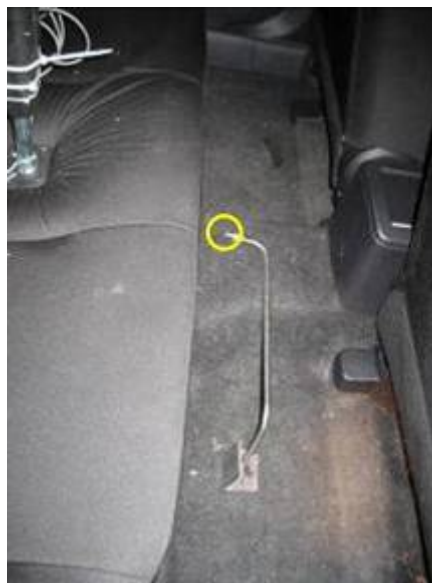
- 1 leak fed directly into the passenger compartment (Figure I-8).

**Figure I-8. Hydrogen leak originating from the rear passenger compartment.**

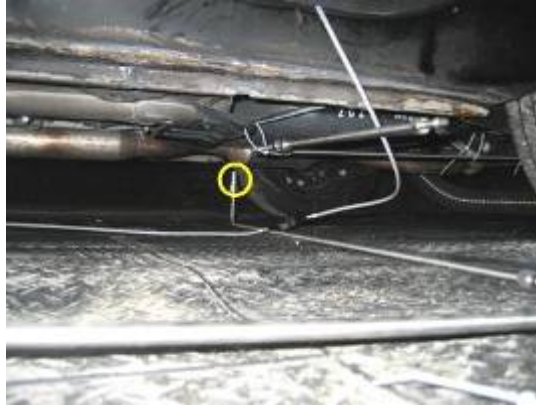
- 1 leak flowed straight up (Figure I-9).

**Figure I-9. Hydrogen leak straight up from tank position underneath automobile.**

Five secondary leak scenarios represented leaks originating from the fuel tank and system line underneath the automobile. Four locations were under the vehicle near its lengthwise midpoint along the centerline at an envisioned hydrogen tank position:

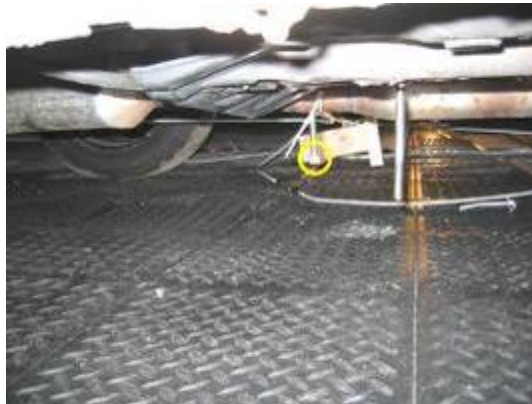
- 1 leak flowed straight down (Figure I-10).

**Figure I-10. Hydrogen leak straight down from tank position underneath automobile.**

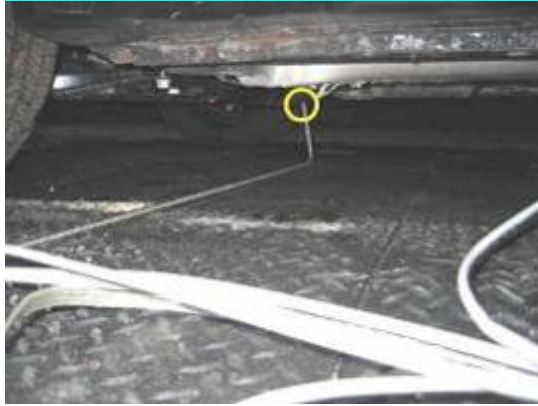
The final position was near the automobile's firewall with an orientation set to maximize hydrogen flow into the engine compartment. This scenario was added to the test matrix because none of the other leakage locations resulted in significant hydrogen concentrations in the engine compartment.

- 1 leak flowed up forward of the firewall (Figure I-13).

**Figure I-13. Hydrogen leak slightly forward at firewall position underneath automobile.**

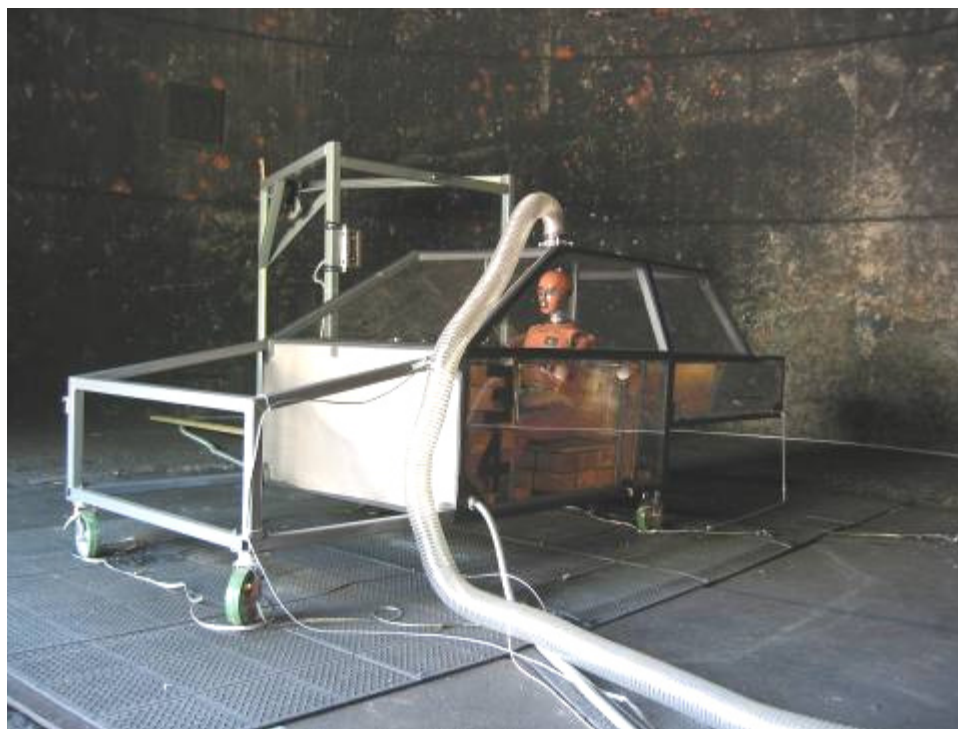
**Figure II-1. ACS and manikin in JS-10 blast chamber for hydrogen ignition testing.**

**Test Facility.** Tests were conducted at the Battelle HERLA inside JS-10, a 40-ft diameter, steel-reinforced concrete, domed chamber capable of containing up to 50 lbs of TNT explosive or energy equivalent of other flammable materials, including hydrogen and CNG. Conducting tests inside this large blast containment chamber precluded the influence of variable meteorological conditions, which could affect the dispersion and ignition properties of the hydrogen. Factors such as ventilation, temperature, and relative humidity were recorded during the testing (quiescent and within a controllable range). JS-10, shown in Figure II-1, is large enough to accommodate a vehicle and allows leak and ignition-fire tests to be conducted with flammable hydrogen-air mixtures.

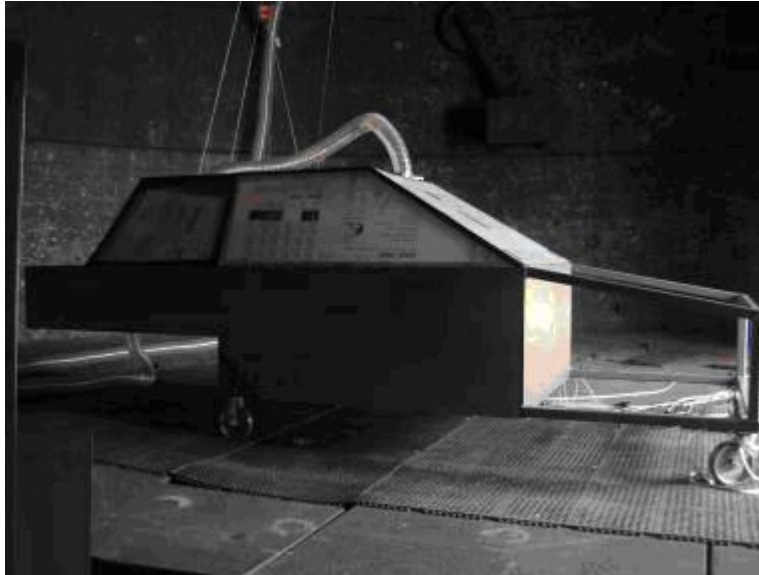
**Figure II-2. Fully assembled ACS.**

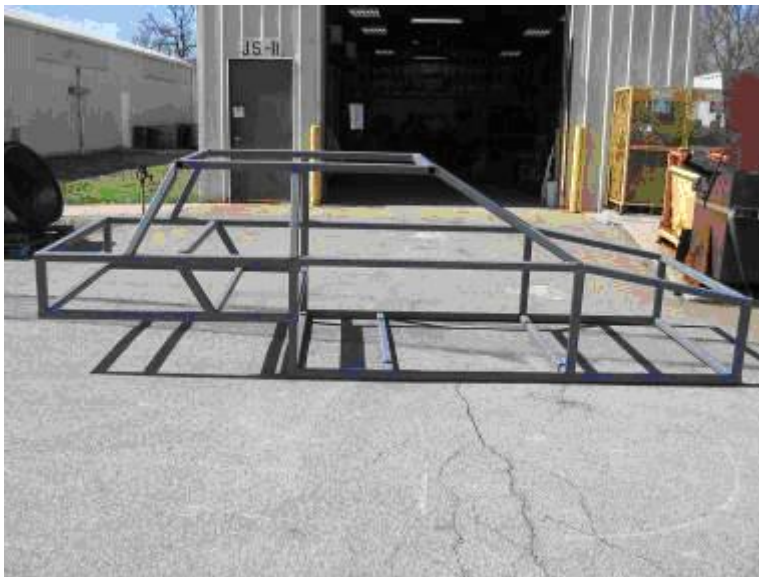
**Figure II-3. Welded framework of ACS.**

The ACS framework, Figure II-3, consisted of 2 in. steel tubing welded together to approximate the overall geometry and dimensions of the Lancer. A section of the ACS framework representing the engine compartment was included in the design; however, no use of this

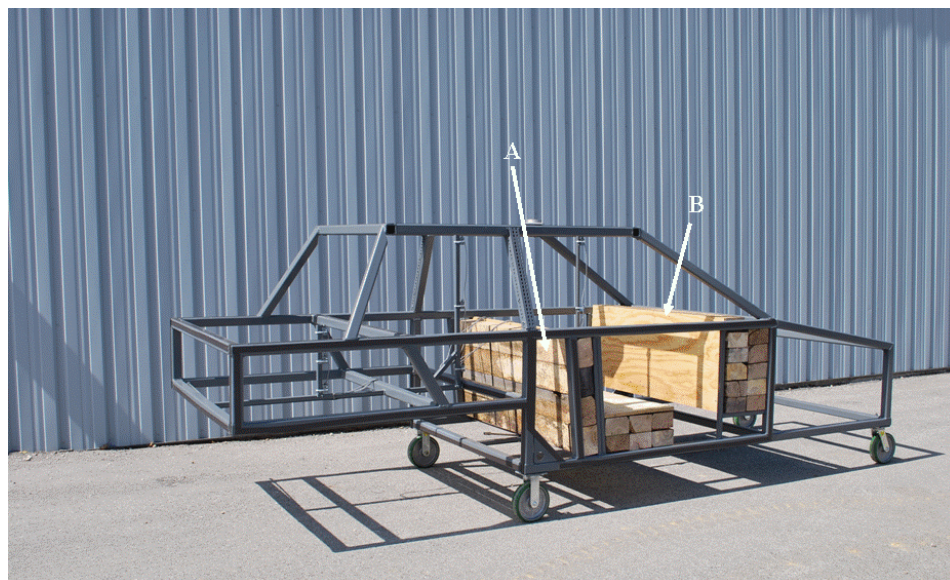
**Figure II-4. View of simulator front seat (A) and dashboard (B) components in ACS.**

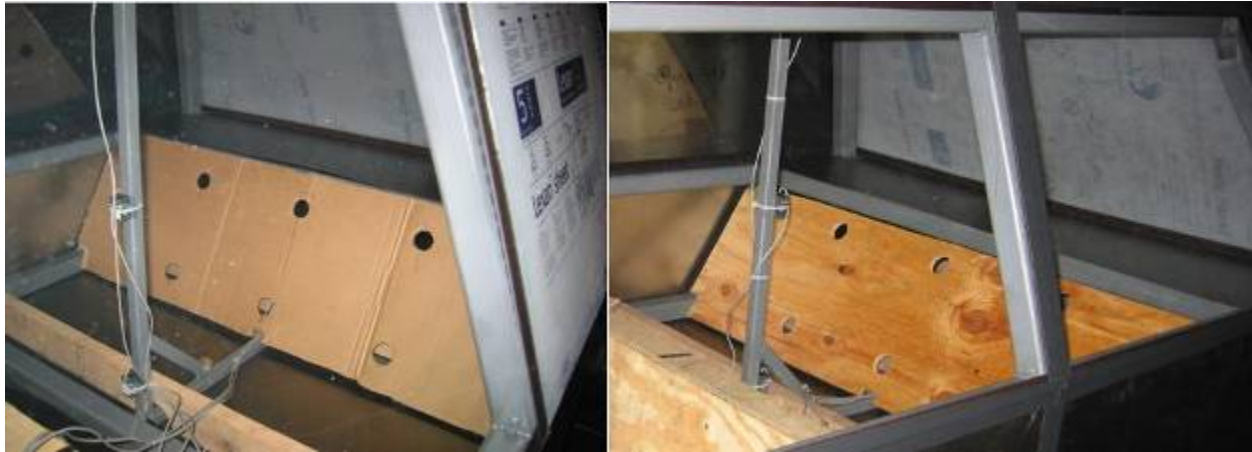
A plywood version of the panel was used for the ignition tests after a satisfactory design was identified. The final separation panel contained a set of six 1.0 in. diameter holes along the top and bottom of the panel. The panel also had a 1.0 in. gap along the top edge to allow sufficient flow between the two compartments.

**Figure II-6. Cardboard (left) and plywood (right) separation panels in ACS.**

In Task 2a, the design of the interior of the test vehicle permitted rapid flow of hydrogen between the trunk and passenger compartments. To replicate this interaction in the ACS, a separation panel, Figure II-6, was placed in the position occupied by the back of the rear seat in the test vehicle. A cardboard version of this panel was used for ACS hydrogen concentration calibration tests, which allowed on-the-fly changes to the panel. The number and locations of holes on the separation panel were adjusted after each test until an adequate accumulation of hydrogen in the trunk and passenger compartments occurred for leaks fed directly into either the trunk or passenger compartment.

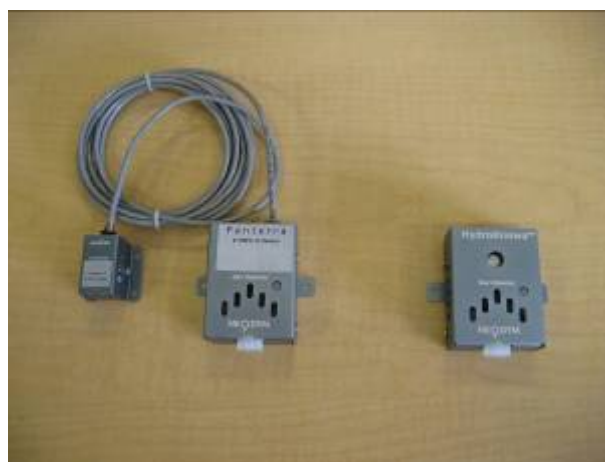
**Figure II-7. Neodym Panterra (left) and HydroKnowz (right) sensors.**

**Hydrogen Sensors.** Two types of hydrogen sensors were used during testing. Neodym Panterra hydrogen sensors with remote heads were used to measure hydrogen concentrations from 0 to 100 percent. These sensors have a measured rise time of approximately 1.5 sec and were employed to measure hydrogen concentrations inside the ACS and on the blast chamber ceiling.

Neodym HydroKnowz sensors equipped with alarms were placed on the ceiling in the blast chamber and in the control room to monitor the presence of hydrogen during testing to safeguard against the accumulation of potentially dangerous (flammable) hydrogen in either location while personnel were present. These sensors have higher resolutions, but can measure only 0 to 4 percent hydrogen concentrations. The alarms were set to activate when hydrogen concentrations reached 1 percent (10,000 ppm) in air. Figure II-7 shows the two sensor types in their respective housings.

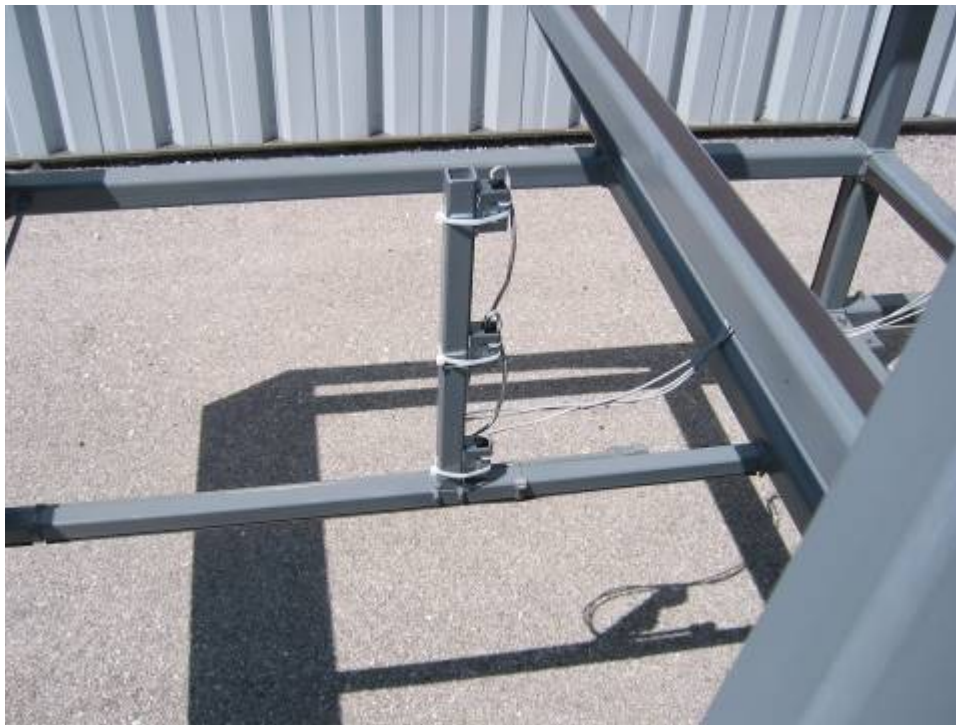
Trunk compartment sensors were located approximately 138 in. back from the sensor reference point, Figure II-8. Sensors were mounted along a vertical pole that extended from the trunk bottom inside surface to the top inside surface, covering a vertical dimension of approximately 15.5 in. This sensor array was positioned above the spare tire location.

**Figure II-8. Position of trunk compartment sensor suite at 10 percent, 50 percent, and 90 percent height.**

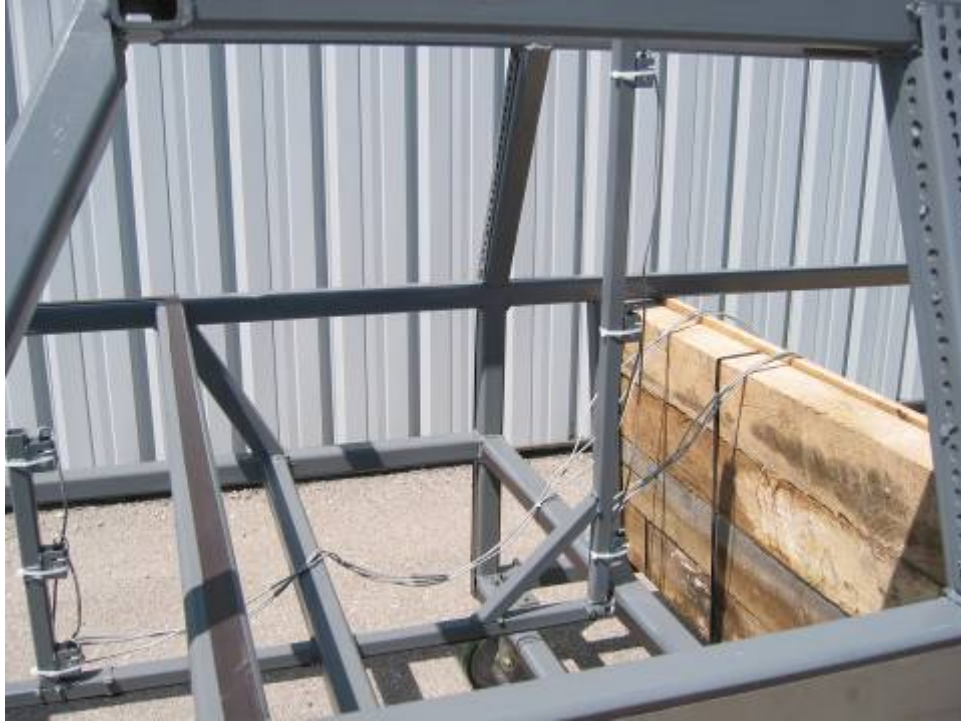
The rear passenger compartment sensors were mounted in a similar fashion, Figure II-9, and were located approximately 107 in. from the vehicle sensor reference point. The compartment height, approximately 35 in., was defined as the rear passenger seat (trunk floor) to the roof panel.

**Figure II-9. Position of rear passenger compartment sensor suite at 10 percent, 50 percent, and 90 percent height.**

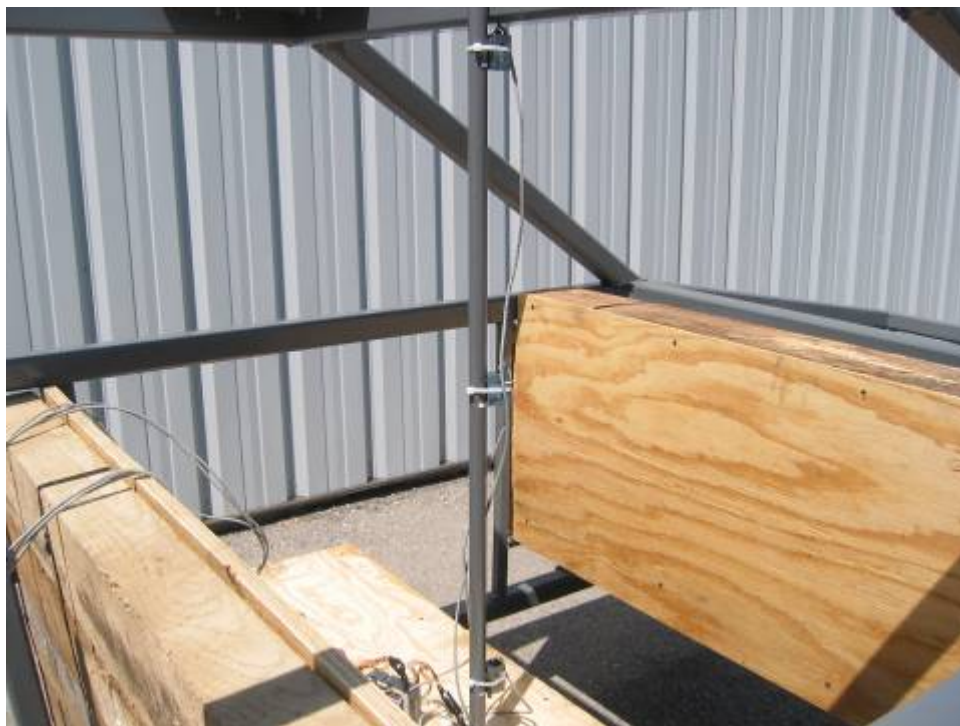
The front passenger compartment sensors were placed approximately 76.25 in. back from the reference point, Figure II-10. The sensors were mounted on a pole placed on the front seat and extended to the roof panel, approximately 38.25 in.

**Figure II-10. Position of front passenger compartment sensor suite at 10 percent, 50 percent, and 90 percent height.**

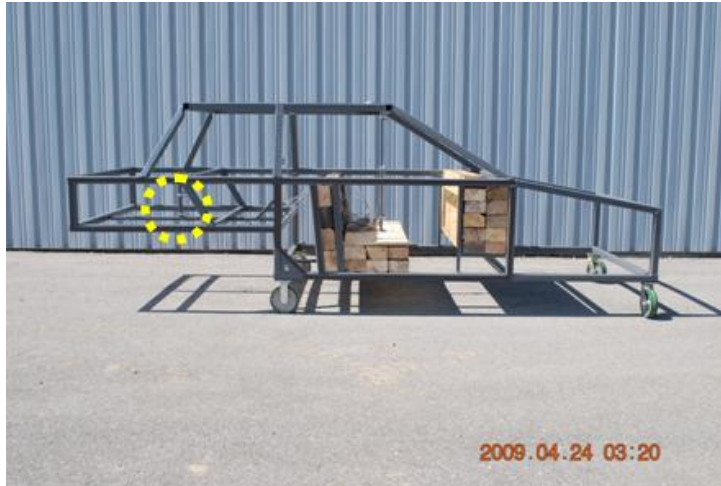
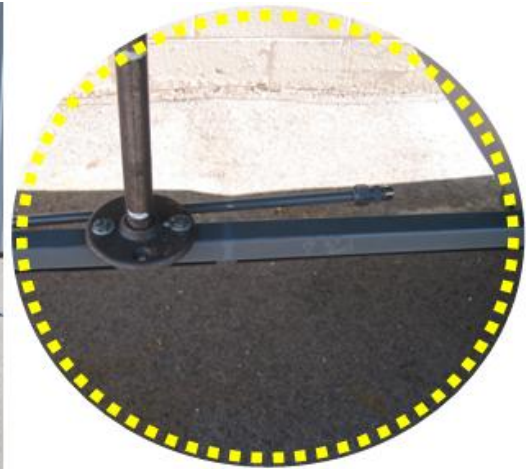
The leak originating from the trunk, Figure II-11, was positioned near the bottom of the ACS trunk compartment, 8 in. forward of sensor mounting post, with the nozzle aligned so that the hydrogen flow was directed towards the front of the ACS.

**Figure II-11. Hydrogen leak originating in trunk, flow towards the front of the ACS.**

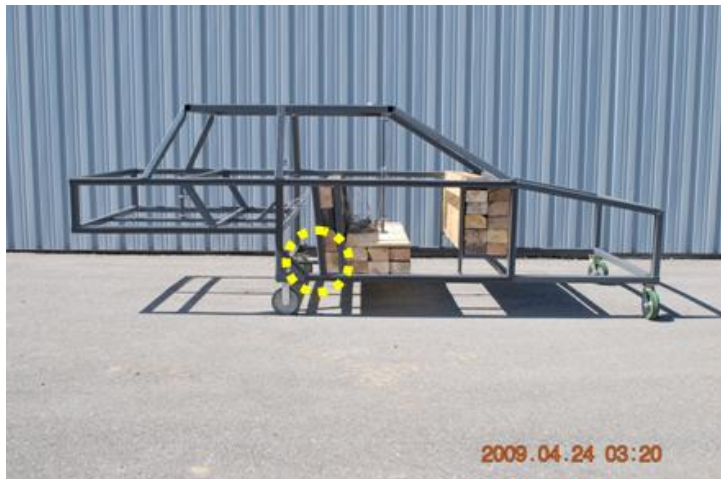
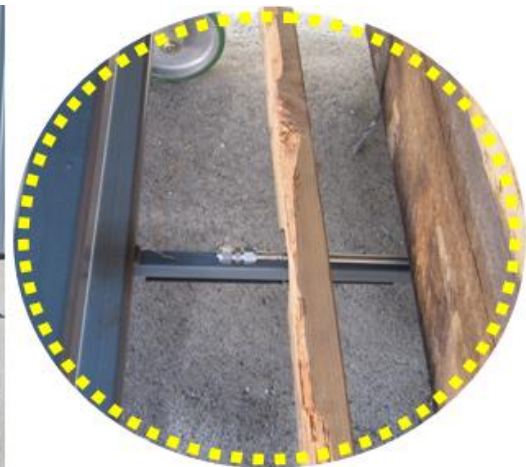
The leak originating from the passenger compartment, Figure II-12, was positioned near the floor of the ACS, 7 in. forward of the rear passenger sensor mounting post, with the nozzle aligned so that the hydrogen flow was directed towards the rear of the ACS.

**Figure II-12. Hydrogen leak originating in rear passenger compartment, flowing to rear of ACS.**

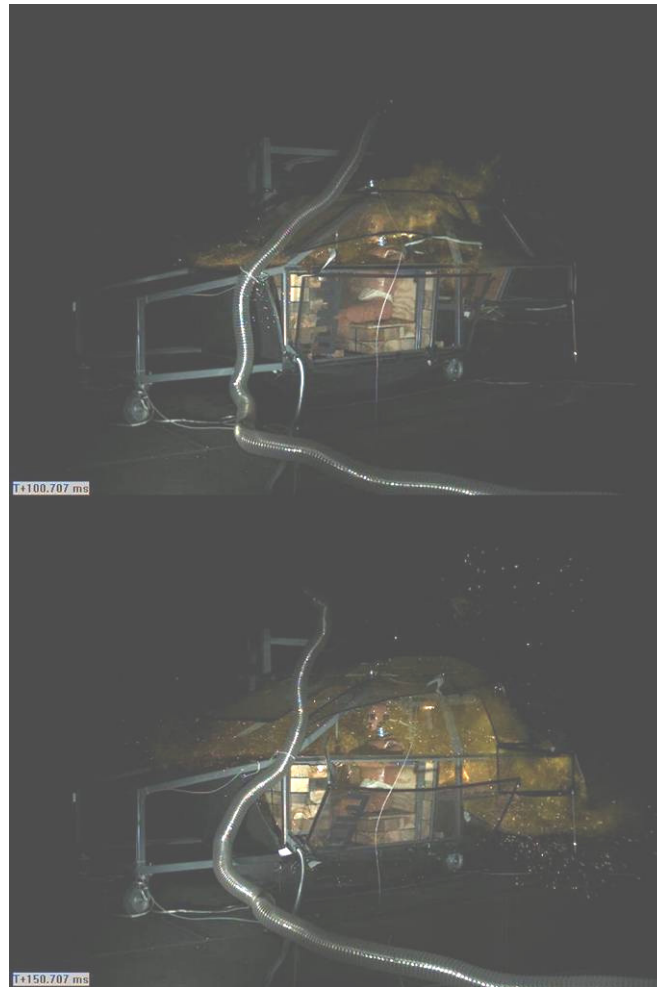
**Figure II-24. High-speed stills showing combustion in Test 33.**

Stills from the high-speed imagery are shown in Figure II-24. Because of the nonvisible luminosity of the flame, it was difficult to determine the initial combustion of the hydrogen/air mixture. The ignition source was located on the dashboard. Bulging of ACS panels was observed as early as 30 msec. The combustion event was not nearly as bright as the 30 percent or 60 percent hydrogen tests. The slight overpressure from the combustion caused panels to separate either partially or completely from the ACS framework.

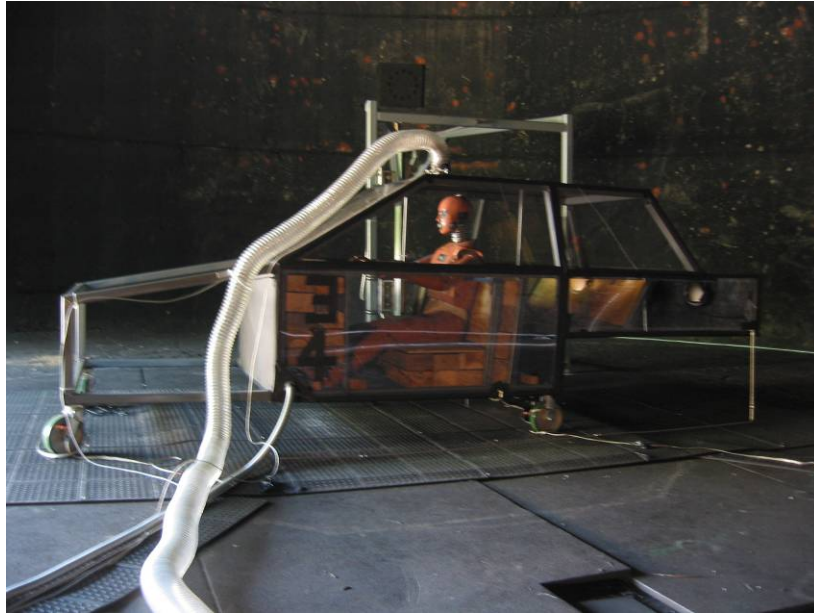
**Figure II-25. Test 34 ACS setup.**

**Test 34: 60 Percent Ignition, Trunk Leak.** All seams were taped; hydrogen sensors were mounted at the 50 percent front passenger compartment and trunk locations; and Lexan was used for most panel locations. The ignition source was located on the dashboard. Heat flux sensors located in the right back knee, right underarm, left cheek, right inner wrist, and left outer wrist were not used. A photograph of Test 34 is shown in Figure II-25.

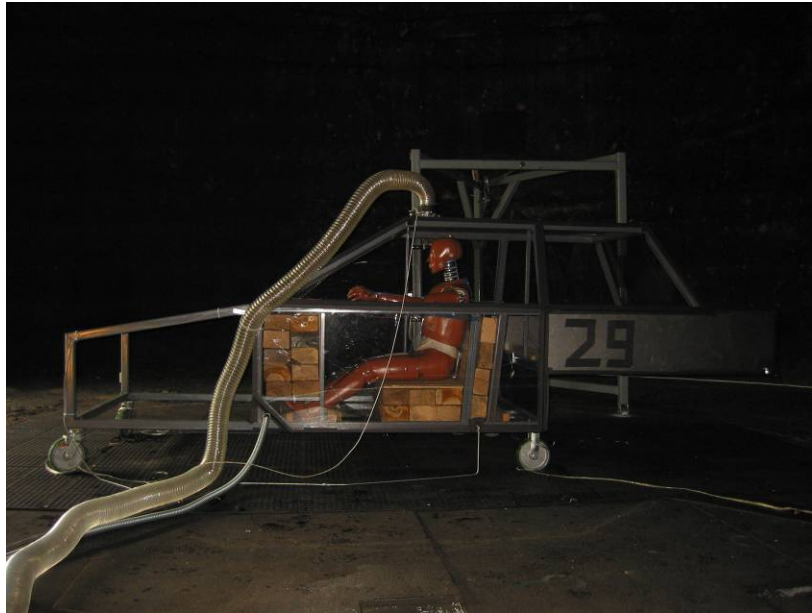
**Figure II-30. Test 29 ACS setup.**

**Test 29: 5 Percent Ignition, Passenger Leak.** Steel panels were employed in all locations, except the windows and driver front side panel where Lexan was used. All exterior ACS panel seams were taped with duct tape, and hydrogen sensors were positioned at the 50 percent trunk and front passenger compartments. The ignition source was located on the dashboard. The right underarm, right back knee, left outer wrist, and left cheek sensors were not active in this test. The setup for Test 29 is shown in Figure II-30.

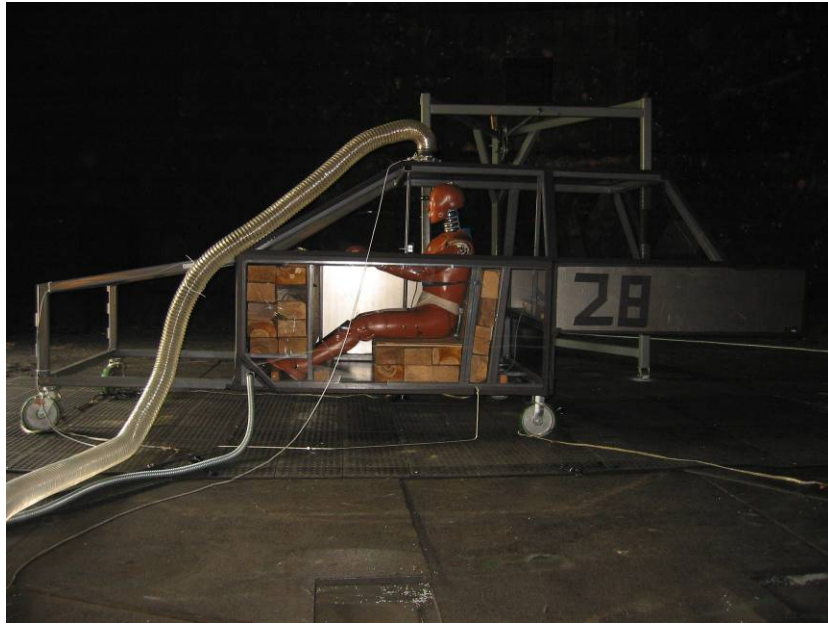
**Figure II-42. Test 28 ACS setup.**

**Test 28: 60 Percent Ignition, Passenger Leak.** All panel seams were sealed with duct tape. Ten steel panels were used; six Lexan panels, for window locations and one for the driver front side panel. Two hydrogen panels were stationed at the 50 percent front passenger and trunk compartments. The ignition source was located on the dashboard. The right underarm sensor and right back knee sensor were not used in this test. A photograph of Test 28 is shown in Figure II-42.

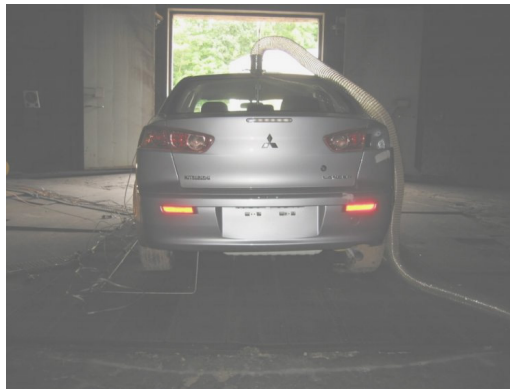
**Figure III-1. JS-10 blast chamber used for indoor testing of hydrogen leaks into vehicles and ignitions.**

**Test Facility.** Tests were conducted at the Battelle High Energy Research Laboratory Area inside JS-10 (Figure III-1), a 40-ft. diameter, steel-reinforced, concrete domed chamber capable of containing up to 50 lbs of TNT explosive or equivalent flammable materials, including hydrogen. Conducting tests inside this large blast containment chamber precluded the influence of variable meteorological conditions, which could affect the dispersion and ignition properties of hydrogen. Parameters such as ventilation, temperature, and relative humidity were recorded during testing (quiescent, within a controllable range). JS-10 can accommodate a vehicle and allows both leak and ignition-fire tests to be conducted inside.

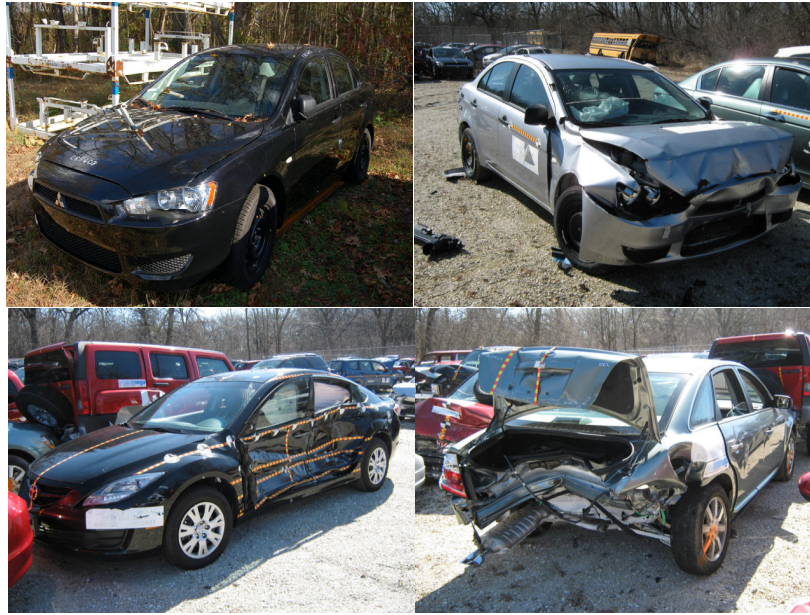
**Figure III-2. Task 2c vehicles (clockwise, top left): intact Mitsubishi Lancer, front-impact Mitsubishi Lancer, rear-impact Ford Taurus, and side-impact Mazda (no endorsement implied).**

**Vehicles.** Vehicles used in Task 2c tests included intact and front-impact 2008 Mitsubishi Lancers, side-impact 2009 Mazda6 Sedan, and rear-impact 2008 Ford Taurus. These vehicles, shown in Figure III-2, were shown by the client to Battelle as government-furnished equipment. Prior to all tests, all fluids were drained and batteries were removed. Window and door seals in the front and rear-crashed vehicles appeared intact, but those in the side-crashed car appeared compromised (driver's side door and window). To the extent possible, windows were put back into their upright condition. If windows had been ejected from impact (front, rear, and side), thin plastic film was taped over the openings.

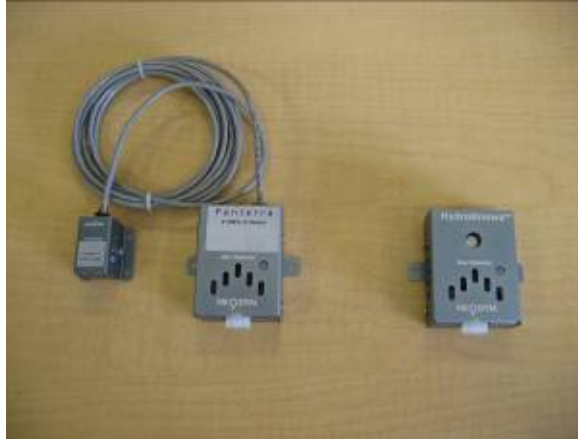
**Figure III-3. Neodym Panterra (left) and HydroKnowz (right) hydrogen sensors (no endorsement implied).**

Neodym HydroKnowz sensors equipped with alarms were placed on the ceiling in the blast chamber and in the control room to monitor the presence of hydrogen during testing as a safeguard against the accumulation of potentially dangerous (flammable) hydrogen while personnel were present. These sensors have higher resolution, but measure only 0–4 percent hydrogen levels. Their alarms were set to activate when hydrogen levels reached 1 percent (10,000 ppm) in air. Figure III-3 shows the two sensor types in their respective housings.

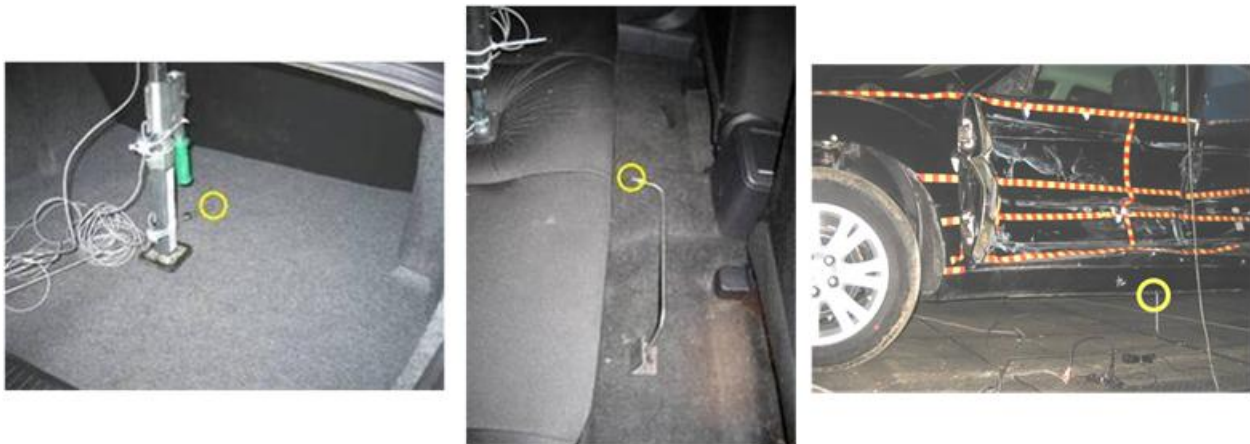
**Figure III-5. Hydrogen leak locations in trunk floor (left), rear-passenger compartment floor (center), and underneath vehicle (right).**

The flow of hydrogen originated from a specific location either directly into or underneath the vehicle. Leak locations were as similar as possible given the dimensional differences among the different automobile models. The end of the leak tube was open, representing a sheared fuel line. No diffusers or nozzles were employed during any of Task 2c testing. Figure III-4 displays the typical positions of the hydrogen sensors and Figure III-5 shows representative leak locations. Detailed positions for sensors in each test vehicle are shown in Appendix I.

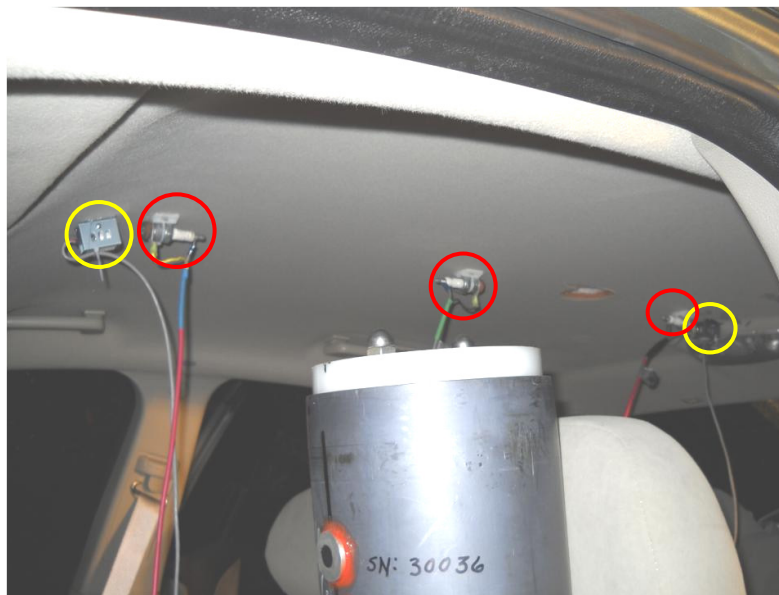
**Figure III-7.** Typical arrangement of hydrogen sensors (circled in yellow) and spark plugs (circled in red) deployed in ignition tests.

**Ignition.** Standard gasoline-engine spark plugs were employed as the ignition source. These spark plugs were connected to a 100-joule Cordin 640 pulser. The pulser's energy delivery circuitry consisted of a charged capacitor and spark gap trigger. The charging voltage was 5,000 V, and the discharge time a few microseconds. Figure III-7 shows the typical hydrogen sensor and spark plug arrangement used during ignition tests. Several variations were used and are documented in Appendix I.

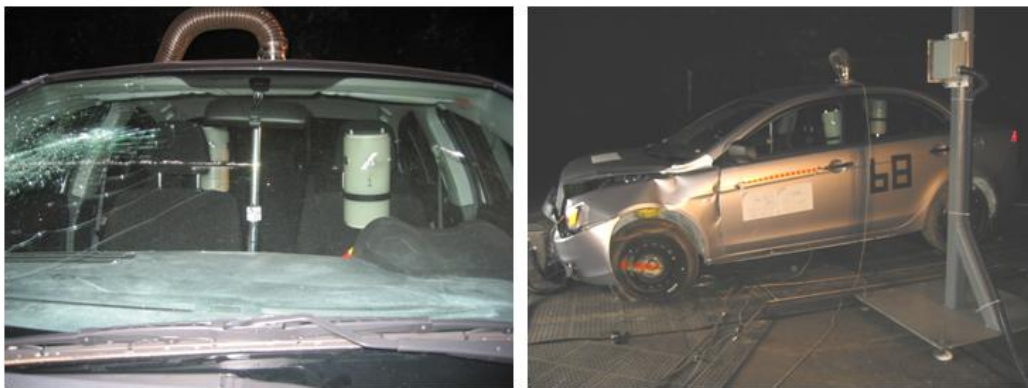
**Test 68.** The first ignition test was conducted with the front-impact vehicle (Figure III-18). The leak was located in the trunk and flowed at a rate of 118 lpm for 90 sec. The total hydrogen volume delivered was  $\approx 177$  l into  $\approx 3,012$  l, or  $\approx 5$  percent of the trunk and passenger compartment volumes. A hydrogen sensor was located at 50 percent height in both the front-passenger and trunk compartments. The ignition source was a spark plug (100 J), located a few inches between the leak in the trunk and the 50 percent sensor location. Heat flux and overpressure sensors were located at the front driver side at head height, rear passenger side at head height, and outside the driver side *B* pillar (outside vertical support between driver and passenger compartments) at a standing head height (4 ft).

**Figure III-18.** Heat flux gauges and pressure transducers mounted in plastic cylinders at driver's and rear passenger's head locations and exterior (first responder) test stand (right) in Test 68.

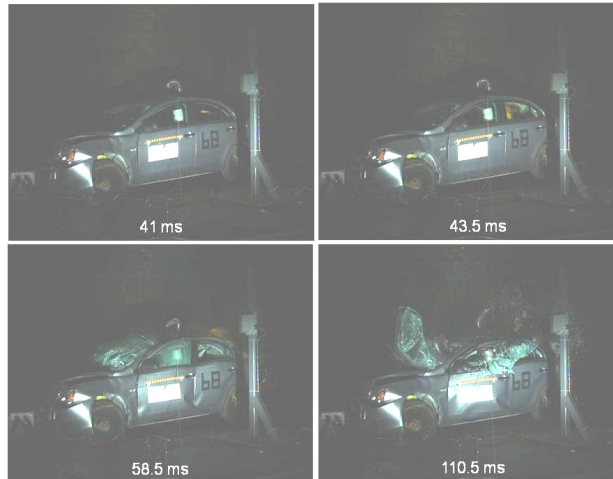
Although neither hydrogen sensor detected a flammable hydrogen concentration, sparking resulted in a combustion event more damaging than expected based on Task 2b testing. The increased confinement of the vehicle, albeit after impact (front), compared to that of the ACS that was sealed with magnets and tape, appears to have held pressure generated longer after ignition and allowed it to build to significantly higher levels. Figure III-19 shows the effects.

**Figure III-19. High-speed imagery stills for showing first observed light (41 msec), rear headliner motion (43.5 msec), glass fracture/door bulge (58.5 msec), and glass ejection (110.5 msec) in Test 68.**

Because Test 68 was a first-of-its-kind vehicle-ignition test, its outcome was analyzed to confirm or upgrade procedures for subsequent tests. Of particular concern was the lack of response of the hydrogen sensors. Just prior to sparking, neither sensor in the trunk or passenger compartment detected hydrogen after 90 sec of flow. However, the result of sparking after injecting hydrogen equivalent to ≈ 5 percent of the volume of the trunk and passenger compartments was a definite ignition, implying a flammable level of hydrogen somewhere near the spark. The ignition caused window glass to be shattered, windshield to be blown out (in one piece), and doors and trunk to be buckled and breached.

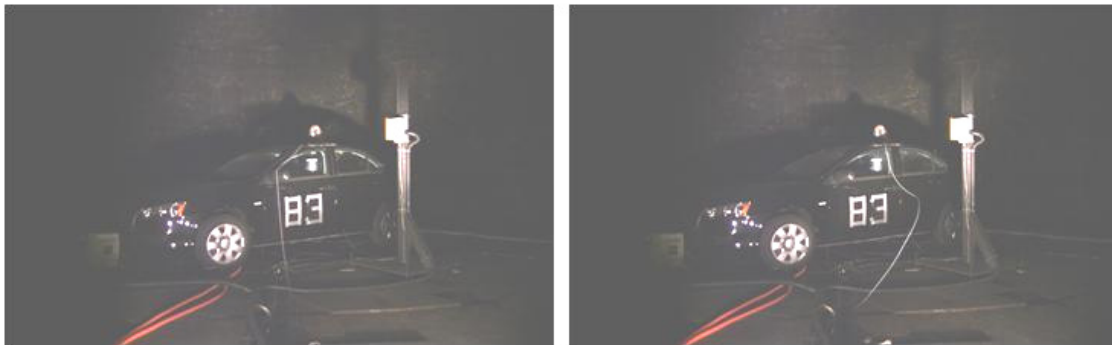
In Test 83, in an attempt to create a flammable atmosphere, the hydrogen leak rate was doubled to 6 lpm. Upon sparking, ignition occurred (Figure III-23). Figure III-24 – Figure III-26 respectively show data on hydrogen accumulation, heat flux, and overpressure. In this test, the hydrogen sensor detected flammable hydrogen levels in the vent hole (Figure III-24).

**Figure III-23. High-speed imagery stills showing intact vehicle at moment of first spark (left at T = 0 sec) and when windows fogged (right at T = 1.4 sec, note displacement of string) in Test 83.**

Ignition originated in the vehicle headliner from Spark #1 in the vent hole near the hydrogen sensor. Damage consisted of the front driver door window frame being bent out slightly (about 0.25 in. at the top rear corner). This test also produced a secondary fire, to be discussed later.

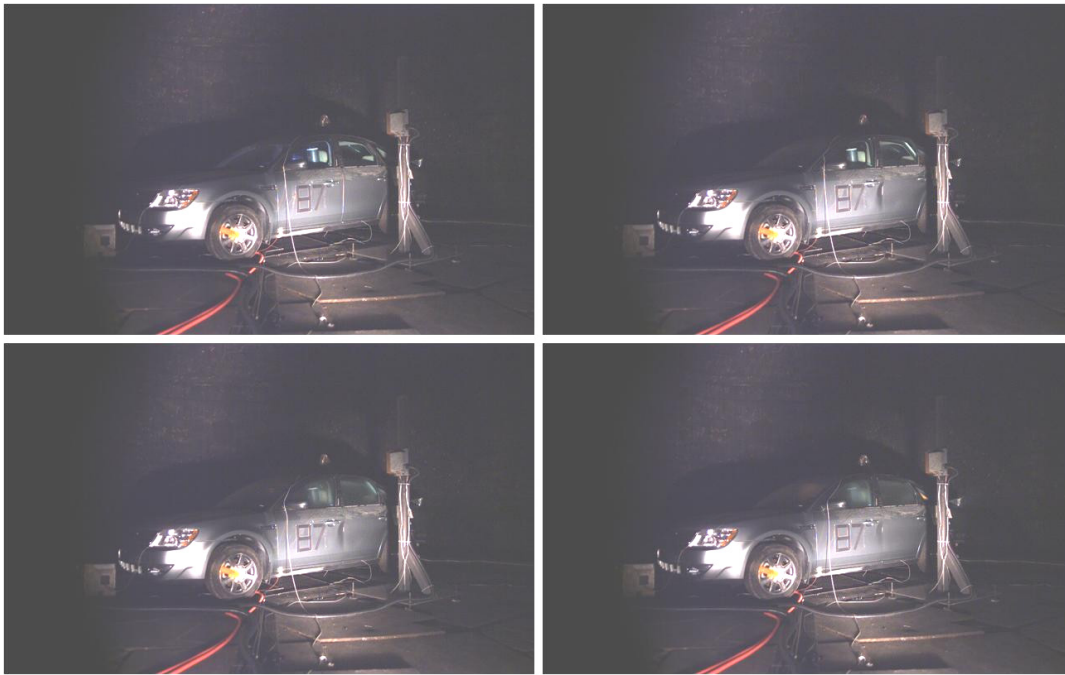
**Test 87.** Because no visible damage occurred, the rear-impact vehicle was used in another ignition test, this time with the hydrogen flow doubled to 48 lpm. Upon sparking, a much more energetic combustion event was observed (Figure III-31) despite neither hydrogen sensor detecting measurable hydrogen (Figure III-32). The stills from high-speed imagery show the driver-side and rear-passenger doors bulging from the internal overpressure. Post-test visual inspection of the vehicle revealed that all four vehicle doors were bulged. The deformation at the top of the window frames was measured as  $\approx 1\text{--}1.25$  in. No secondary fire occurred. Heat flux and pressure effects were measured and are displayed in Figure III-33 and Figure III-34, respectively.

**Figure III-31. High-speed imagery stills showing rear-impact vehicle at moment of first spark (top left at T = 0 sec); deformation of vehicle doors (top right at  $\sim T = 0.28$  sec); noticeable smoke accumulation (bottom left at  $\sim T = 0.34$  sec); and fireball inside vehicle (bottom right at  $\sim T = 0.61$  sec) in Test 87.**

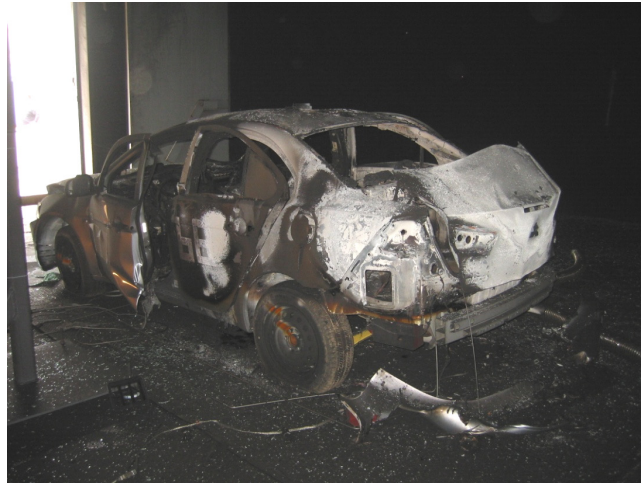
Two 15-pound carbon dioxide fire extinguishers were used to extinguish the fire. Preplumbed nozzles, one on the dashboard and one in the trunk aimed directly across the top of the spare tire, were insufficient. The fire totally consumed the car including all instrumentation (Figure III-40).

**Figure III-40. Damage to front-impact vehicle after secondary fire burned to completion in Test 68.**
