SSC 7LB – LEXUS ES 350 ALL WEATHER FLOOR MAT ACCESSORY SAFETY RECALL NOTICE FOR 2007 AND EARLY 2008 MODEL YEAR VEHICLES

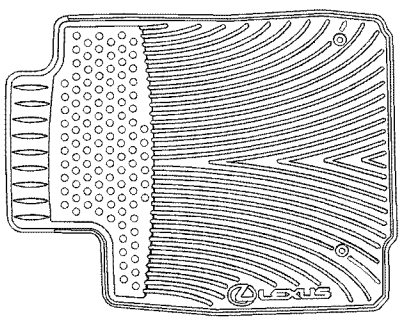
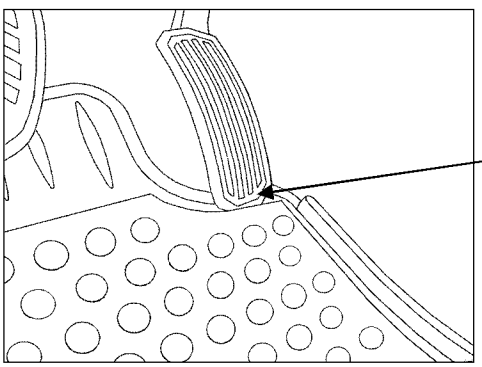
Lexus ES 350 All Weather Floor Mat Involved in this recall

The *optional* Lexus ES 350 All Weather Floor Mat is specifically engineered and manufactured for ES 350 vehicles. There are two grommet holes in the All Weather Floor Mat and retaining hooks (clips) attached to the carpet of the vehicle to secure the mat. Lexus has received reports that if the *optional* Lexus ES 350 All Weather Floor Mat (either by itself or if it is placed on top of an existing carpeted floor mat) is not secured by the retaining hooks (clips), the mat can move forward and interfere with the accelerator pedal returning to the idle position. If this condition occurs, in the worst case, it may increase the possibility of a crash.

If the Lexus ES 350 All Weather Floor Mat is not **secured by the retaining hooks (clips)** and the mat moves forward, it may interfere with the accelerator pedal.

Any Lexus dealer will replace the original driver's seating position All Weather Floor Mat with a newly designed one at **NO CHARGE** to you.
