U.S. Department  
of Transportation  
**National Highway  
Traffic Safety  
Administration**

DOT HS 811 816

# **Post-Crash Hydrogen Leakage Limits and Fire Safety Research**

| 9. Performing Organization Name and Address<br>Battelle Memorial Institute<br>505 King Avenue<br>Columbus, OH 43201 | | | | 10. Work Unit No. (TRAIS) | |

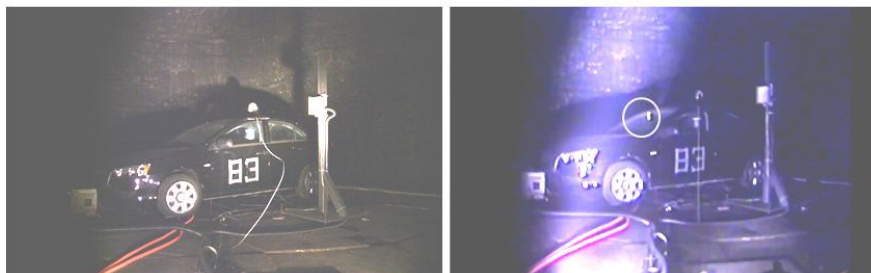
**Test 83 Secondary Fire.** Figure III-41 shows the timeline of events. In Test 83, the possibility of a secondary fire was anticipated. No fire was observed during the first 20 min wait period after ignition although smoke was generated nearly the entire time. First flame was observed shortly after the hydrogen exhaust system was activated, probably caused by the forced ventilation of air around and inside the vehicle.

The fire was small and appeared near the front edge of the headliner, directly above the front passenger seat. This smaller (than Test 68) secondary fire was extinguished with a Halotron fire suppression system (no endorsement implied). Scorching was noted above the headliner in the vent hole. A relatively large area on the top side of the headliner must have been burning given the amount of smoke produced during the wait period (Figure III-42).

**Figure III-41. Timeline of events after ignition (left) and secondary fire (right; circled) in Test 83.**

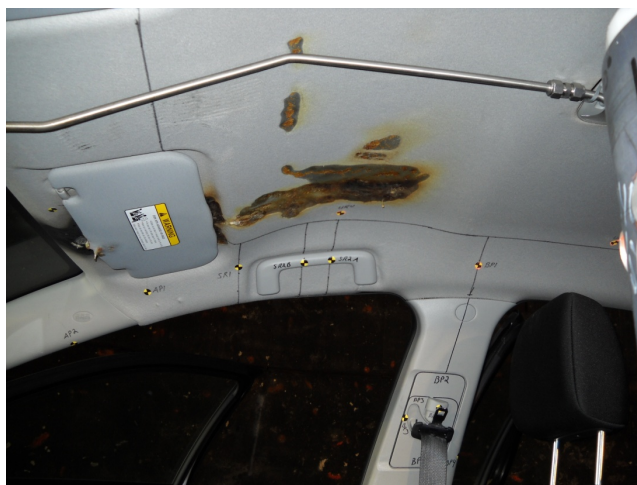
**Figure III-42. Damage to headliner above front-passenger seat after secondary fire was extinguished in Test 83.**

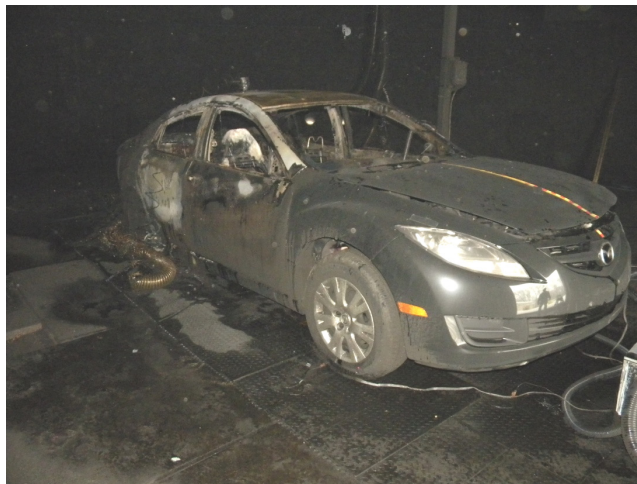
**Figure III-44. Damage to front-impact vehicle after secondary fire burned to completion in Test 88.**

Two 15-pound Halotron fire extinguishers were used to extinguish the fire. Preplumbed nozzles, one on the dashboard and one in the trunk aimed directly across the top of the spare tire, were insufficient to extinguish the fire, which consumed the interior of the car, including all instrumentation (Figure III-44).
