SSC 7LB - ALL WEATHER FLOOR MAT ACCESSORY SAFETY RECALL NOTICE
FOR 2007AND EARLY 2008 LEXUS ES 350

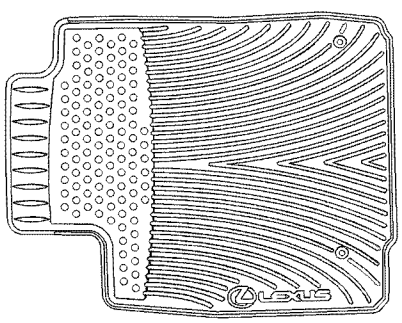
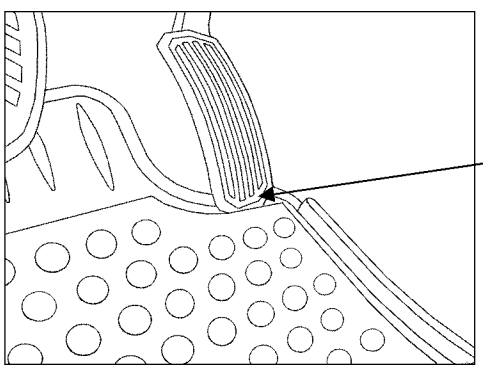
Lexus ES 350 All Weather Floor Mat
Involved in this recall

The *optional* Lexus ES 350 All Weather Floor Mat is specifically engineered and manufactured for ES 350 vehicles. This includes two grommet holes in the All Weather Floor Mat and retaining hooks (clips) to secure the mat to the vehicle's carpet. In recent months, Lexus has received reports regarding the optional Lexus ES 350 All Weather Floor Mat slipping forward and interfering with the movement of the accelerator pedal. (Please see the diagram for the specific mat involved). Lexus has investigated these reports and determined that if the optional Lexus ES 350 All Weather Floor Mat (either by itself or if it is placed on top of the existing carpeted floor mat) is **not secured by the retaining hooks (clips)** and the mat moves forward, it may interfere with the accelerator pedal from returning to the idle position. If this condition occurs, in the worst case, it may increase the possibility of a crash.

If the Lexus ES 350 All Weather Floor Mat is not **secured by the retaining hooks (clips)** and the mat moves forward, it may interfere with the accelerator pedal

Lexus is currently developing a design modification to the driver's seating position All Weather Floor Mat. We will send another notification when the new driver's seating position All Weather Floor Mat is available. The original driver's seating position All Weather Floor Mat will be exchanged for a new one at that time.

Until the new driver's seating position Lexus ES 350 All Weather Floor Mat is ready, we request your assistance in regularly verifying the floor mat is properly secured using the retaining hooks (clips) provided. If the mat is properly secured, it will not interfere with the accelerator pedal. Good times to check are after filling your vehicle's tank with gasoline, after a carwash and/or vehicle interior cleaning, when another driver is about to drive the vehicle, etc. More than one floor mat should ***never*** be used in the driver's seating position, as the retaining hooks (clips) are designed to accommodate only one floor mat at a time. Please refer to the floor mat section of your Owner's Manual for further information regarding the retaining hooks (clips).
