SSC 7LB – LEXUS ES 350 ALL WEATHER FLOOR MAT ACCESSORY
SAFETY RECALL NOTICE FOR 2007 AND EARLY 2008 MODEL YEAR VEHICLES

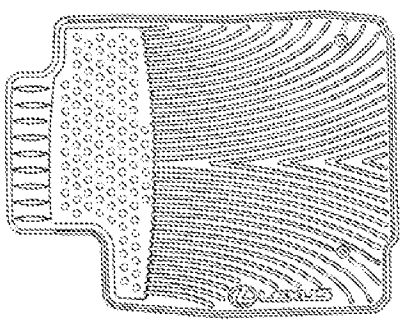
Lexus ES 350 All Weather Floor Mat Involved in this recall

The *optional* Lexus ES 350 All Weather Floor Mat is specifically engineered and manufactured for ES 350 vehicles. This includes two grommet holes in the All Weather Floor Mat and retaining hooks (clips) to secure the mat to the vehicle's carpet. In recent months, Lexus has received reports regarding the optional Lexus ES 350 All Weather Floor Mat slipping forward and interfering with the movement of the accelerator pedal. (Please see the diagram for the specific mat involved). Lexus has investigated these reports and determined that if the optional Lexus ES 350 All Weather Floor Mat (either by itself or if it is placed on top of the existing carpeted floor mat) is **not secured by the retaining hooks (clips)** and the mat moves forward, it may interfere with the accelerator pedal returning to the idle position. If this condition occurs, in the worst case, it may increase the possibility of a crash.

Lexus is currently developing a design modification to the driver's seating position All Weather Floor Mat. We will send another notification when the new driver's seating position All Weather Floor Mat is available. We anticipate the second notification will begin mailing in mid-to-late November, 2007. The original driver's seating position All Weather Floor Mat will be exchanged for a new one at that time.

Until the new driver's seating position Lexus ES 350 All Weather Floor Mat is ready, we request your assistance in regularly verifying the floor mat is properly secured using the retaining hooks (clips) provided. If the mat is properly secured, it will not interfere with the accelerator pedal. Good times to check are after filling your vehicle's tank with gasoline, after a carwash and/or vehicle interior cleaning, when another driver is about to drive the vehicle, etc. More than one floor mat should ***never*** be used in the driver's seating position, as the retaining hooks (clips) are designed to accommodate only one floor mat at a time. Please refer to the floor mat section of your Owner's Manual for further information regarding the retaining hooks (clips).

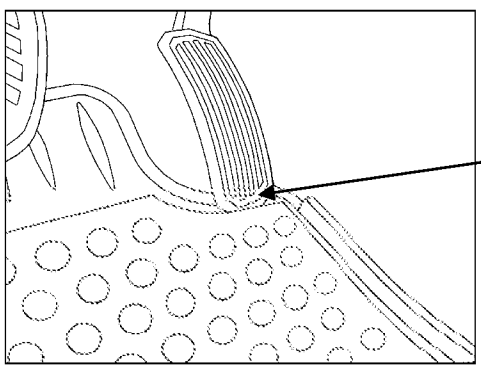
If the Lexus ES 350 All Weather Floor Mat is not **secured by the retaining hooks (clips)** and the mat moves forward, it may interfere with the accelerator pedal.
