SSC 7LB – LEXUS ES 350 ALL WEATHER FLOOR MAT ACCESSORY
SAFETY RECALL NOTICE FOR 2007 AND EARLY 2008 MODEL YEAR VEHICLES

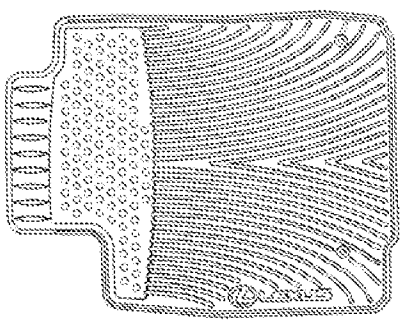
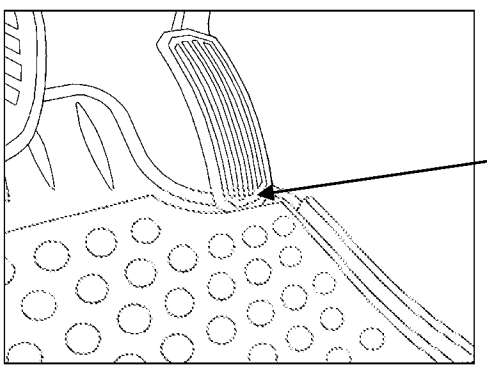
Lexus ES 350 All Weather Floor Mat Involved in this recall

The *optional* Lexus ES 350 All Weather Floor Mat is specifically engineered and manufactured for ES 350 vehicles. This includes two grommet holes in the All Weather Floor Mat and retaining hooks (clips) to secure the mat to the vehicle's carpet. In recent months, Lexus has received reports regarding the optional Lexus ES 350 All Weather Floor Mat slipping forward and interfering with the movement of the accelerator pedal. (Please see the diagram for the specific mat involved). Lexus has investigated these reports and determined that if the optional Lexus ES 350 All Weather Floor Mat (either by itself or if it is placed on top of the existing carpeted floor mat) is **not secured by the retaining hooks (clips)** and the mat moves forward, it may interfere with the accelerator pedal returning to the idle position. If this condition occurs, in the worst case, it may increase the possibility of a crash.

If the Lexus ES 350 All Weather Floor Mat is not **secured by the retaining hooks (clips)** and the mat moves forward, it may interfere with the accelerator pedal.

Lexus is currently developing a design modification to the driver's seating position All Weather Floor Mat. We will send another notification when the new driver's seating position All Weather Floor Mat is available. We anticipate the second notification will begin mailing in mid-to-late November, 2007. The original driver's seating position All Weather Floor Mat will be exchanged for a new one at that time.

Until the new driver's seating position Lexus ES 350 All Weather Floor Mat is ready, we request your assistance in regularly verifying the floor mat is properly secured using the retaining hooks (clips) provided. If the mat is properly secured, it will not interfere with the accelerator pedal. Good times to check are after filling your vehicle's tank with gasoline, after a carwash and/or vehicle interior cleaning, when another driver is about to drive the vehicle, etc. More than one floor mat should ***never*** be used in the driver's seating position, as the retaining hooks (clips) are designed to accommodate only one floor mat at a time. Please refer to the floor mat section of your Owner's Manual for further information regarding the retaining hooks (clips).
