SSC 70F – TOYOTA CAMRY ALL WEATHER FLOOR MAT ACCESSORY SAFETY RECALL NOTICE FOR 2007 AND EARLY 2008 MODEL YEAR VEHICLES

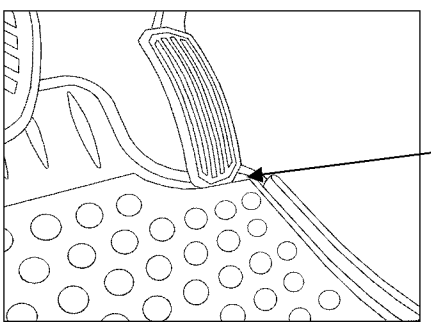
Toyota Camry All Weather Floor Mat Involved in this Recall

The *optional* Toyota Camry All Weather Floor Mat is specifically engineered and manufactured for Camry vehicles. This includes two grommet holes in the All Weather Floor Mat and retaining hooks (clips) to secure the mat to the vehicle's carpet. Toyota has received reports that if the optional Toyota Camry All Weather Floor Mat (either by itself or if it is placed on top of an existing carpeted floor mat) is not secured by the retaining hooks (clips), the mat can move forward and interfere with the accelerator pedal returning to the idle position. If this condition occurs, in the worst case, it may increase the possibility of a crash.

If the Toyota Camry All Weather Floor Mat is not **secured by the retaining hooks (clips)** and the mat moves forward, it may interfere with the accelerator pedal.

Any Toyota dealer will replace the original driver's seating position All Weather Floor Mat with a newly designed one at **NO CHARGE** to you.
