SSC 70F – TOYOTA CAMRY ALL WEATHER FLOOR MAT ACCESSORY SAFETY RECALL NOTICE FOR 2007 AND EARLY 2008 MODEL YEAR VEHICLES

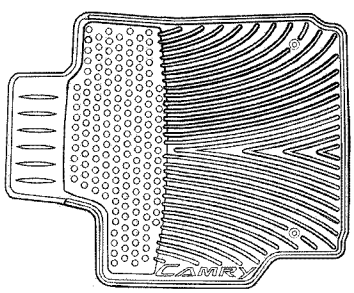
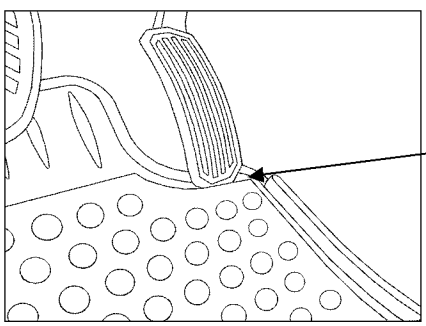
Toyota Camry All Weather Floor Mat Involved in this Recall

The *optional* Toyota Camry All Weather Floor Mat is specifically engineered and manufactured for Camry vehicles. This includes two grommet holes in the All Weather Floor Mat and retaining hooks (clips) to secure the mat to the vehicle's carpet. Toyota has received reports that if the optional Toyota Camry All Weather Floor Mat (either by itself or if it is placed on top of an existing carpeted floor mat) is not secured by the retaining hooks (clips), the mat can move forward and interfere with the accelerator pedal returning to the idle position. If this condition occurs, in the worst case, it may increase the possibility of a crash.

If the Toyota Camry All Weather Floor Mat is not **secured by the retaining hooks (clips)** and the mat moves forward, it may interfere with the accelerator pedal.

Any Toyota dealer will replace the original driver's seating position All Weather Floor Mat with a newly designed one at **NO CHARGE** to you.
