TECHNICAL INSTRUCTIONS

SPECIAL SERVICE CAMPAIGN 70F (SAFETY RECALL)

2007 AND EARLY 2008 MODEL YEAR
TOYOTA CAMRY ALL WEATHER FLOOR MAT

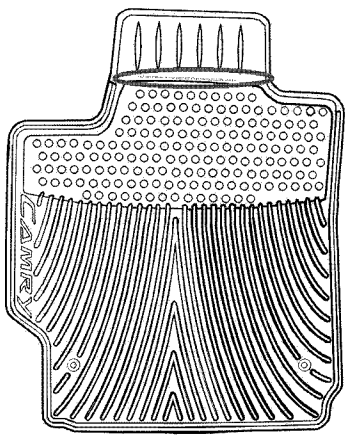
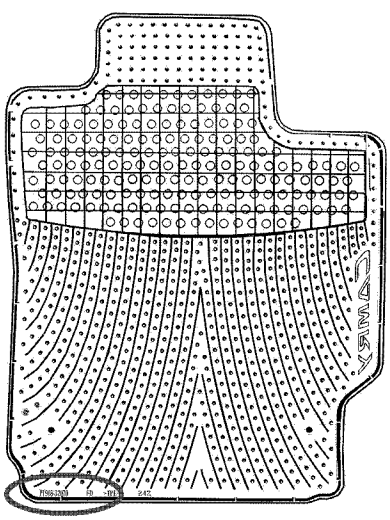
NG **Need to Replace**	OK **Do NOT Replace**
ORIGINAL FRONT - Small or large warning located at TOP of mat	NEWLY DESIGNED FRONT - Larger, CENTRALLY located warning

ORIGINAL BACK - PN: PT908-03070-02 (Black) -PN: PT908-03070-14 (Brown)	NEWLY DESIGNED BACK - PN: PT908-0307F-02 (Black) -PN: PT908-0307F-14 (Brown)

B. REPLACE THE AFFECTED DRIVER SIDE ALL WEATHER FLOOR MAT WITH THE NEWLY DESIGNED ONE

IMPORTANT: MAKE SURE THE RETAINING HOOKS (CLIPS) ARE PROPERLY INSTALLED AND SECURED TO THE VEHICLES CARPET AND THE ALL WEATHER FLOOR MAT.
