SSC 70F – TOYOTA CAMRY ALL WEATHER FLOOR MAT ACCESSORY
FOR 2007 AND EARLY 2008 MODEL YEAR VEHICLES
SAFETY RECALL NOTICE

DRAFT

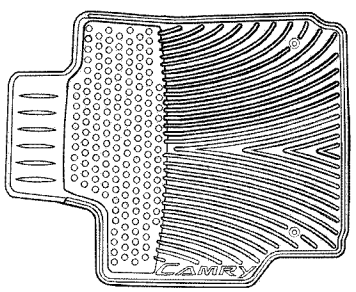
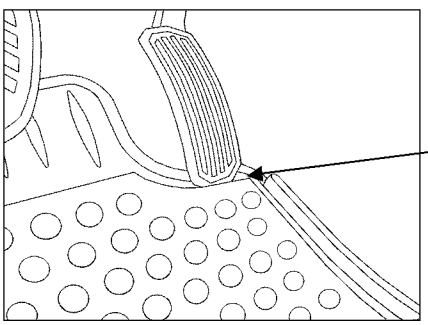
Toyota Camry All Weather Floor Mat Involved in this Recall

The *optional* Toyota Camry All Weather Floor Mat is specifically engineered and manufactured for Camry vehicles. This includes two grommet holes in the All Weather Floor Mat and retaining hooks (clips) to secure the mat to the vehicle's carpet. Toyota has received reports that if the optional Toyota Camry All Weather Floor Mat (either by itself or if it is placed on top of an existing carpeted floor mat) is not secured by the retaining hooks (clips), the mat can move forward and interfere with the accelerator pedal returning to the idle position. If this condition occurs, in the worst case, it may increase the possibility of a crash.

If the Toyota Camry All Weather Floor Mat is not **secured by the retaining hooks (clips)** and the mat moves forward, it may interfere with the accelerator pedal.

Any Toyota dealer will replace the original driver's seating position All Weather Floor Mat with a newly designed one at **NO CHARGE** to you.

As we indicated to you previously, we required time to prepare the necessary parts. Toyota is pleased to inform you that the replacement driver's seating position All Weather Floor Mat for your vehicle is now ready. Please contact your authorized Toyota dealer to make an appointment to replace the original driver's seating position All Weather Floor Mat as soon as possible. The replacement will take approximately 10 minutes. However, depending upon the dealer's work schedule, it may be necessary to make your vehicle available for a longer period of time. **Until the replacement All Weather Floor Mat for the driver's seating position is replaced, we request your assistance in regularly verifying the floor mat is properly secured using the retaining hooks (clips) provided. If the mat is properly secured, it will not interfere with the accelerator pedal. More than one floor mat should never be used in the driver's seating position, as the retaining hooks (clips) are designed to accommodate only one floor mat at a time.**
