SSC 70F – TOYOTA CAMRY ALL WEATHER FLOOR MAT ACCESSORY SAFETY RECALL NOTICE FOR 2007 AND EARLY 2008 MODEL YEAR VEHICLES

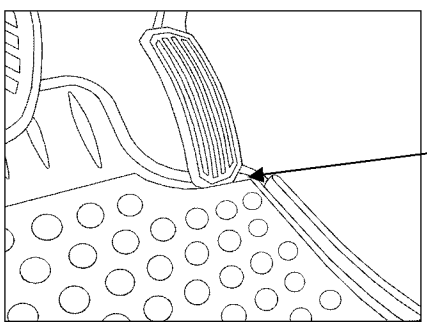
Toyota Camry All Weather Floor Mat Involved in this Recall

The *optional* Toyota Camry All Weather Floor Mat is specifically engineered and manufactured for Camry vehicles. This includes two grommet holes in the All Weather Floor Mat and retaining hooks (clips) to secure the mat to the vehicle's carpet. Toyota has received reports that if the optional Toyota Camry All Weather Floor Mat (either by itself or if it is placed on top of an existing carpeted floor mat) is not secured by the retaining hooks (clips), the mat can move forward and interfere with the accelerator pedal returning to the idle position. If this condition occurs, in the worst case, it may increase the possibility of a crash.

If the Toyota Camry All Weather Floor Mat is not **secured by the retaining hooks (clips)** and the mat moves forward, it may interfere with the accelerator pedal.

Any Toyota dealer will replace the original driver's seating position All Weather Floor Mat with a newly designed one at **NO CHARGE** to you.

As we indicated to you previously, we required time to prepare the necessary parts. Toyota is pleased to inform you that the replacement driver's seating position All Weather Floor Mat for your vehicle is now ready. Please contact your authorized Toyota dealer to make an appointment to replace the original driver's seating position All Weather Floor Mat as soon as possible. The replacement will take approximately 10 minutes. However, depending upon the dealer's work schedule, it may be necessary to make your vehicle available for a longer period of time. **Until the replacement All Weather Floor Mat for the driver's seating position is replaced, we request your assistance in regularly verifying the floor mat is properly secured using the retaining hooks (clips) provided. If the mat is properly secured, it will not interfere with the accelerator pedal. More than one floor mat should never be used in the driver's seating position, as the retaining hooks (clips) are designed to accommodate only one floor mat at a time.**
