SUBJECT: **UPDATE** - SAFETY RECALL (SPECIAL SERVICE CAMPAIGN) – 70F
(TOYOTA CAMRY ALL WEATHER FLOOR MAT ACCESSORY FOR 2007 AND EARLY 2008 MODEL YEAR VEHICLES)

SSC 70F – TOYOTA CAMRY ALL WEATHER FLOOR MAT ACCESSORY
FOR 2007 AND EARLY 2008 MODEL YEAR VEHICLES
SAFETY RECALL NOTICE

Special Service Campaign (SSC) – 70F (Safety Recall) Q&A
Toyota Camry All Weather Floor Mat for 2007 and Early 2008 Model Year Vehicles

SPECIAL SERVICE CAMPAIGN 70F (SAFETY RECALL)

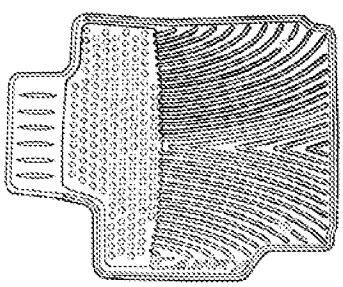
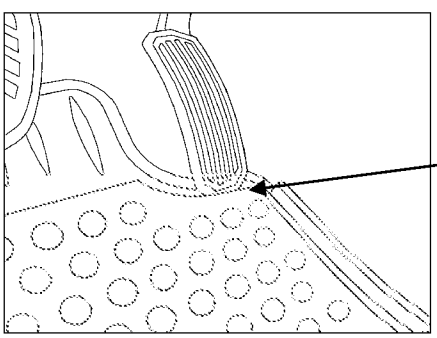
Toyota Camry All Weather Floor Mat Involved in this recall

If the Toyota Camry All Weather Floor Mat is not **secured by the retaining hooks (clips)** and the mat moves forward, it may interfere with the accelerator pedal.

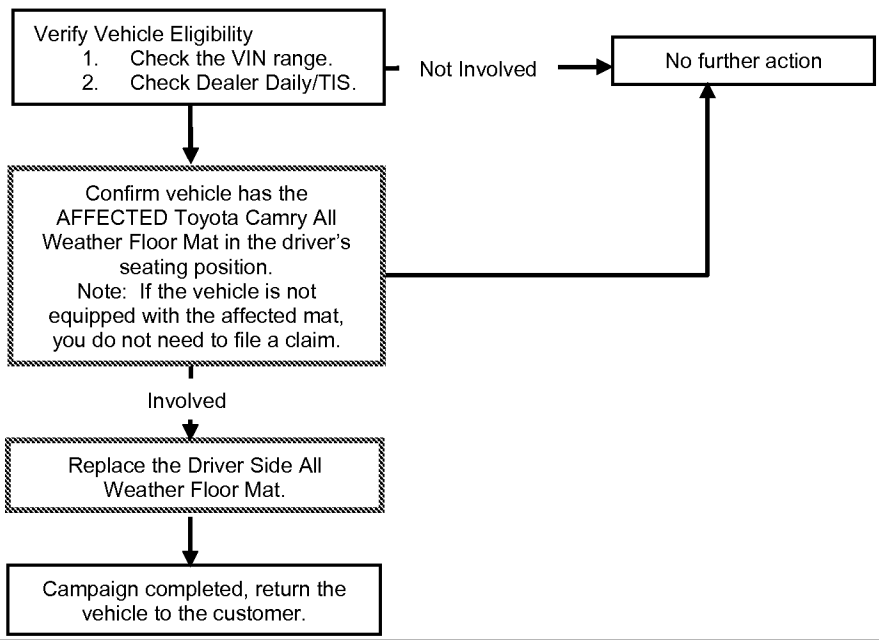
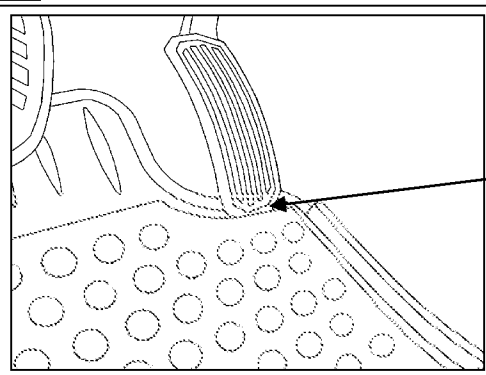
Toyota Camry All Weather Floor Mat Involved in this recall
(Refer to the Technical Instructions to determine if a mat is affected or not)

If the Toyota Camry All Weather Floor Mat is not **secured by the retaining hooks (clips)** and the mat moves forward, it may interfere with the accelerator pedal.

SSC #	Op. Code	Description	Flat Rate Hour
70F	7519J1	Replace the Affected Original Driver's Side All Weather Floor Mat with the Newly Designed Floor Mat	0.2 Hr/Veh

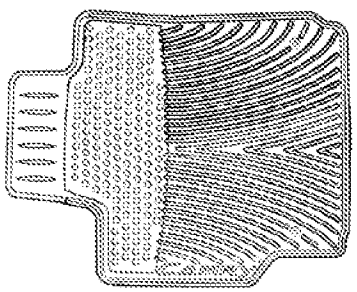
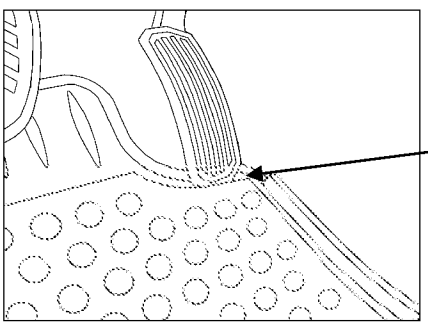
Toyota Camry All Weather Floor Mat Involved in this Recall

If the Toyota Camry All Weather Floor Mat is not **secured by the retaining hooks (clips)** and the mat moves

Any Toyota dealer will replace the original driver's seating position All Weather Floor Mat with a newly designed one at **NO CHARGE** to you.

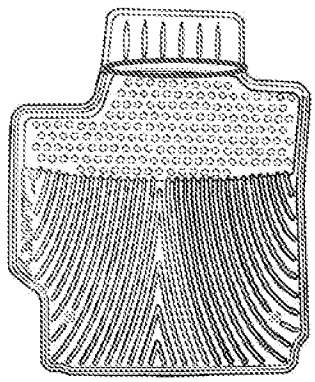
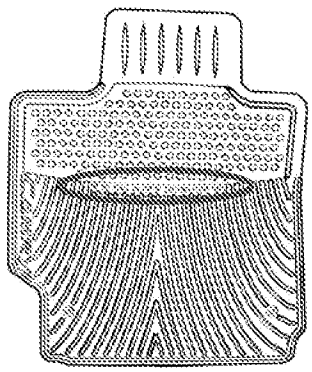
NG **Need to Replace**	**OK** **Do NOT Replace**
ORIGINAL FRONT - Small or large warning located at TOP of mat	NEWLY DESIGNED FRONT - Larger, CENTRALLY located warning

- MAKE SURE THE RETAINING HOOKS (CLIPS) ARE PROPERLY INSTALLED TO THE VEHICLE'S CARPET AND SECURE THE ALL WEATHER FLOOR MAT.
- MORE THAN ONE FLOOR MAT SHOULD NEVER BE USED IN THE DRIVER'S SEATING POSITION, AS THE RETAINING HOOKS (CLIPS) ARE DESIGNED TO ACCOMMODATE ONLY ONE FLOOR MAT AT A TIME.

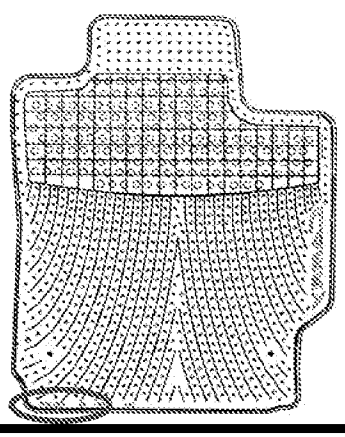
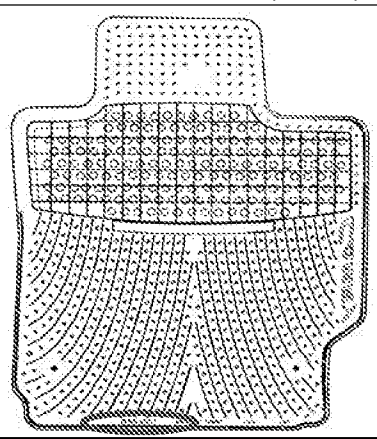
ORIGINAL BACK - PN: PT908-03070-02 (Black) -PN: PT908-03070-14 (Brown)	NEWLY DESIGNED BACK - PN: PT908-0307F-02 (Black) -PN: PT908-0307F-14 (Brown)
