TOYOTA CUSTOMER SERVICES

Volume: XVI
Number: TC09-024
Date: 09/16/09
_X_ Action
_X_ Retain
____ Information

Subject: Toyota All Weather Floor Mats

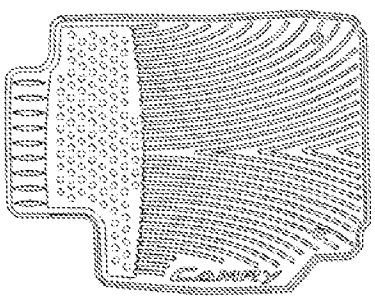
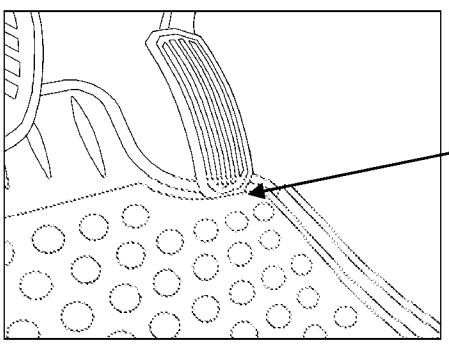
If the correct model/year specific Toyota All Weather Floor Mat is not used and/or not **secured by the retaining hooks (clips)**, it may interfere with the accelerator pedal.

3. All Weather Floor Mat Inspection
   After the training is complete, please instruct your departments to immediately inspect all Region/PD fleet and pool vehicles. This should include new, used, as well as any other fleet or pool vehicle in your Region/PD inventory. Any reserve AWFM inventories, particularly for pool vehicles must also be inspected.
