# TOYOTA CUSTOMER SERVICES

Volume: XVI
Number: TC09-024
Date: 09/16/09
_X_ Action
_X_ Retain
____ Information

Subject: Toyota All Weather Floor Mats

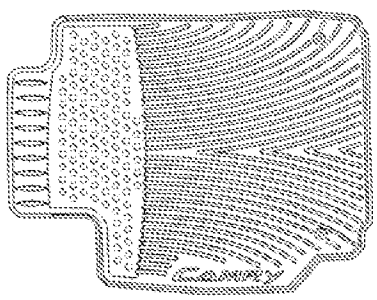
**Toyota All Weather Floor Mat**

If the correct model/year specific Toyota All Weather Floor Mat is not used and/or not **secured by the retaining hooks (clips)**, it may interfere with the accelerator pedal.

3. All Weather Floor Mat Inspection
   After the training is complete, please instruct your departments to immediately inspect all Region/PD fleet and pool vehicles. This should include new, used, as well as any other fleet or pool vehicle in your Region/PD inventory. Any reserve AWFM inventories, particularly for pool vehicles must also be inspected.
