FOR IMMEDIATE RELEASE
TMS-050-09

Toyota/Lexus Consumer Safety Advisory Potential Floor Mat Interference with Accelerator Pedal

September 29, 2009

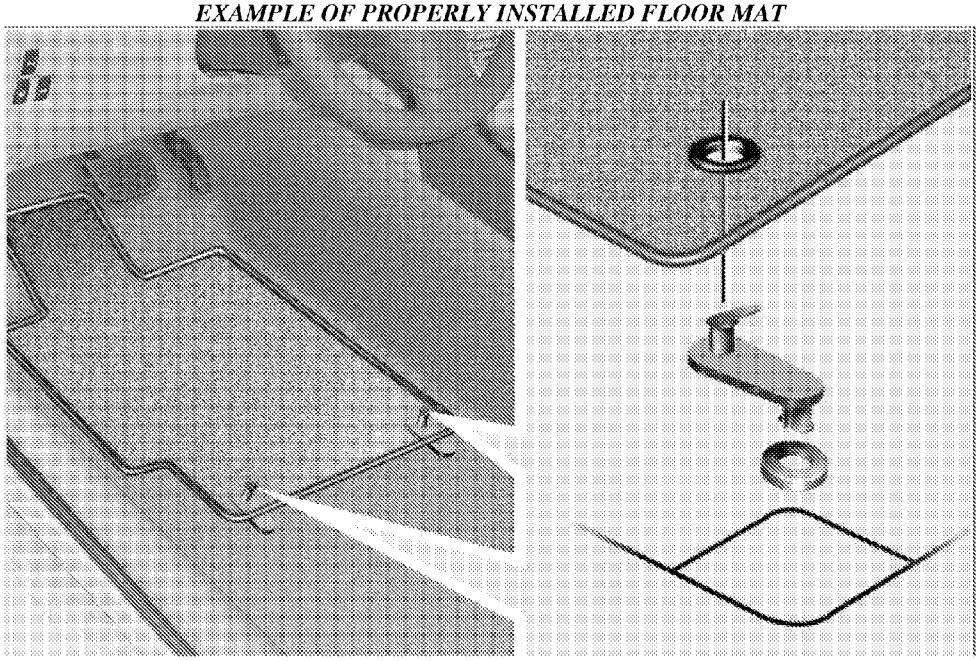
EXAMPLE OF PROPERLY INSTALLED FLOOR MAT

In the event owners choose not to remove their floor mat, Toyota strongly recommends that they ensure that the correct floor mat is being used, that it is properly installed and secured, that it is not flipped over with bottom-side up, and that one floor mat is not stacked over another. Information on proper floor mat installation can be found on http://www.toyota.com and http://www.lexus.com.
