NEWS FROM TOYOTA
PUBLIC AFFAIRS, TOYOTA MOTOR SALES, U.S.A., INC.

FOR IMMEDIATE RELEASE
TMS-050-09

Toyota/Lexus Consumer Safety Advisory Potential Floor Mat Interference with Accelerator Pedal

September 29, 2009

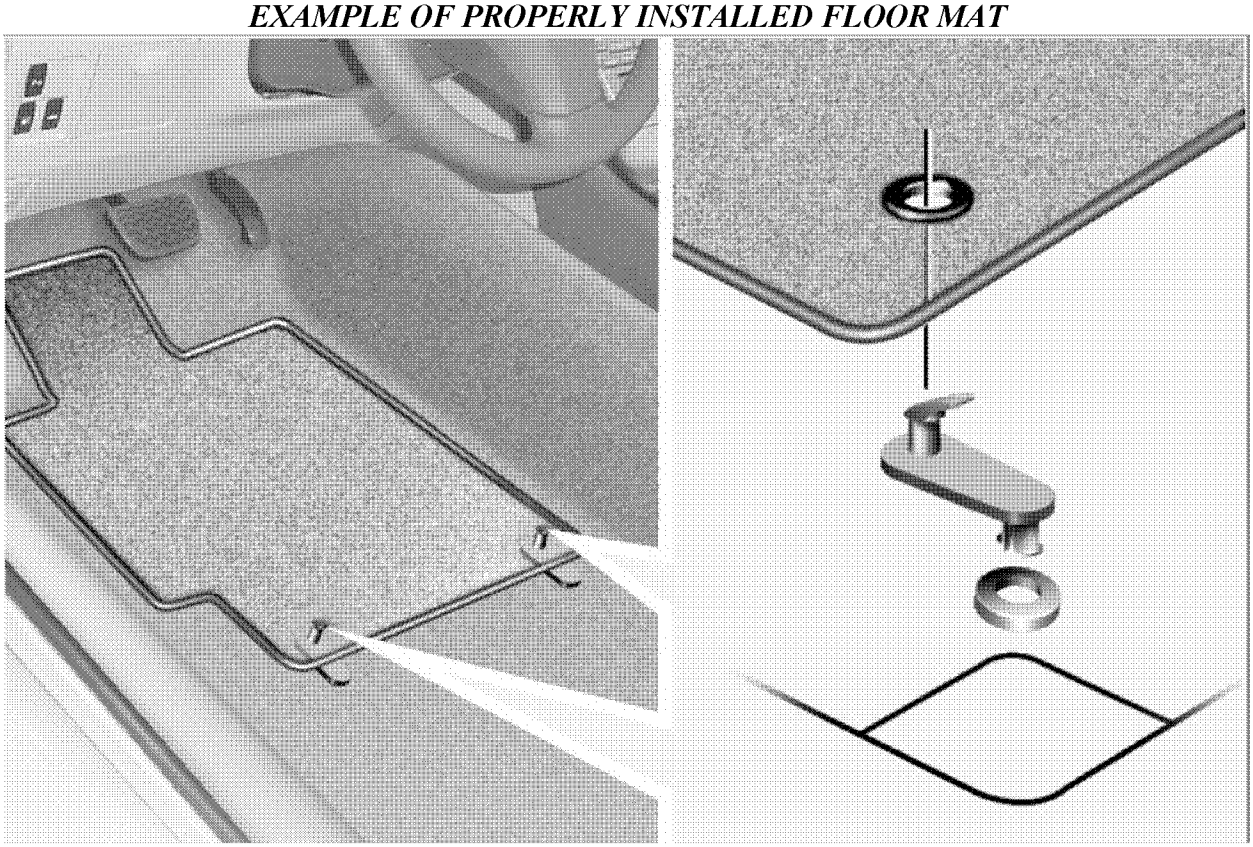
EXAMPLE OF PROPERLY INSTALLED FLOOR MAT

In the event owners choose not to remove their floor mat, Toyota strongly recommends that they ensure that the correct floor mat is being used, that it is properly installed and secured, that it is not flipped over with bottom-side up, and that one floor mat is not stacked over another. Information on proper floor mat installation can be found on http://www.toyota.com and http://www.lexus.com.
