Alternative Approaches to Occupant Response Evaluation in Frontal Impact Crash Testing

Timothy Keon

NHTSA

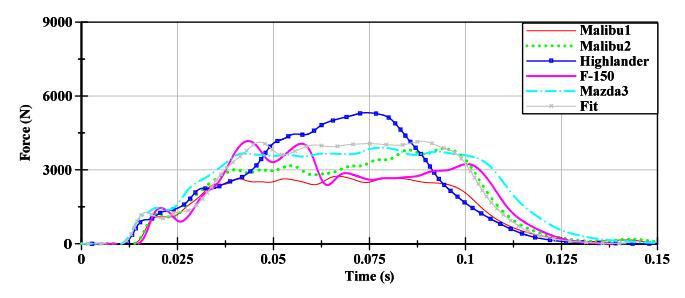
During the tests, seat belt pretensioners and frontal air bags deployed for the driver. Force limiting seat belts were noted in all tests at the driver position. However, the Toyota Highlander lap belt force also showed a rise and peak that is more characteristic of a seat belt without force limiting. The initial lap belt force indicated force limiting behavior until approximately 40 milliseconds after impact. The belt force then steadily increases up to a 6000 lb peak. Seat belt loads for the driver are shown in Figure 1 and Figure 2.

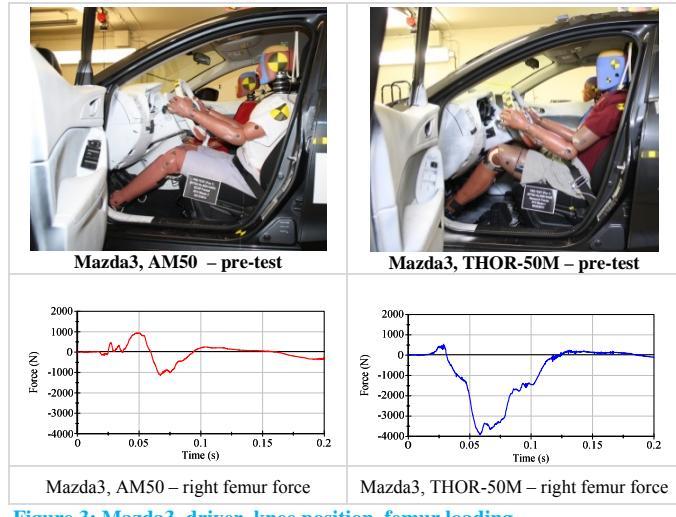
Mazda3 pre-test photos demonstrate the noticeable change in dash to knee clearance between the two ATDs (Figure 3). The THOR-50M knees are considerably closer to the knee bolster than the AM50. The z-axis response of the femur load cell confirms that close proximity of the THOR-50M knee lead to compressive loading early in the test event. Output from the femur load cell is initially positive indicating a tensile force. Knee contact with the dash compressively loads the femur and results in a negative output value.

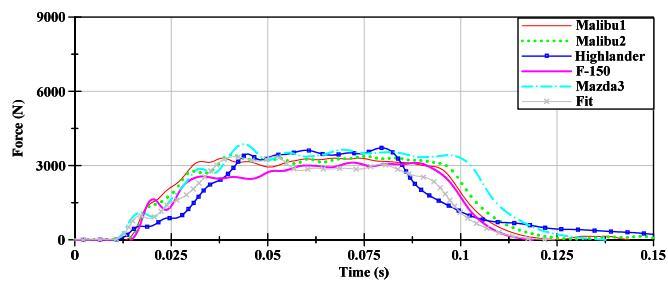
In all of the tests, seat belt pretensioners and frontal air bags deployed for the right front passenger. This study's seat belt load cells indicated seat belt load limiters for the right front passenger. Shoulder belt load cells showed force limiting behavior at approximately 3,000 N (Figure 4). Lap belt load cell output for all vehicles is seen as similar except for the Toyota Highlander (Figure 5). In this vehicle, lap belt force appears to be more similar to the right rear seat position in the Highlander which does not have a force limiting seat belt (Figure 12). There was no instrumentation for the right front passenger belt force in the prior Highlander NCAP test available for comparison.

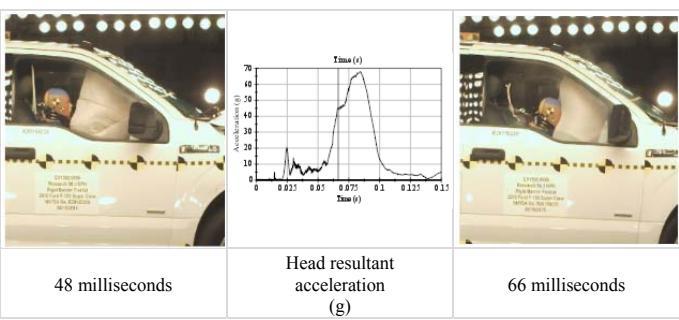
Figure 6: Right front passenger, Ford F-150 air bag deployment in research test

To investigate the higher HIC_{15} value, video and data was reviewed from the Ford F-150 crash tests. Head position and timing of air bag contact is shown in Figure 6 along with the resultant head acceleration. For the AF05 seated full forward (NCAP), the head fully contacts the air bag at 48 milliseconds with a resultant head acceleration of 20 g. For the AF05 positioned at mid-track in the current study, there is head to air bag clearance at 48 milliseconds (left image) and head contact with the air bag at 66 milliseconds (right image). Head acceleration is greater than 40 g at that time point. The additional clearance to the dash panel due to the mid-track seat position allows the AF05 head greater free travel prior to air bag contact, which results in a higher head acceleration value.

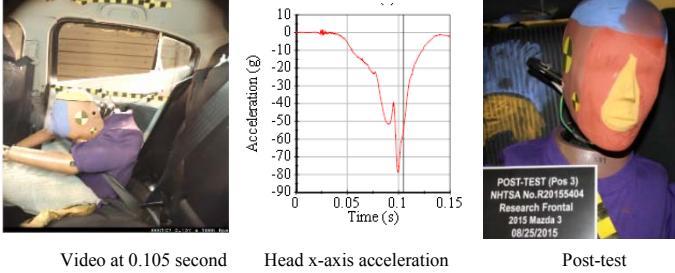
Figure 8: Mazda3, right rear passenger, chin to chest contact

Chin to chest contact was judged to have occurred in the Highlander, Mazda3 and Fit tests. In addition to high x-axis head acceleration peaks (> 70 g) which corresponded with substantial neck flexion, post-test photos document chalk transfer indicating chin to chest contact. In the case of the Mazda3, video showed that the right rear AF05 had the lap belt slide over the top of both iliac crests (submarining) which induced twisting of the torso with chin to chest contact. Similar chalk transfer was recorded with post-test photos of the F-150 right rear AF05; however the head CG accelerometer output was deemed faulty and is not included as a figure. No indication of chin to chest contact was noted in either Malibu test. Images from the test videos for each test showing right rear AF05 torso flexion are included in Appendix C.

As demonstrated in Figure 8, video of the Mazda3 crash event showed the lap belt sliding over the top of both iliac crests (submarining) of the right rear AF05. This explains the belt force behavior for the Mazda3 shown in Figure 11 and Figure 12.

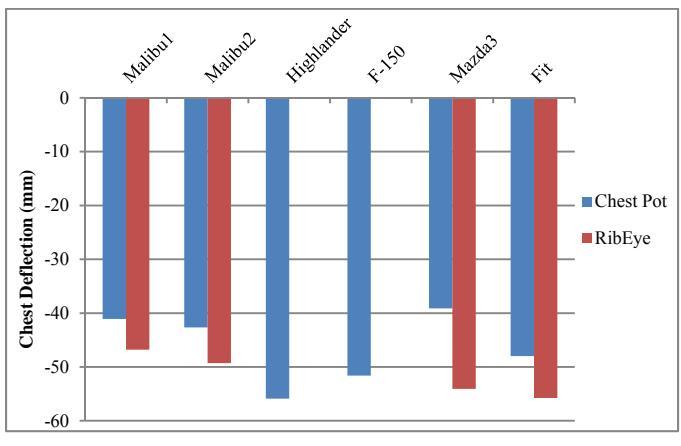
Figure 10: Right rear passenger, chest pot versus maximum RibEye deflection (x-axis)

Like the right front AF05, the right rear AF05 had a RibEye Deflection Measurement System installed. In the Toyota Highlander and Ford F-150 crash events, the RibEye did not collect data. In each test, the maximum deformation (x-axis) recorded by the RibEye was greater than that recorded by the chest pot (Figure 10). The maximum chest deflection was observed on the ATD's left side but the rib that sustained the maximum deflection was not consistent. There is not an injury risk function for RibEye deflections at this time.

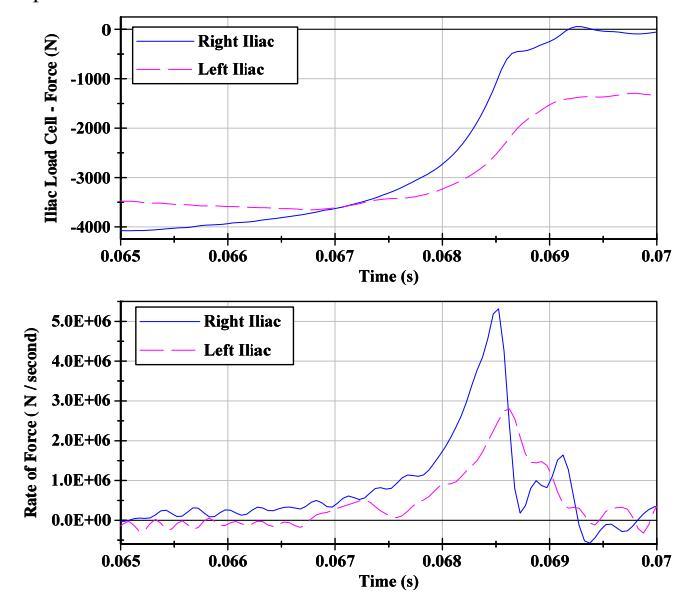
The anterior superior iliac spine (A.S.I.S.) load cell in the AF05 also provided confirmation of the submarining event. Review of the A.S.I.S. load cell data which showed a decreasing rate of ilium bone force of 1,000,000 N/second or more (Figure 13). This instrumentation response rate was considered by the Japanese New Car Assessment Program (JNCAP) to indicate a potential abdominal injury caused by the lap belt sliding off the ilium bone of the pelvis. Such an event would have reduced the JNCAP abdomen weighed score from a maximum of 3.2 points to 0 points [10]. Currently there is no NCAP injury criterion for abdominal injury in the frontal impact test.

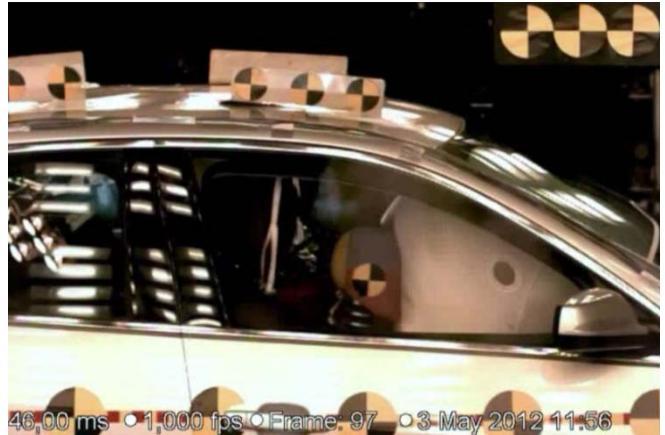
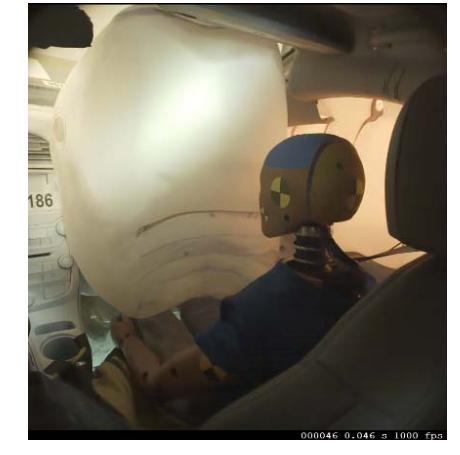
Chevrolet Malibu, test #9332, air bag deployment at 0.046 seconds

Images from test videos showing the right front passenger to air bag clearance is included in Appendix A. In NCAP tests, frame captures are collected when the right front passenger contacts the frontal air bag. A frame capture from the current study at the same event time was paired to demonstrate the clearance due to the mid-track seat position. In all cases, the NCAP tests show right front passenger contact with the air bag occurring earlier than this study due to the seat's full forward-track position. Vehicle air bags appear to be tuned for the AF05 seated at the full forward-track position.
