NHTSA CONSUMER ADVISORY: Secure Floor Mats in 2007/2008 Lexus ES 350, Camry, Other Toyotas; Advisory Also Extended to Other Vehicles

Toyota to Conduct Floor Mat Recall

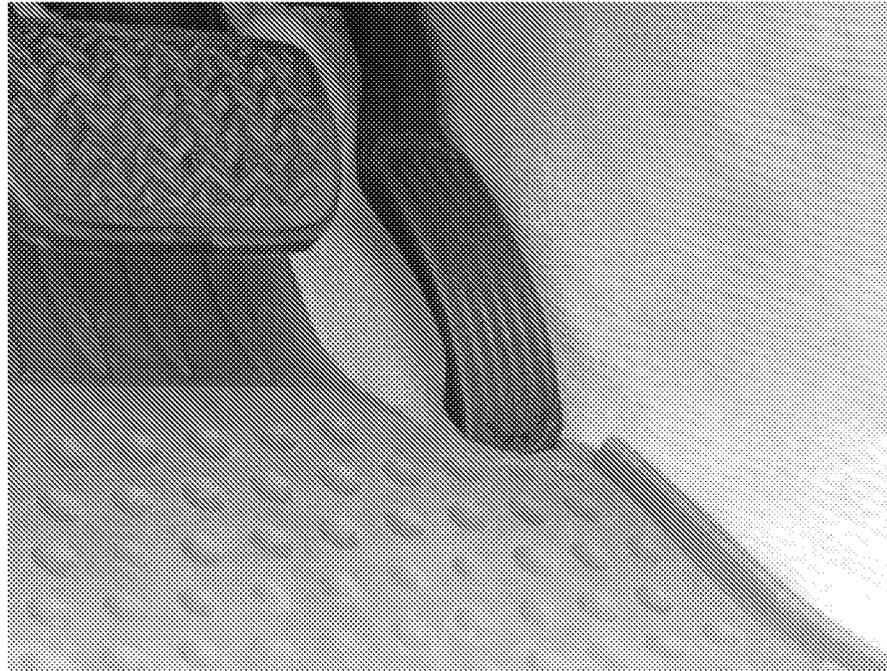
NHTSA and Toyota noted that, if unsecured, the mats being recalled can slip forward and trap the accelerator pedal, causing the vehicle to accelerate uncontrollably.

Example of an unsecured driver-side floor mat trapping the accelerator pedal in a 2007 Lexus ES350

While the recall is underway, drivers of these Toyota vehicles are strongly urged to make sure the driver-side floor mat is properly secured to the retention hooks on the floorboard. Also, never overlay two mats on top of each other because the retention hooks cannot secure the top-most mat which can then slip and trap the accelerator pedal.

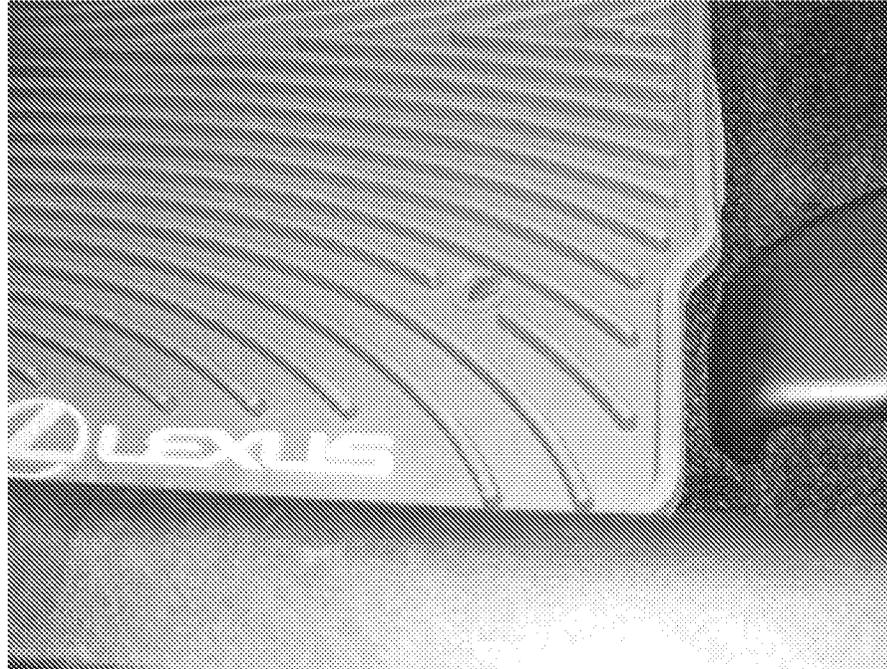
Always make sure your driver-side floor mat is properly secured by the tabs. Never overlay two mats on top of each other because the top-most mat can not be secured properly by the retention hooks.
