**National Highway
Traffic Safety
Administration**

DOT HS 812 582

October 2018

Examination of a Prototype Camera Monitor System For Light Vehicle Outside Mirror Replacement

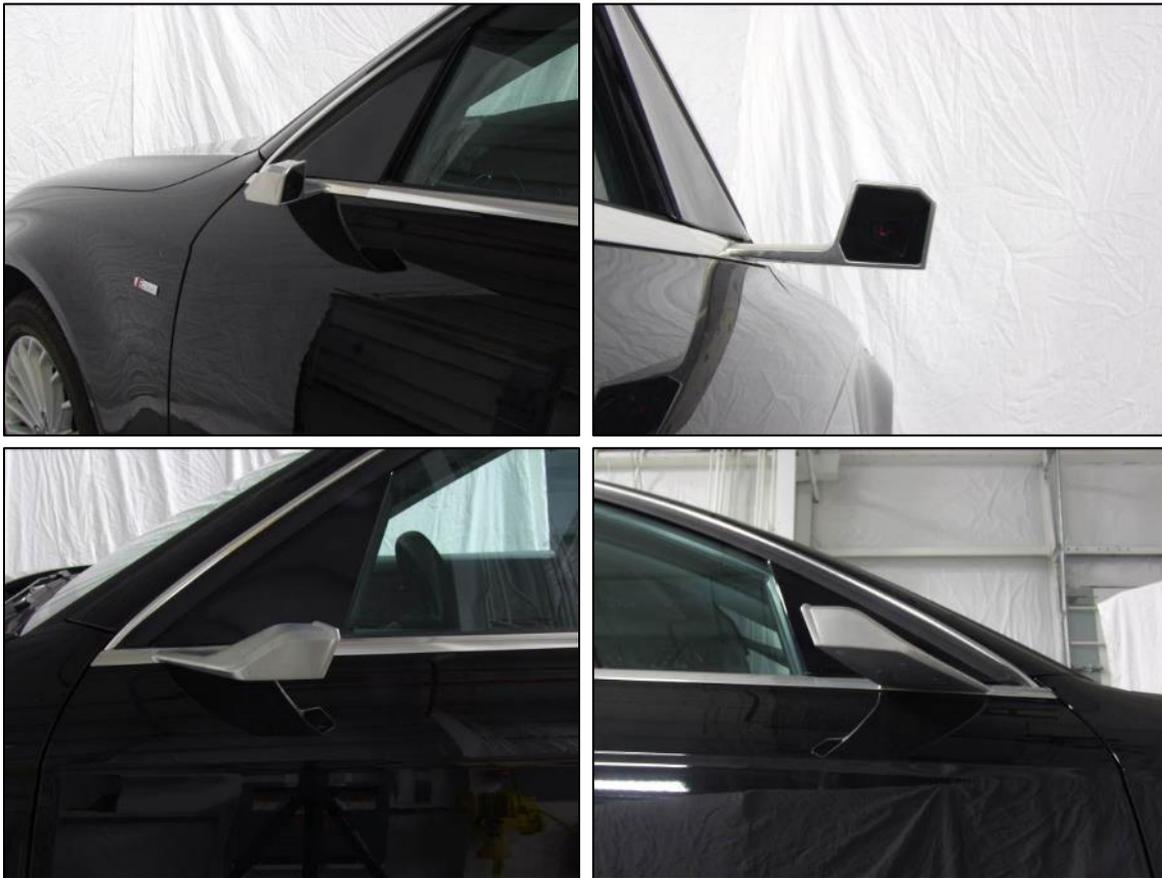
The following figures contain photos of the prototype side camera monitor system, providing examples of the camera components' size and mounting locations on the vehicle's exterior. As can be seen in Figure 1, the exterior cameras are mounted approximately where traditional mirrors would normally be located. The size of the camera, and therefore the impact on aerodynamics, is much smaller than typical outside mirrors.

Figure 1. Photos Showing Cameras of the Prototype Side Camera Monitor System

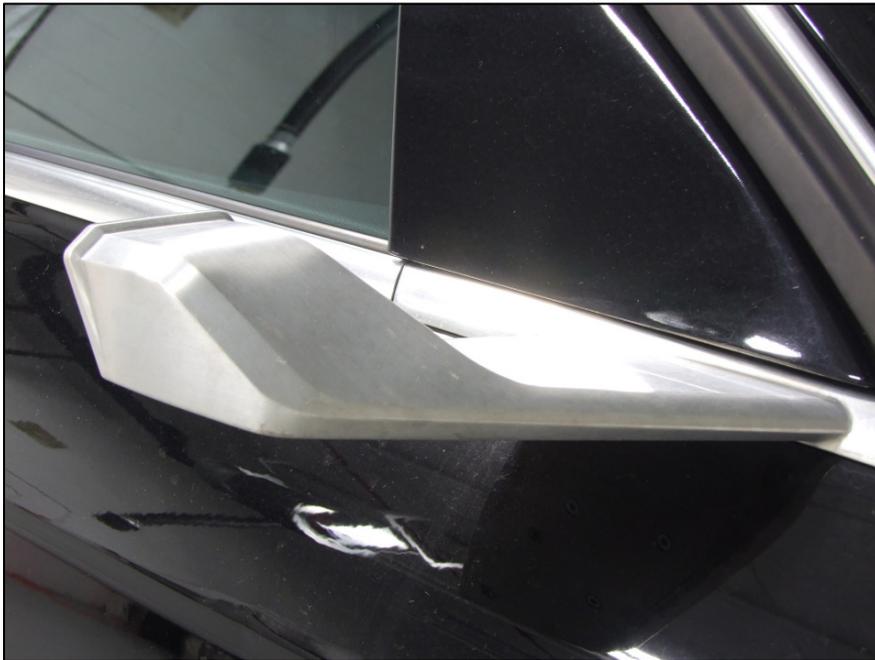
The following two figures provide a close-up look at the design and shape of the camera housing on the passenger side of the vehicle.

Figure 2. Passenger Side Camera Housing

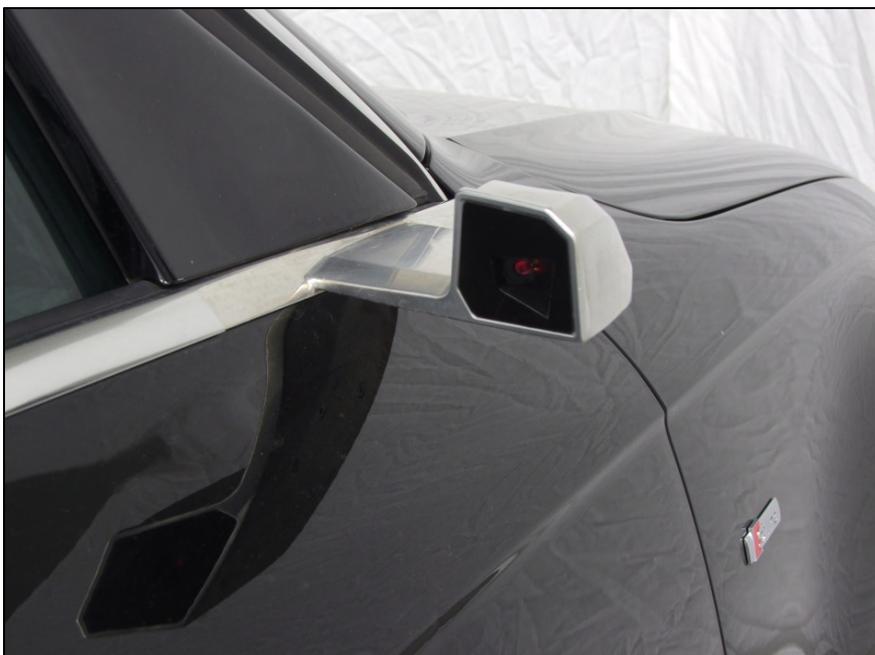
Figure 3. Passenger Side Camera

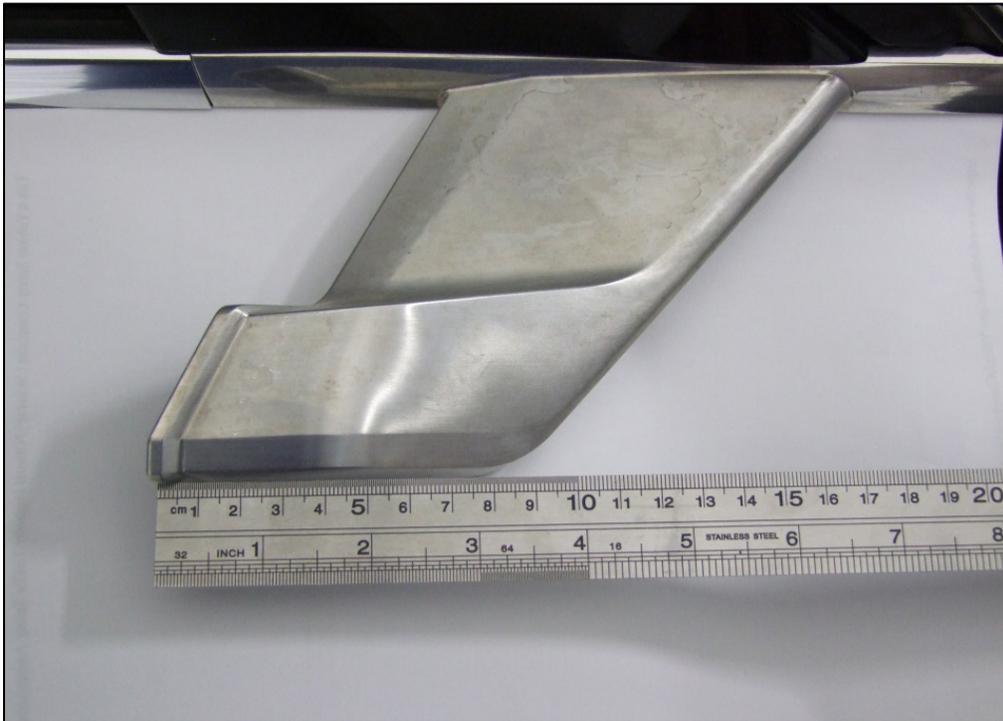
The following two figures provide a close-up view of the camera housing with a ruler included in the image to provide an idea of the length and width of the camera housing.

Figure 4. Camera Housing (Passenger Side), Top-Down View With Ruler in Image

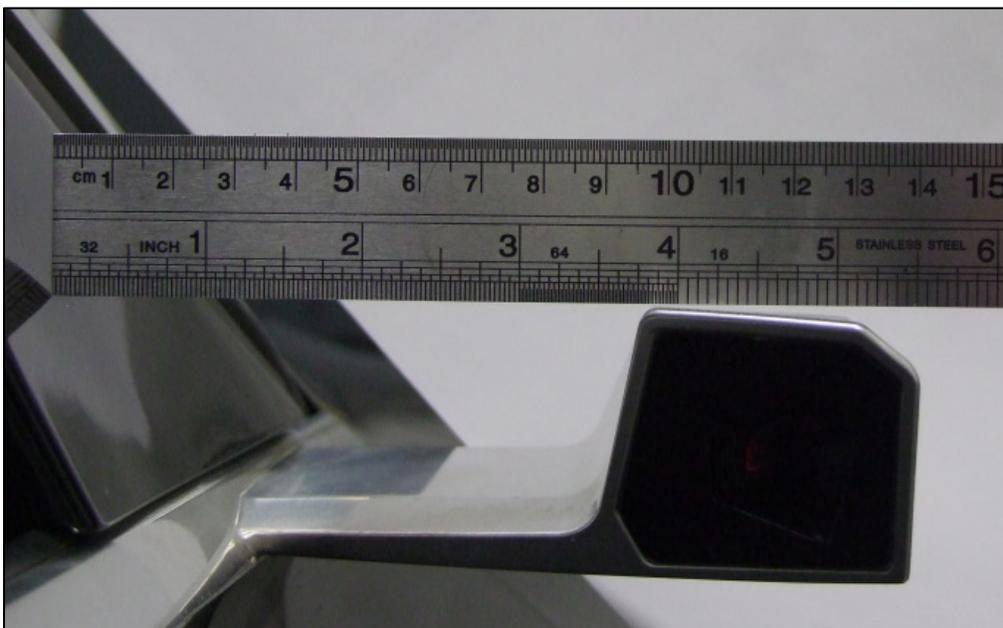
Figure 5. Camera Housing (Passenger Side), With Ruler in Image

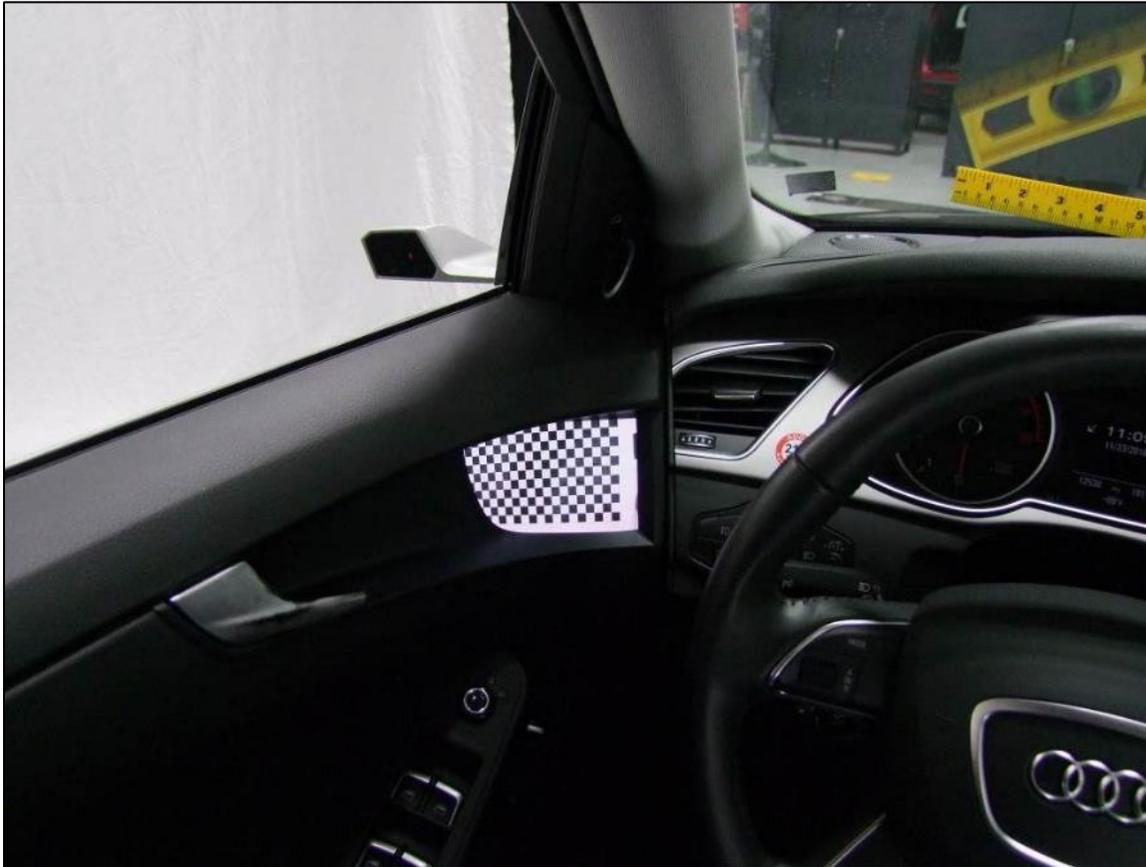
The driver and passenger side CMS displays were located at the leading edge of the corresponding door panels and had overhanging trim above to help block sunlight from striking the displays. Figures 6 and 7 contain photos of the driver and passenger side interior CMS displays, respectively, as viewed from the 50th percentile male driver's viewpoint. The CMS display shows an image of an ISO grid (chessboard chart) in the field of view to highlight the display location and clarity. See section 5.3 for more information on the ISO grid.

Figure 6. Driver-Side Interior Display, Driver's Viewpoint, ISO Grid in View

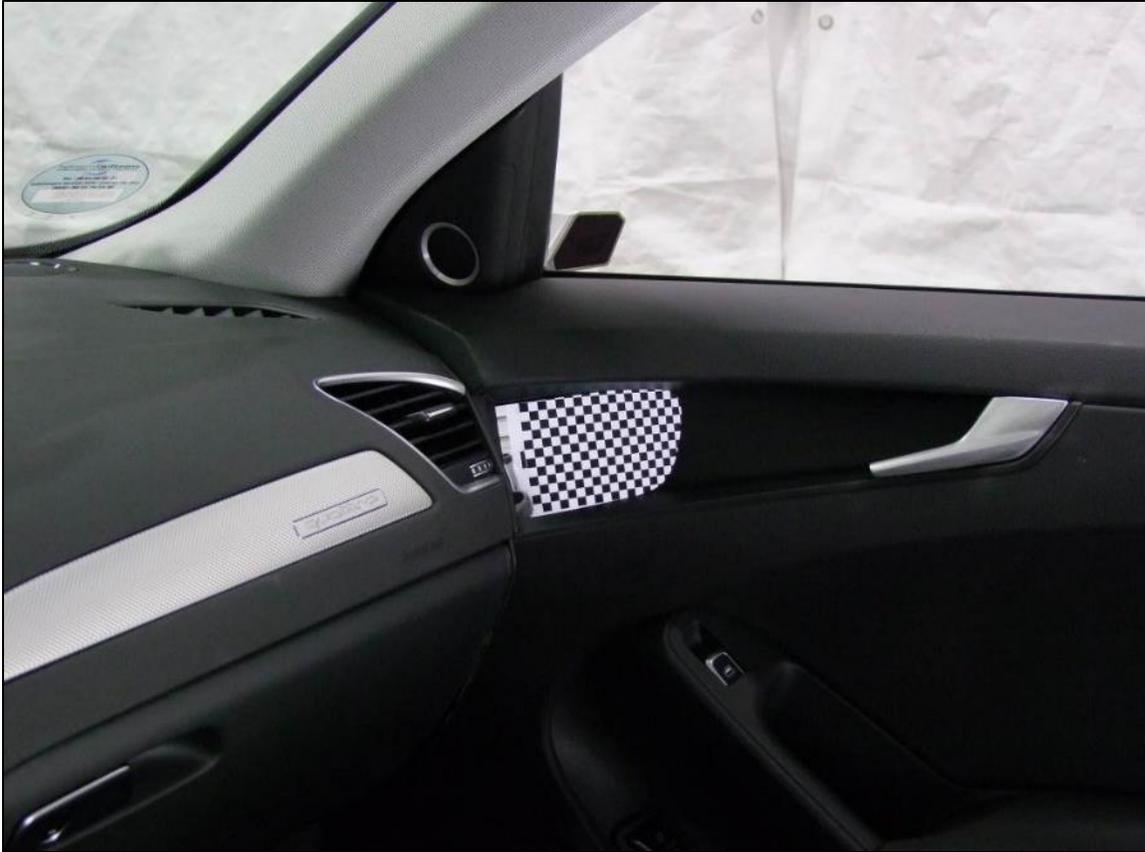
Figure 7. Passenger-Side Interior Display, Driver's Viewpoint, ISO Grid in View

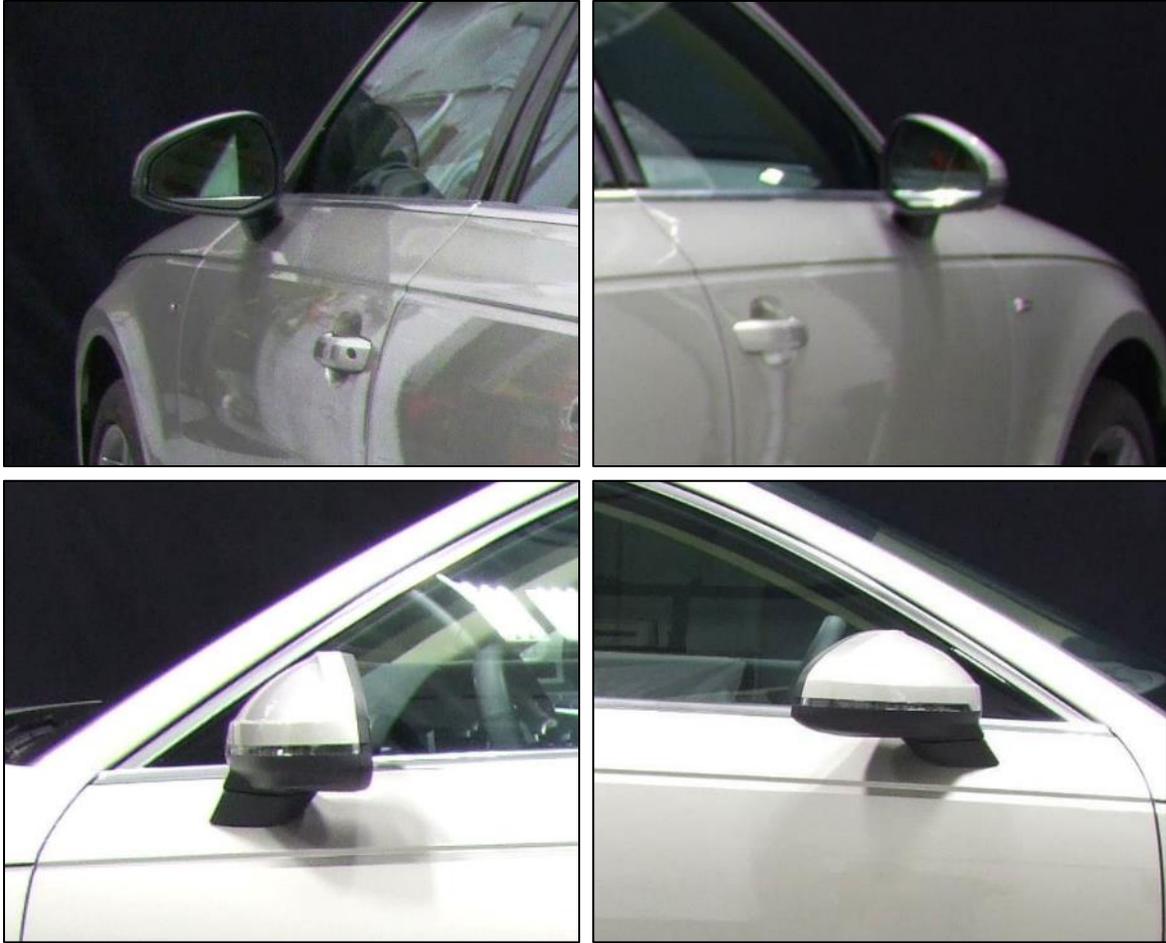
Figure 8 shows images of the comparison vehicle equipped with traditional mirrors. The dimensions of the mirrors were approximately 7 inches (17.8 cm) at the widest point and 4.5 inches (11.4 cm) at the highest point. A close-up view of the mirror housing with a tape measure included in the image is provided in the following figure to provide an idea of the size of the mirror and mirror housing for comparison with the CMS camera unit.

Figure 8. Photos of the Outside Rearview Mirrors on a 2017 Audi A4

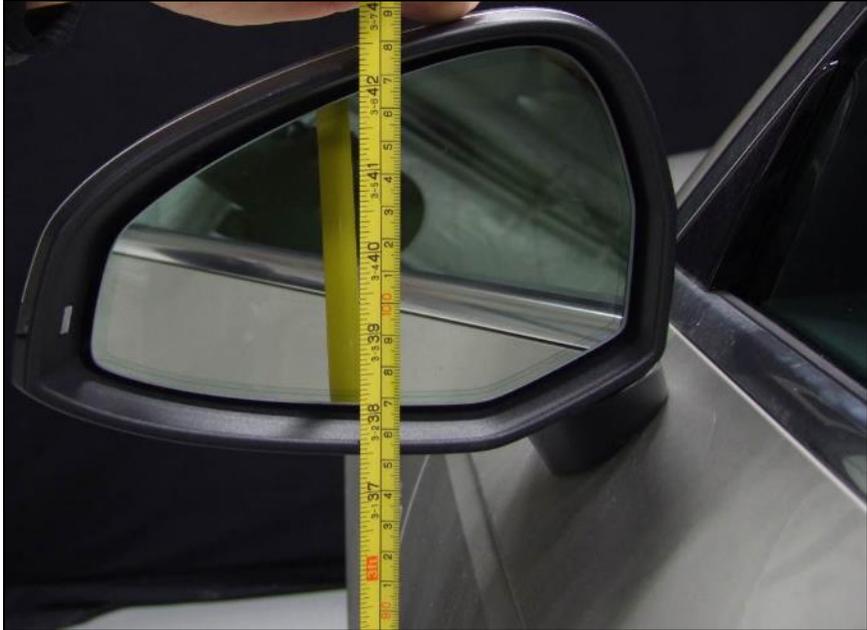
Figure 9. Driver-Side Outside Rearview Mirror

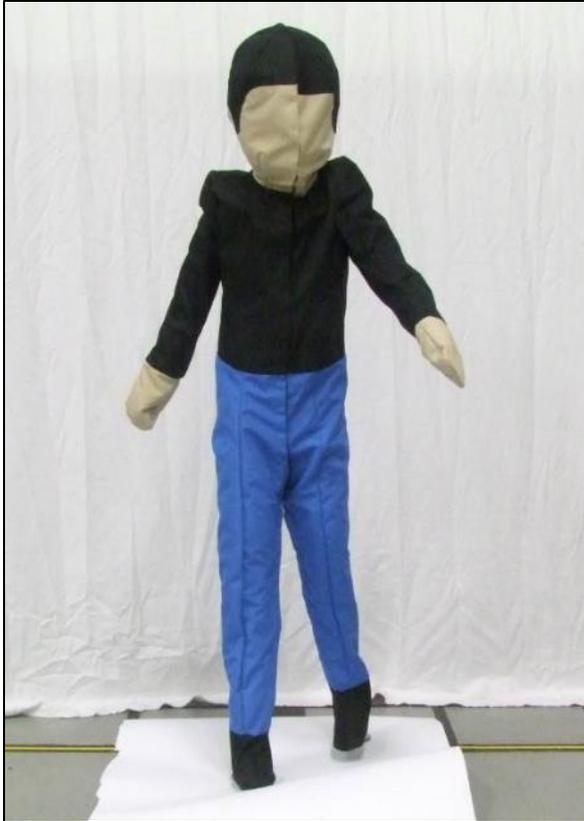
One of the test objects used in this program was a posable pedestrian child mannequin developed by 4a Engineering GmbH, Traboch, Austria. The mannequin is 46.5 inches (1.18 m) in height and was designed to simulate a 6-year-old child. This mannequin is used in EuroNCAP. The posable child mannequin test object is shown in the following figure.

Figure 10. Posable Child Mannequin Test Object, Front View

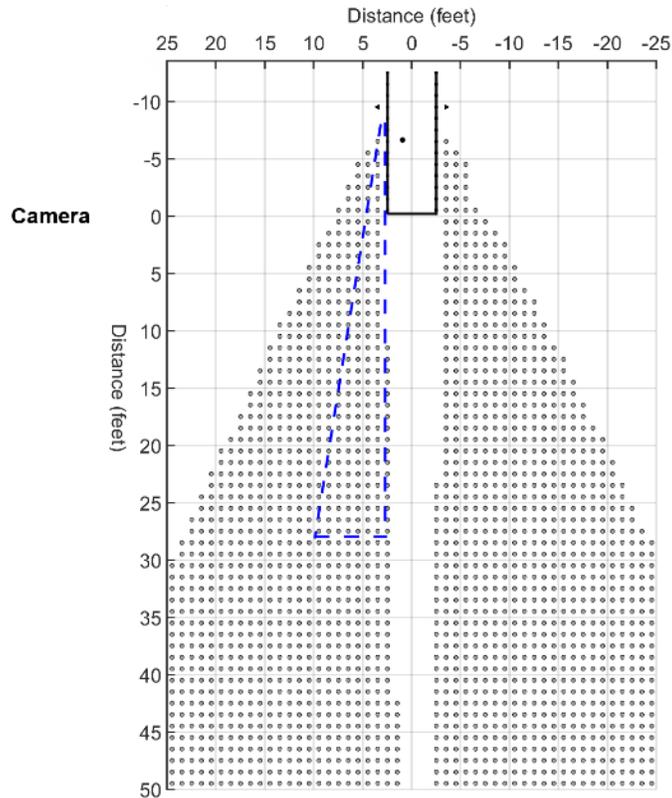
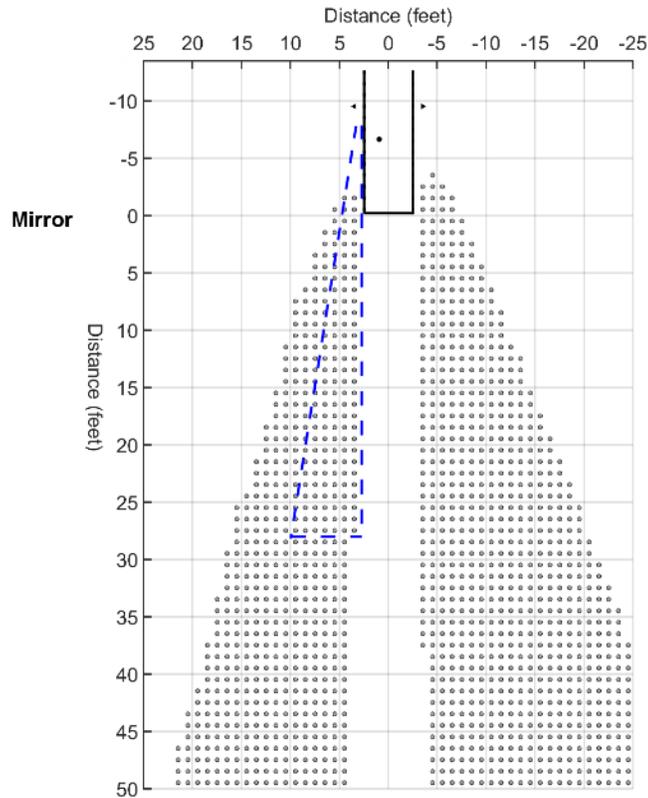
Figure 11 below shows the fields of view for the prototype side CMS and the original equipment mirror system (2017 Audi A4), respectively. Both figures show the test vehicle with its rear bumper face centered at the (0,0) location on the grid. The outside mirror and side camera locations are indicated with small triangles on both sides of the vehicle, which is represented by a rectangular outline. The driver's eye point location is also indicated using a small black circle within the vehicle's perimeter. Grid locations around the vehicle at which the visual target was visible via the mirror or camera system are indicated in both figures using gray circles. A horizontal green line is used to highlight the FMVSS No. 111 outside rearview mirror field of view requirement (S5.2) which states, "The mirror shall provide the driver a view of a level road surface extending to the horizon from a line, perpendicular to a longitudinal plane tangent to the driver's side of the vehicle at the widest point, extending 2.4 m out from the tangent plane 10.7 m behind the driver's eyes, with the seat in the rearmost position." The resultant area is indicated by an outlined triangular area on both sides of the vehicle.

Figure 11. Fields of View for Prototype Side Rearview CMS and Original Equipment Mirrors

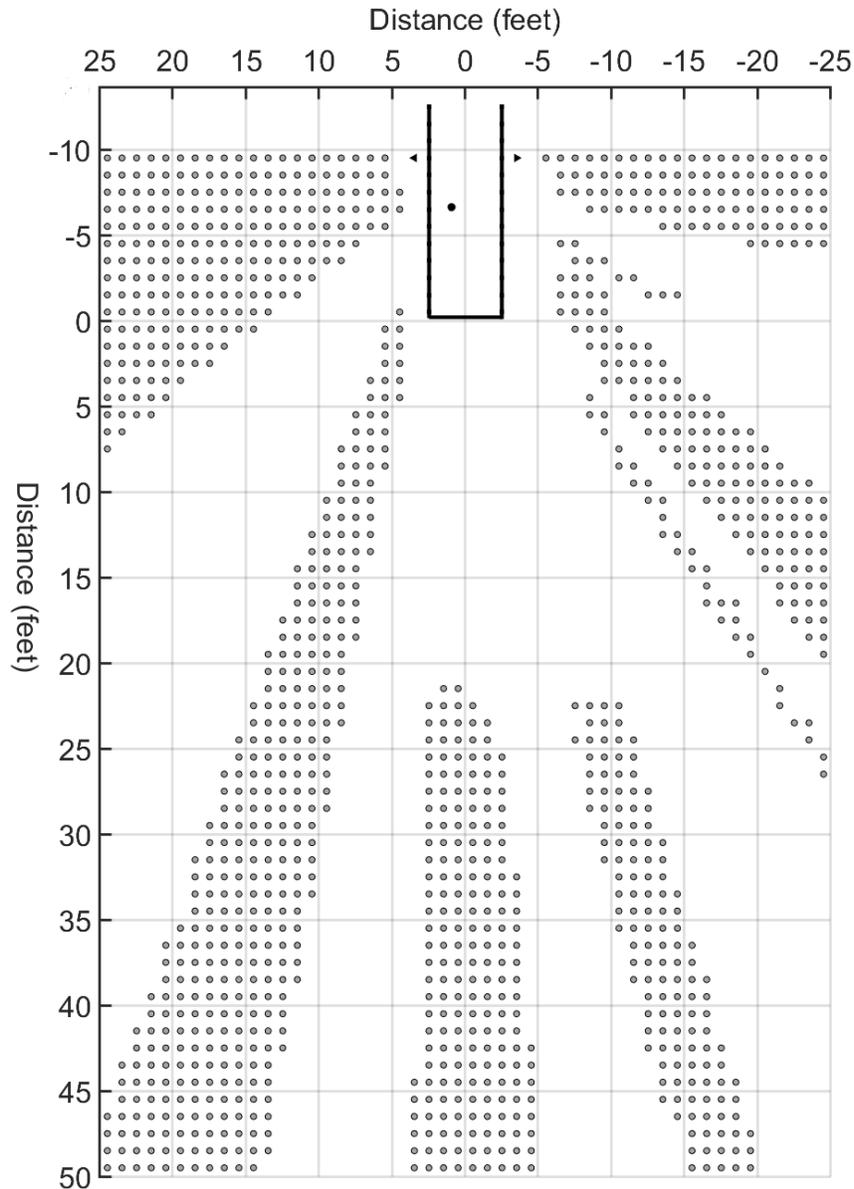
The direct vision field-of-view for the 2017 Audi A4 test vehicle is illustrated in Figure 12 below. This direct field of view was determined using the method outlined in the NHTSA report, *Direct Rear Visibility of Passenger Cars: Laser-Based Measurement Development and Findings for Late Model Vehicles* [4].

Figure 12. Direct Vision Field-of-View for the 2017 Audi A4 Test Vehicle

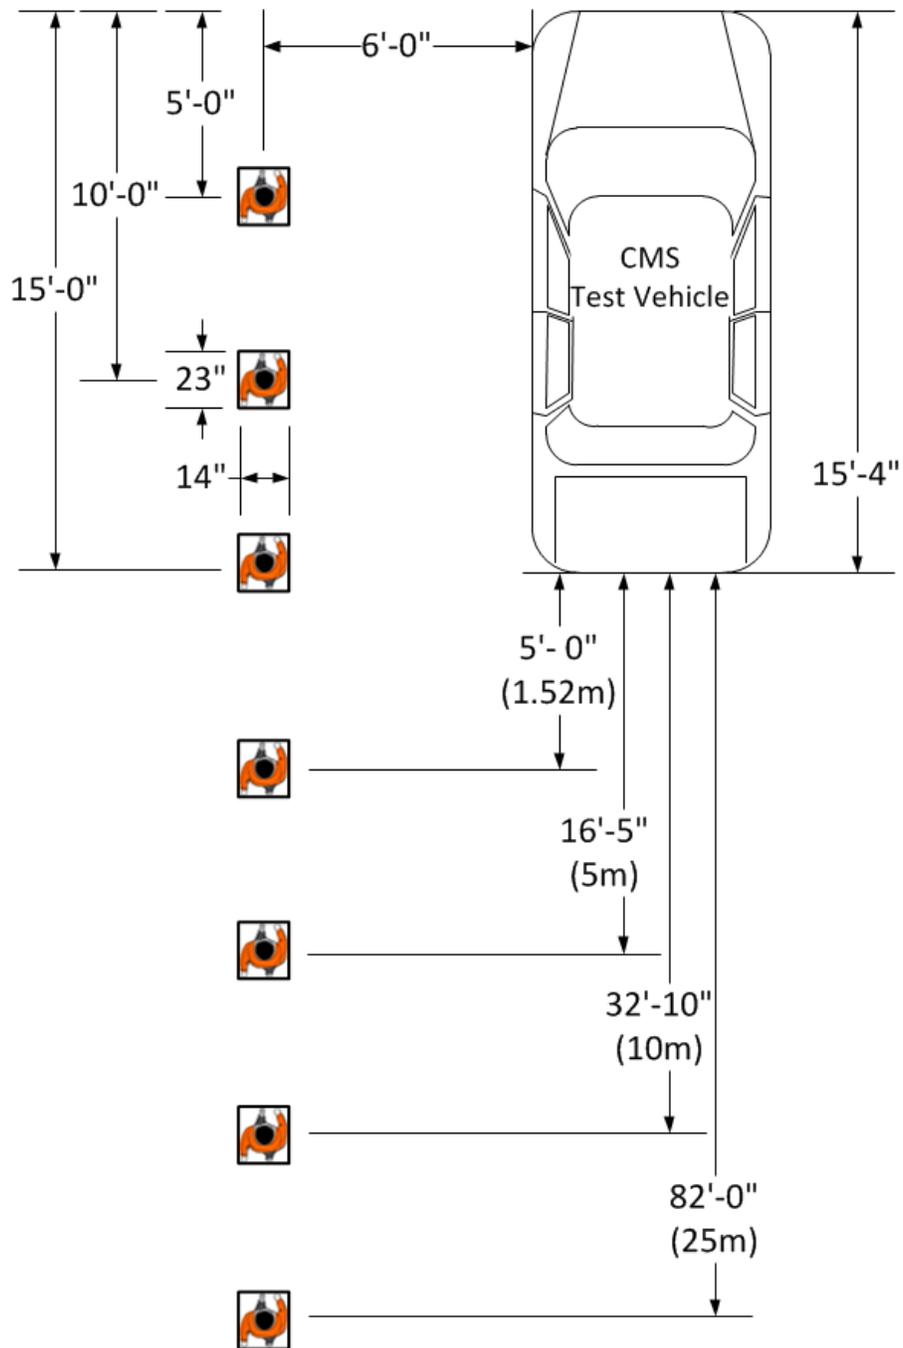
Figure 12 below illustrates how the CMS test vehicle and child mannequin were positioned for the 7 longitudinal test locations. Figure 13 depicts the CMS test vehicle and sedan as tested for the 100 feet aft of front bumper test location.

Figure 13. Illustration of Child Mannequin Test Object Positions With Respect to the CMS Test Vehicle Location.

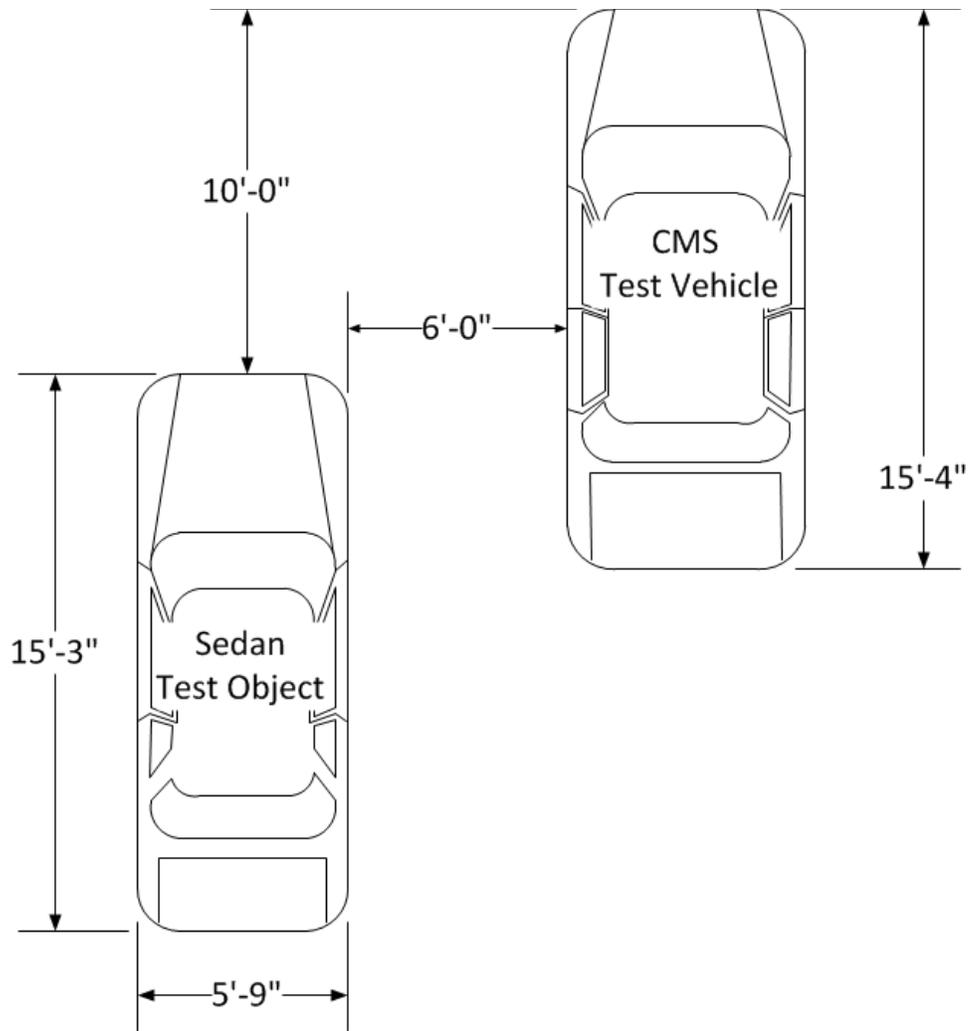
Figure 14. Illustration of Sedan Test Object Positioned 10 Feet Aft of CMS Test Vehicle Front Bumper.

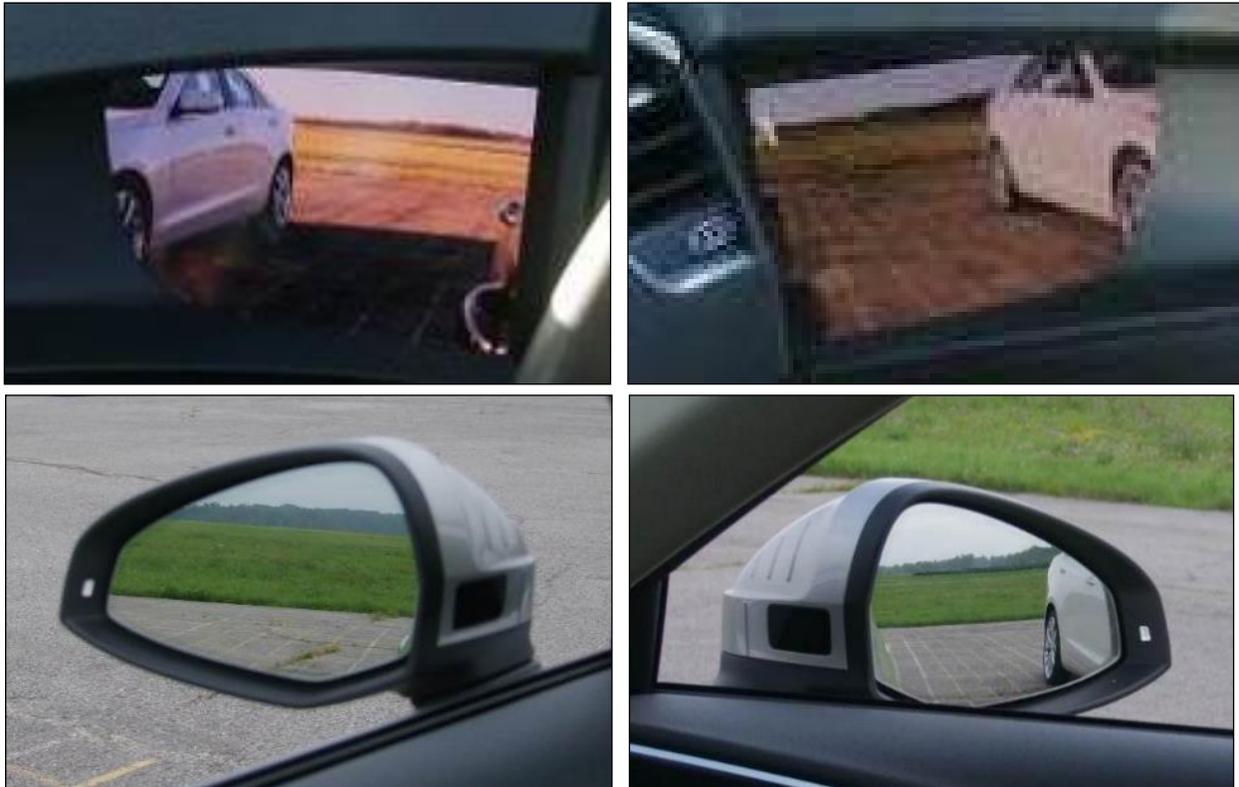
With its wider field of view, the CMS is able to display both test objects at locations next to the vehicle (the aft of front bumper locations) that cannot be seen with traditional mirrors. Figure 15 illustrates this observation for the sedan test object positioned 15 feet aft of the test vehicles' front bumpers.

Figure 15. Sedan Positioned 15 Feet (4.57 m) Aft of Front Bumper, as Viewed With Side CMS (top) and Mirrors (bottom) on Driver (left) and Passenger Side (right)

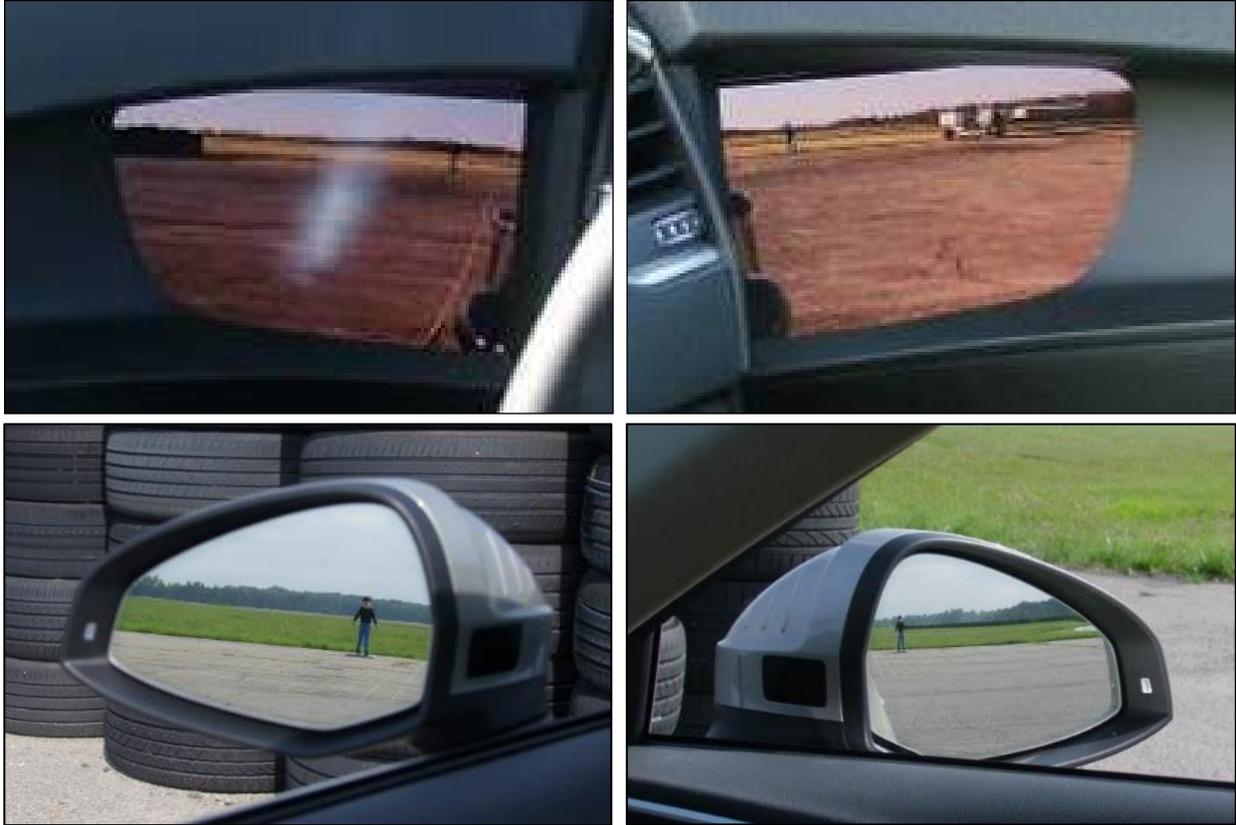
The CMS wider field of view presented over a similar area as a traditional mirror surface results in an image having minification resulting in the child mannequin appearing thinner at a distance of 82 feet aft of the vehicle's rear bumper, as can be seen in Figure 16.

Figure 16. Child Mannequin Positioned 82.0 Feet (25 m) Aft of Rear Bumper, as Viewed With Side CMS (top) and Mirrors (bottom) on Driver (left) and Passenger Side (right)

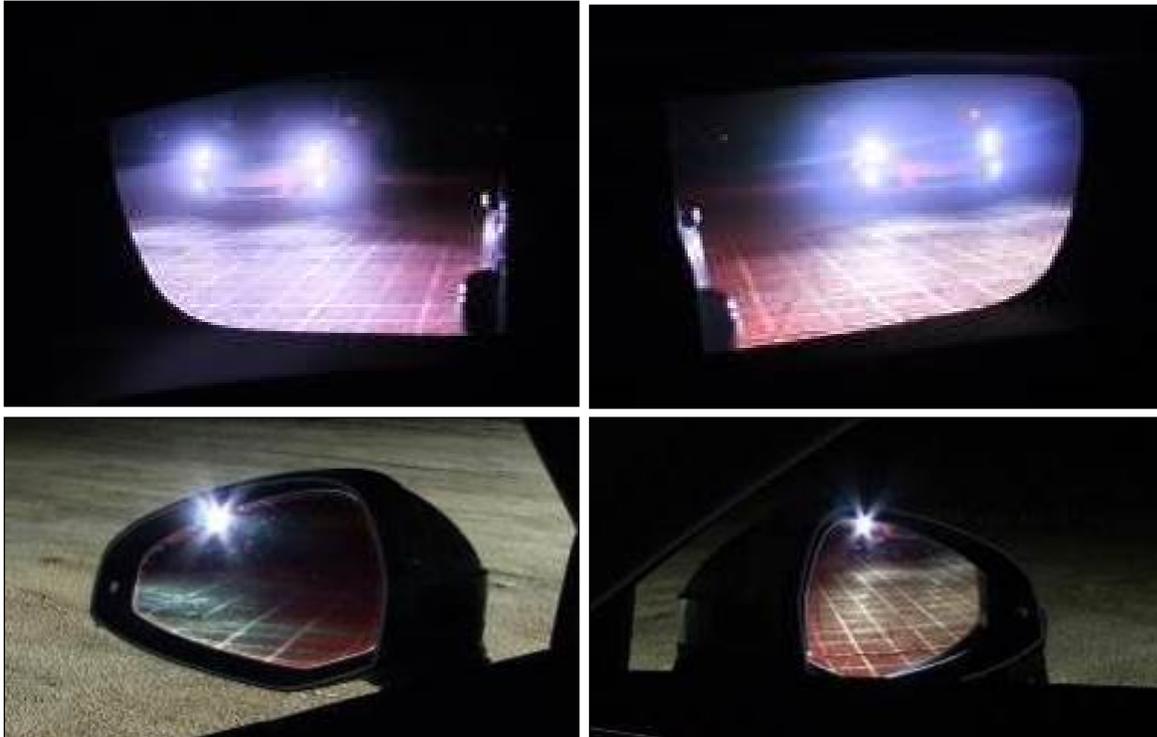
Figure 17 contains photos of the sedan test object positioned 16.4 Feet (5 m) aft of the test vehicle's rear bumper at night as seen with the CMS display and mirrors. This image comparison shows substantially more blooming and lens flare from the sedan test object's headlighting system in the CMS image than can be seen in the mirrors' images.

Figure 17. Sedan Positioned 16.4 Feet (5 m) Aft of Rear Bumper at Night Time, as Viewed With Side CMS (top) and Mirrors (bottom) on Driver (left) and Passenger Side (right)

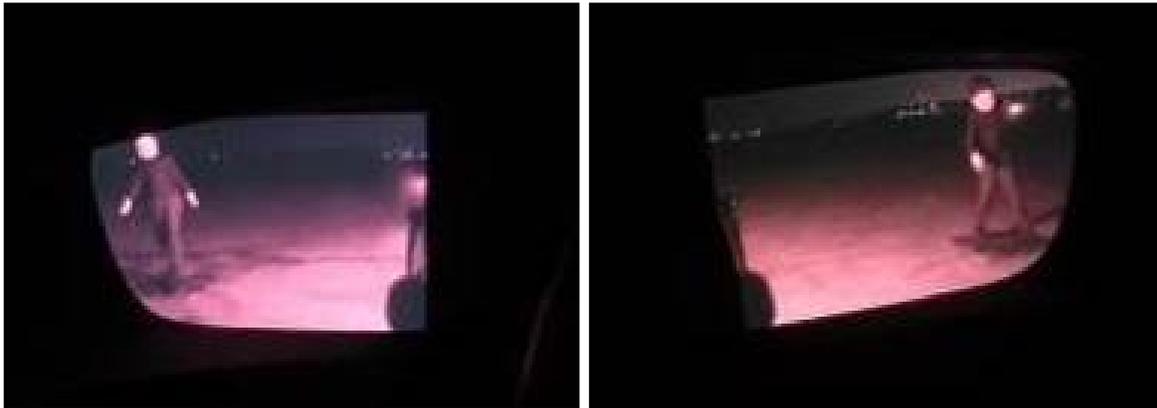
Figure 18 shows images of the CMS display with the child mannequin test object positioned 5 feet aft of the test vehicle's rear bumper in dark conditions. In dark conditions at multiple test object locations the child mannequin could be seen in the CMS display but not in the mirrors.

Figure 18. Child Mannequin Positioned 5 Feet (1.52 m) Aft of Rear Bumper, at Night Time as Viewed With Side CMS on Driver (left) and Passenger Side (right)

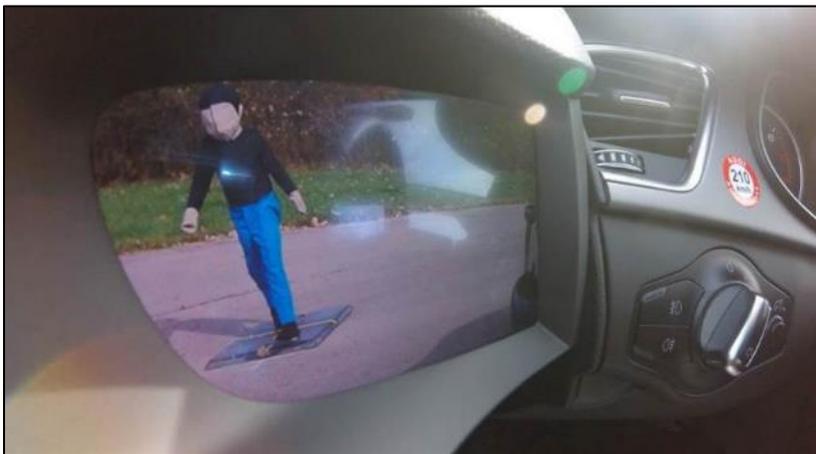
In general, the CMS displays appeared bright and clear under the conditions examined in this effort. In some cases, minor glare and reflections could be observed. Figures 19 and 20 contain photos of the posable child mannequin and sedan test objects in the CMS display's field of view during a bright sunny day, in which the effects of the bright light were noticed on the displays.

Figure 19. Posable Child Mannequin in Sunny Test Conditions, Glare/Reflection in CMS Display

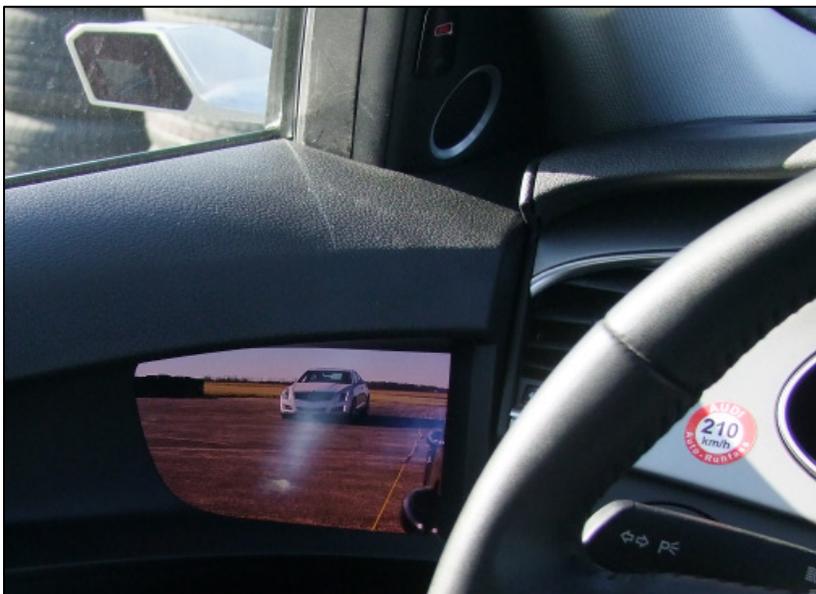
Figure 20. Sedan Test Object in Sunny Test Conditions, Glare/Reflection in CMS Display

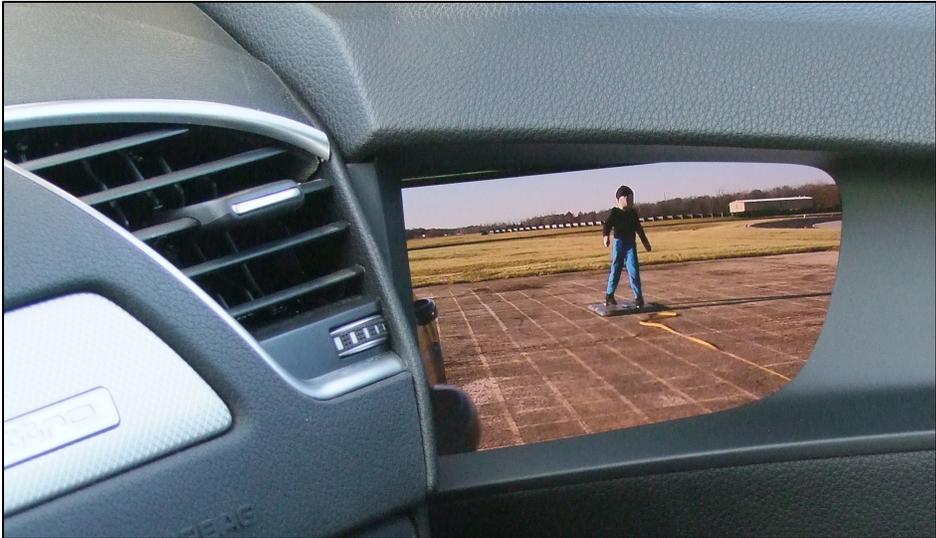
For comparison, the following figures are photos of the posable child mannequin and sedan test objects in the CMS display's field of view during a bright sunny day, in which the effects of the bright light were not noticeable on the displays.

Figure 21. Posable Child Mannequin in Sunny Test Conditions, Minimal Glare/Reflection in CMS Display

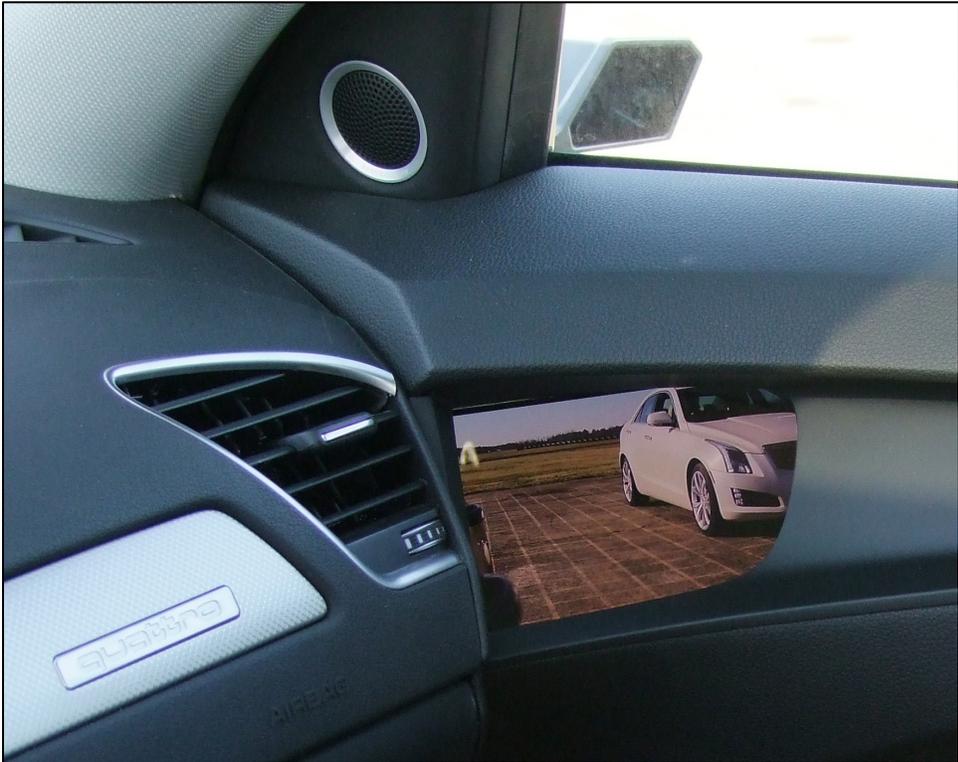
Figure 22. Sedan Test Object in Sunny Test Conditions, Minimal Glare/Reflection in CMS Display

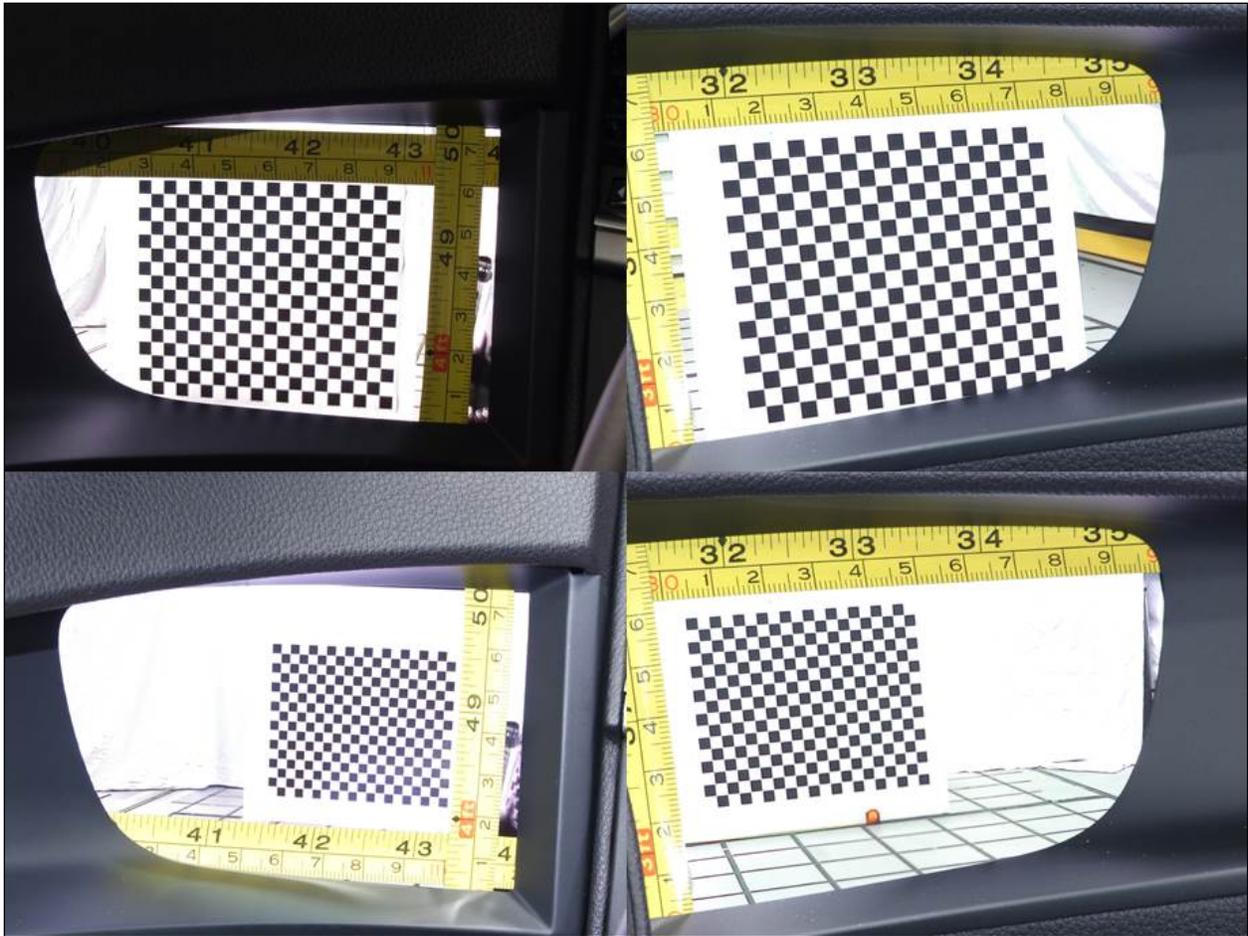
The following figures are examples of the chessboard chart in the field of view of the side-view cameras. As can be seen in the figures, segments of a tape measure were placed over the image surface to provide dimensions of the chessboard chart as it appeared in the displays. The chessboard image in both display types was generally clear.

Figure 23. Near and Far Chessboard in Lighted Environment as Viewed With Driver (left) and Passenger Side (right) CMS Displays

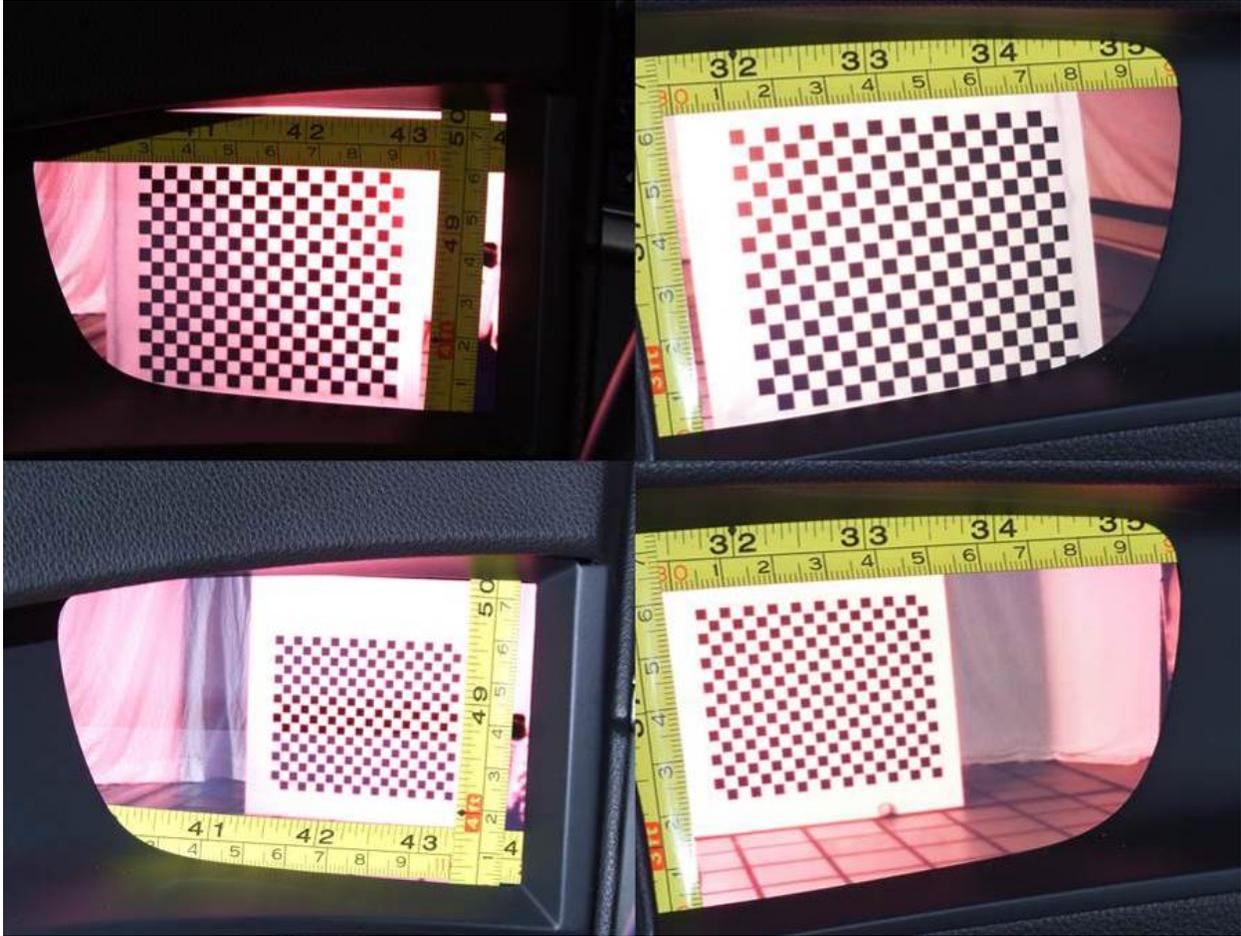
Figure 24. Driver (left) and Passenger Side (right) CMS Displays Showing Near (top) and Far (bottom) Chessboard, Dark Environment, Vehicle Tail Lights On

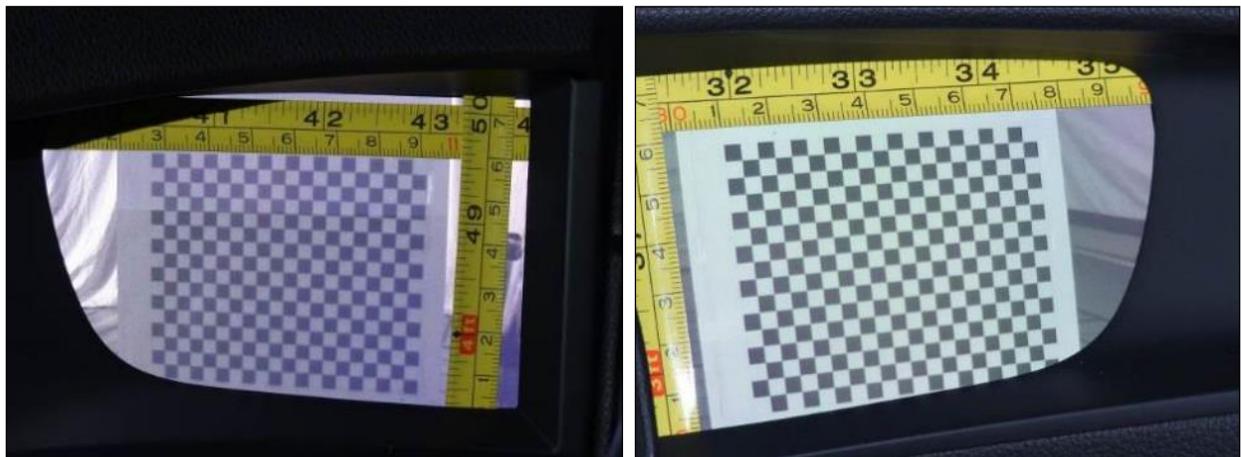
Figure 25. Near Chessboard in Dark Environment With Vehicle Tail Lights Off as Viewed With Driver (left) and Passenger Side (right) CMS Displays
