**National Highway
Traffic Safety
Administration**

DOT HS 812 582

October 2018

Examination of a Prototype Camera Monitor System For Light Vehicle Outside Mirror Replacement

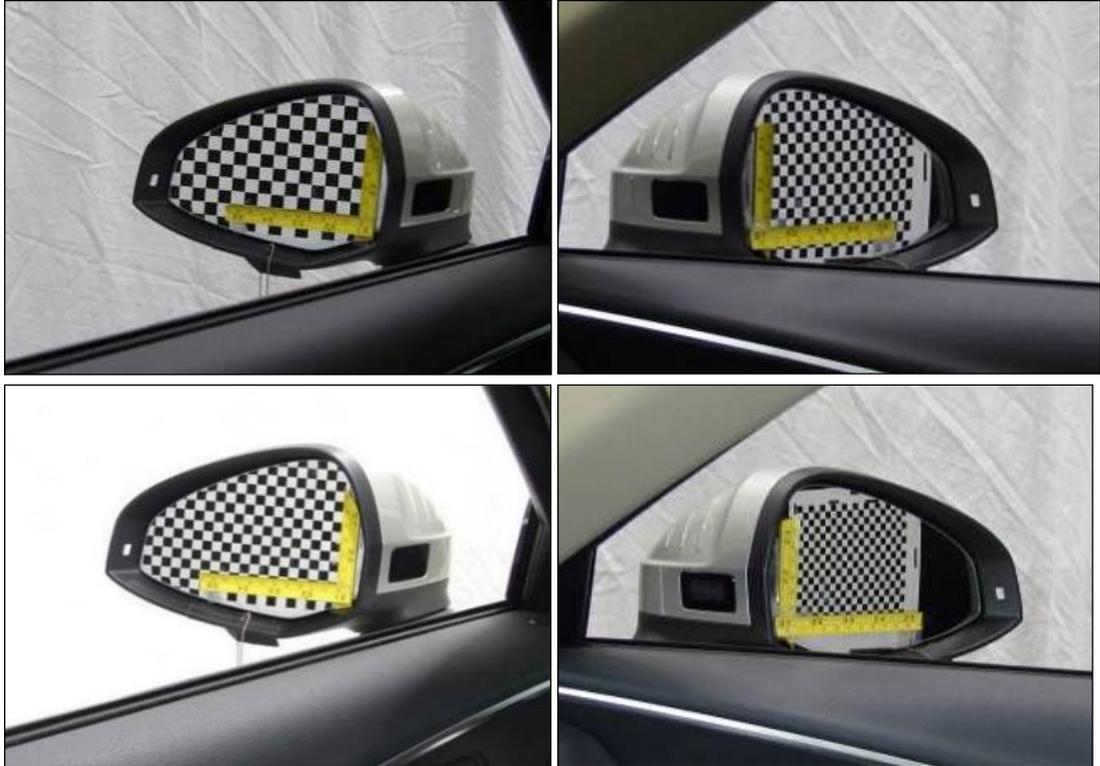
For comparison, the following figures are examples of the chessboard chart in the field of view of the test vehicle with standard outside rearview mirrors.

Figure 26. Near and Far Chessboard in Lighted Environment as Viewed With Driver (left) and Passenger Side (right) Mirrors

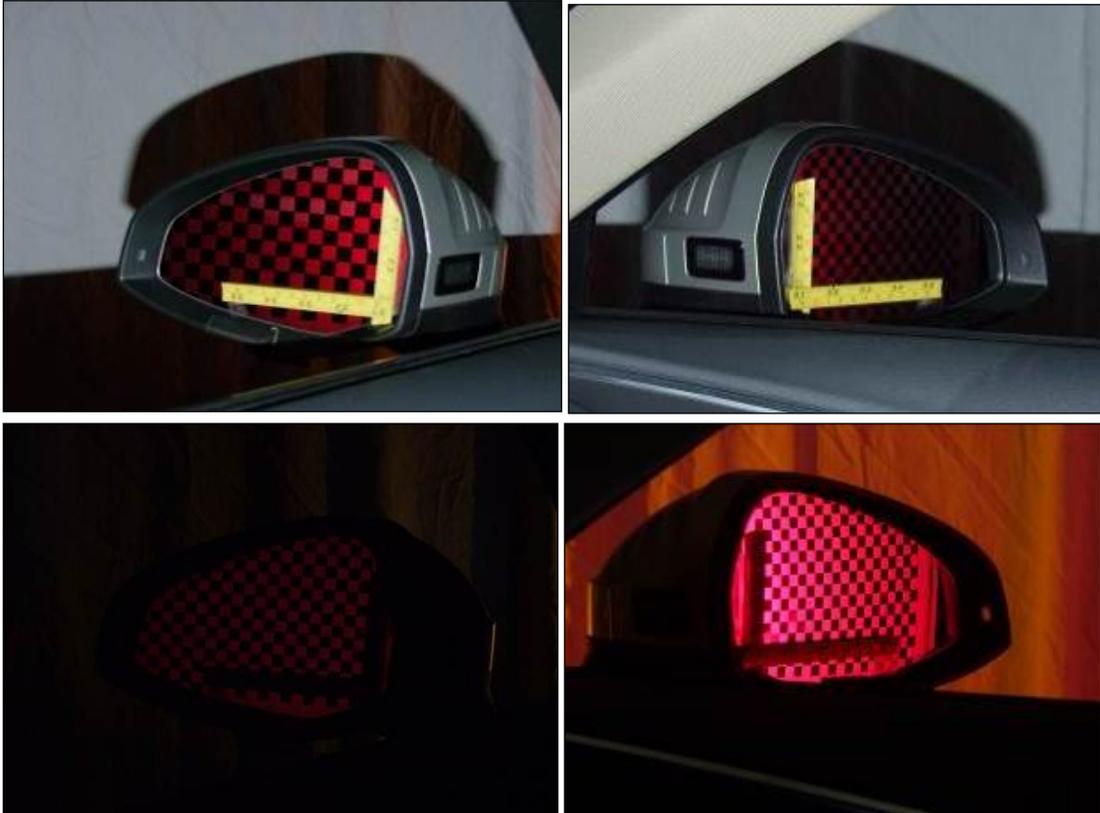
Figure 27. Near and Far Chessboard in Dark Environment as Viewed With Driver (left) and Passenger Side (right) Mirrors

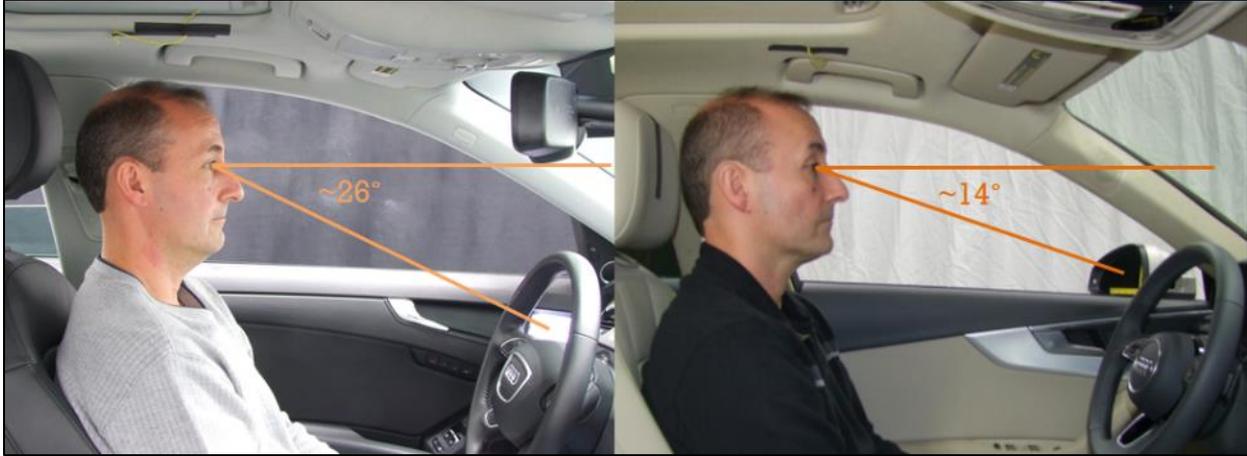
The following figure shows an approximation of the downward viewing angle for the CMS display versus a standard outside mirror, using a 50th percentile male seated in the comparable test vehicles.

Figure 28. Downward Viewing Angle, CMS Display Versus Mirror

As can be seen in the figure, the driver's side CMS display viewing angle is approximately 12 degrees lower than the height of the traditional mirror location. The ease with which drivers may acclimate from acquiring visual information from a traditional outside mirror location versus an interior display at a different visual angle is not known. At approximately 26 degrees below the horizontal, the CMS displays were located within the 30-degree down angle zone recommended in the NHTSA Visual-Manual Driver Distraction Guidelines.

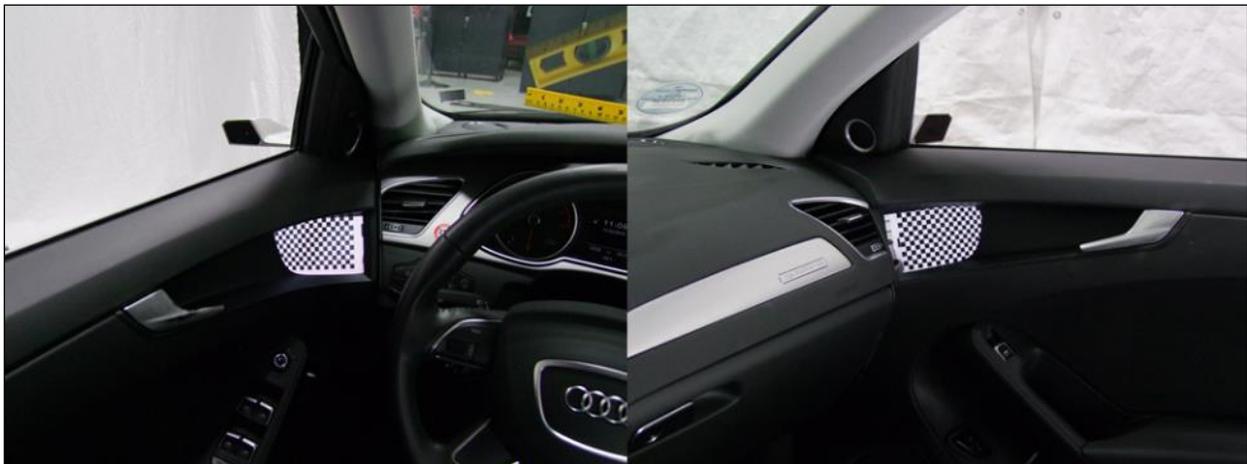
Figure 29. Side CMS Displays, Viewed From 50th Percentile Male Driver's Viewpoint

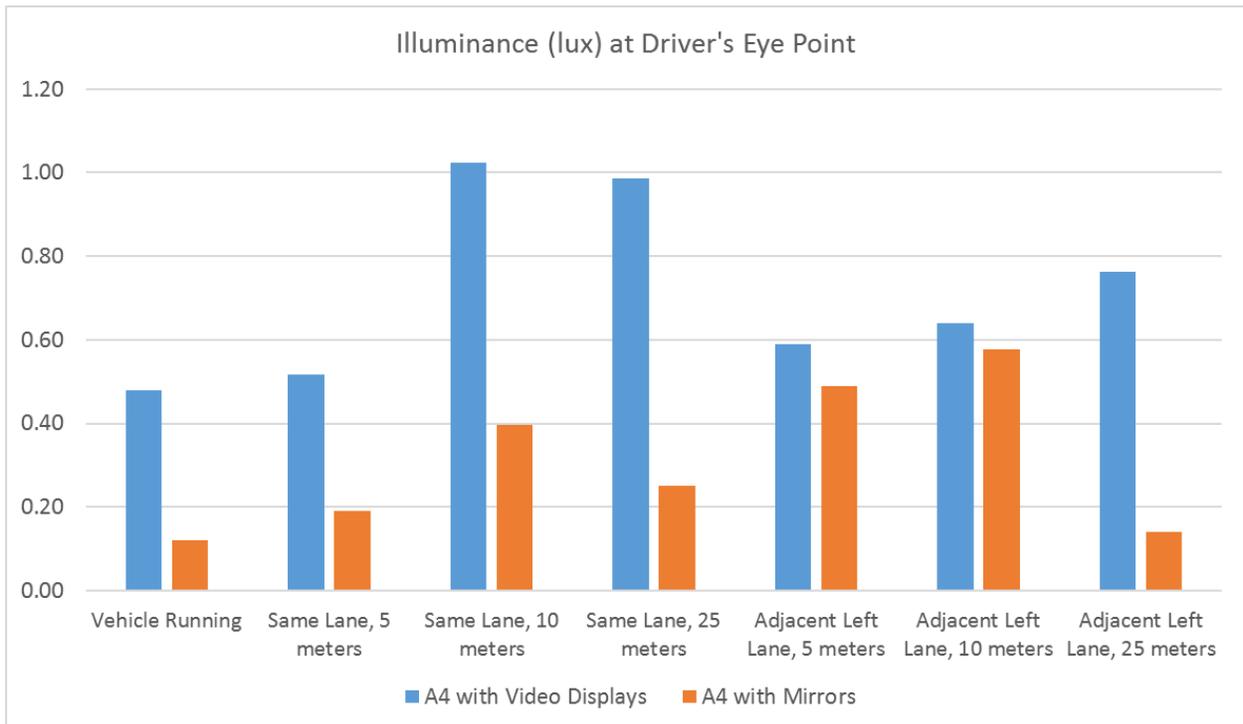
The following table describes each of the conditions in which interior illuminance data were obtained and the corresponding adjusted illuminance values. The subsequent figure illustrates the measured illuminance values.

Figure 30. Measured Illuminance, CMS Displays Versus Mirrors

Measured illuminance values were lower than the test staff anticipated they would be based on direct, subjective observation of the displays in nighttime conditions. While measured illuminance values did not approach a level that would be considered truly glaring to the driver, the constant unnecessary illumination coming from the CMS displays even when no other vehicle was nearby could be distracting or annoying to drivers in dark conditions, particularly in areas without street lights or other environmental lighting.

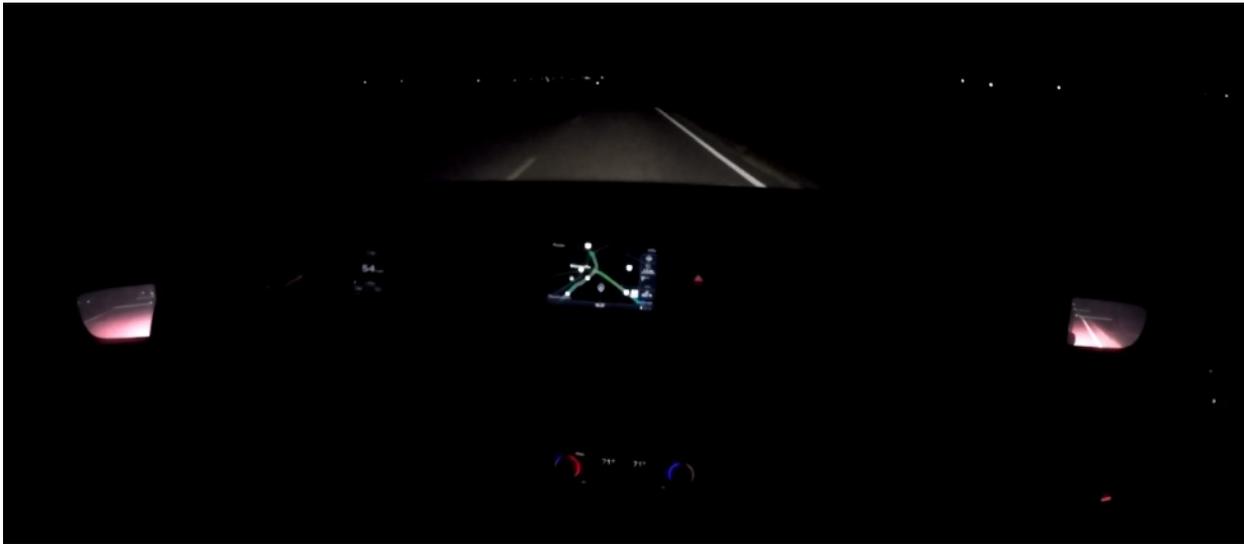
Figure 32. Photo of Side CMS Displays in Unlit Area, Vehicle Taillights Only

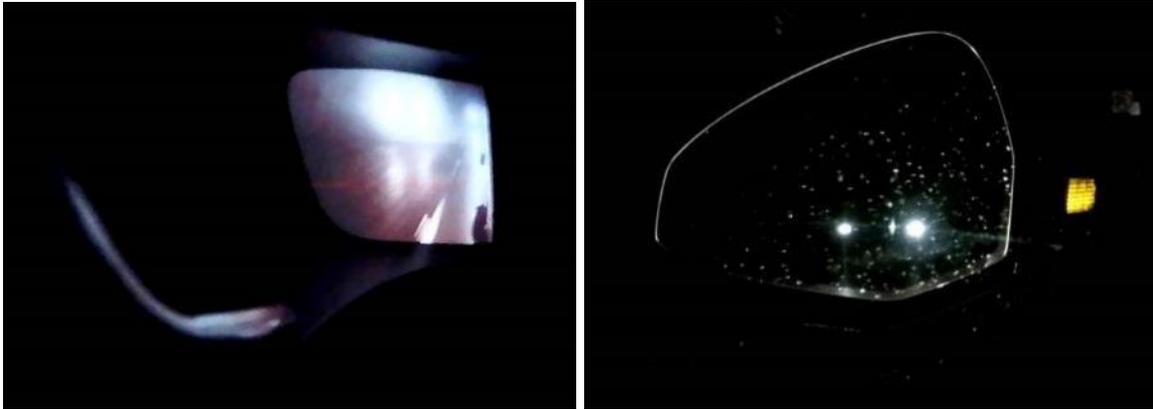
Figure 33. CMS Display Versus Mirror, Vehicle Behind in Adjacent Lane

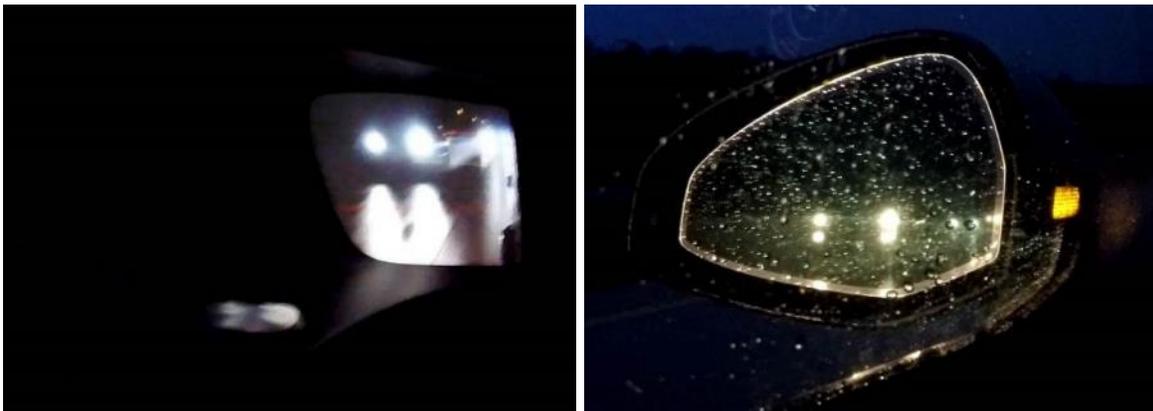
Figure 34. CMS Display Versus Mirror, Multiple Vehicles Behind in Adjacent Lane

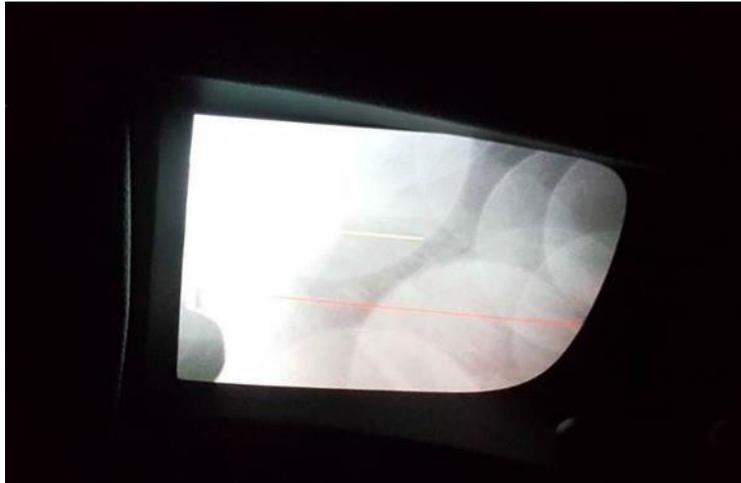
Figure 36. Photo of Passenger-Side CMS Display in Rainy Conditions

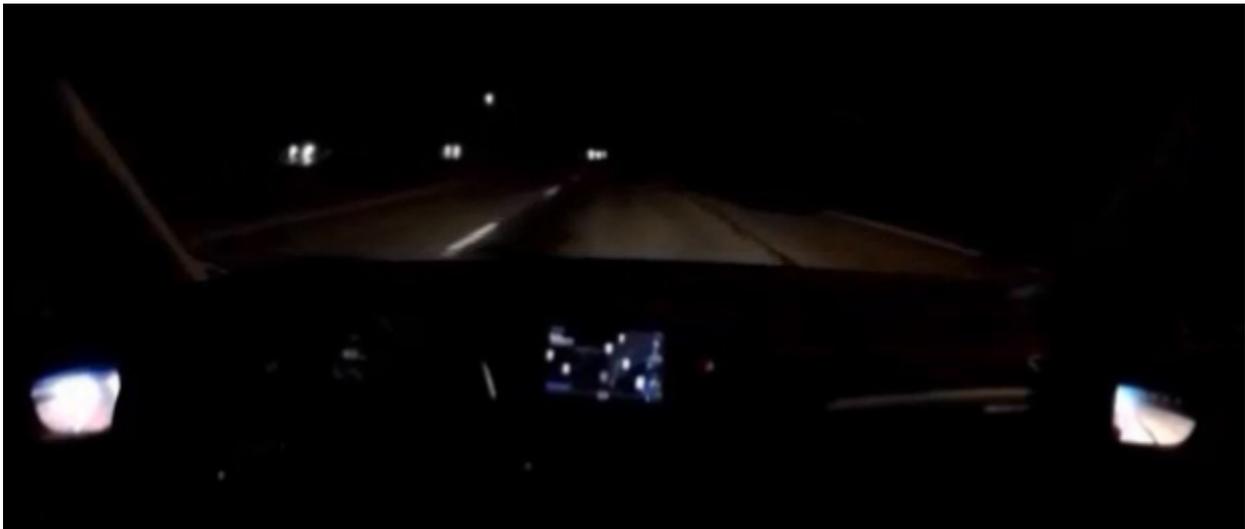
Figure 38. Image of Vehicle Headlights Passing on the Left at Night With Blooming Visible in CMS Display

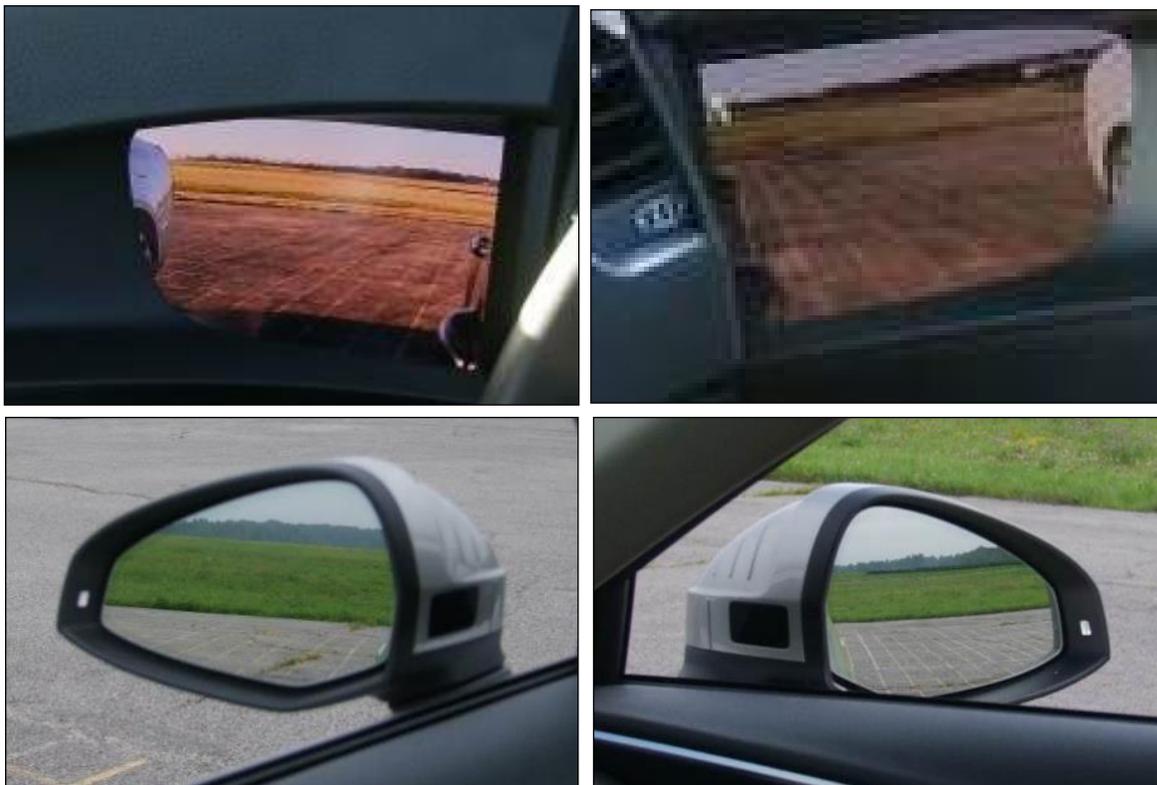
Figure 43. Sedan Positioned 5 Feet (1.52 m) Aft of Front Bumper, as Viewed With Side CMS (top) and Mirrors (bottom) on Driver (left) and Passenger Side (right)

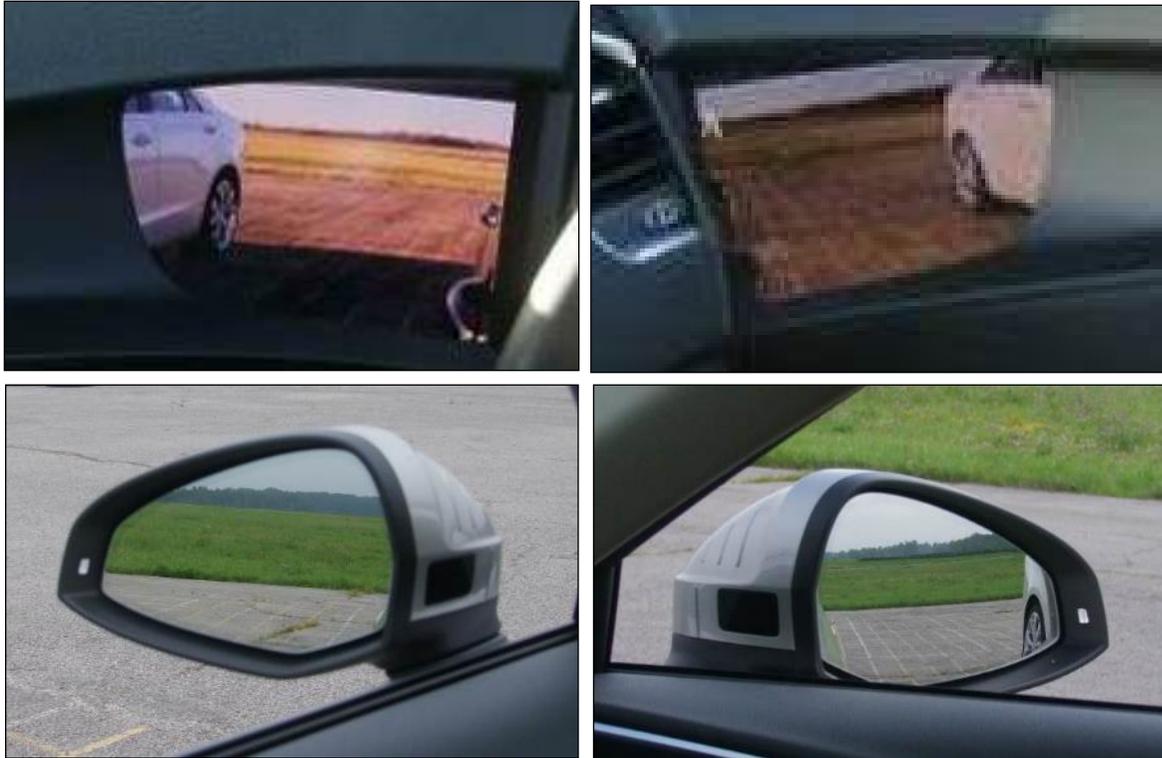
Figure 44. Sedan Positioned 10 Feet (3.05 m) Aft of Front Bumper, as Viewed With Side CMS (top) and Mirrors (bottom) on Driver (left) and Passenger Side (right)

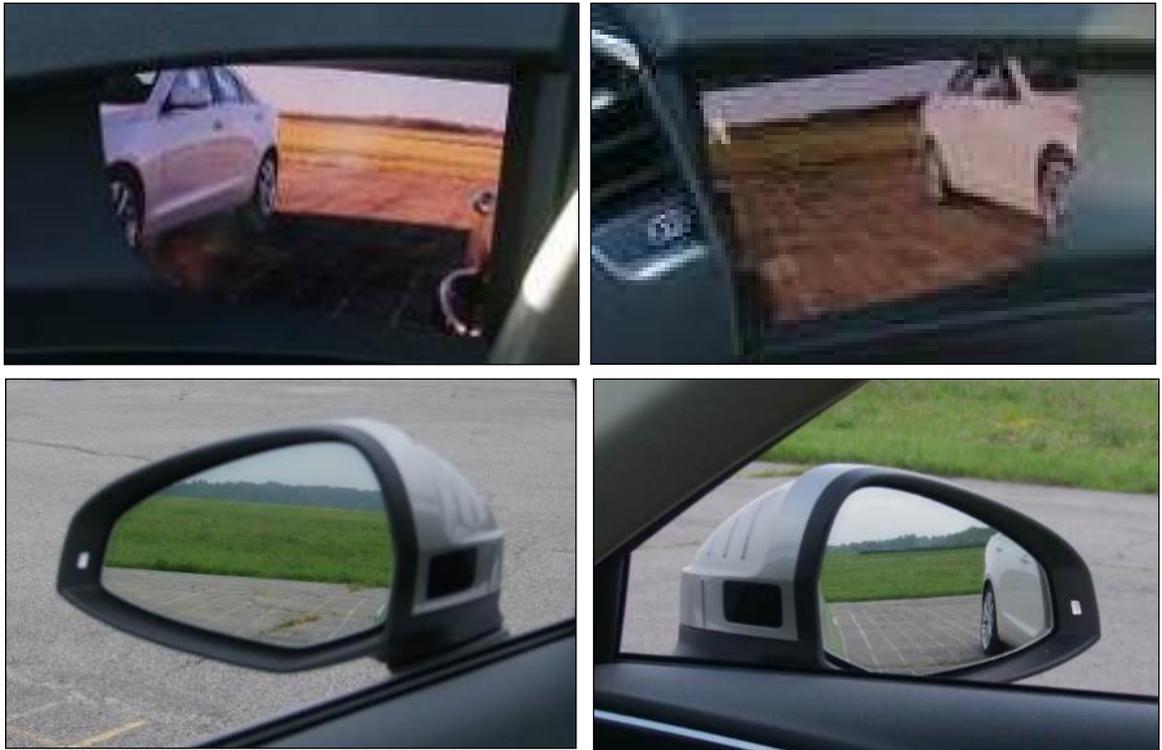
Figure 45. Sedan Positioned 15 Feet (4.57 m) Aft of Front Bumper, as Viewed With Side CMS (top) and Mirrors (bottom) on Driver (left) and Passenger Side (right)

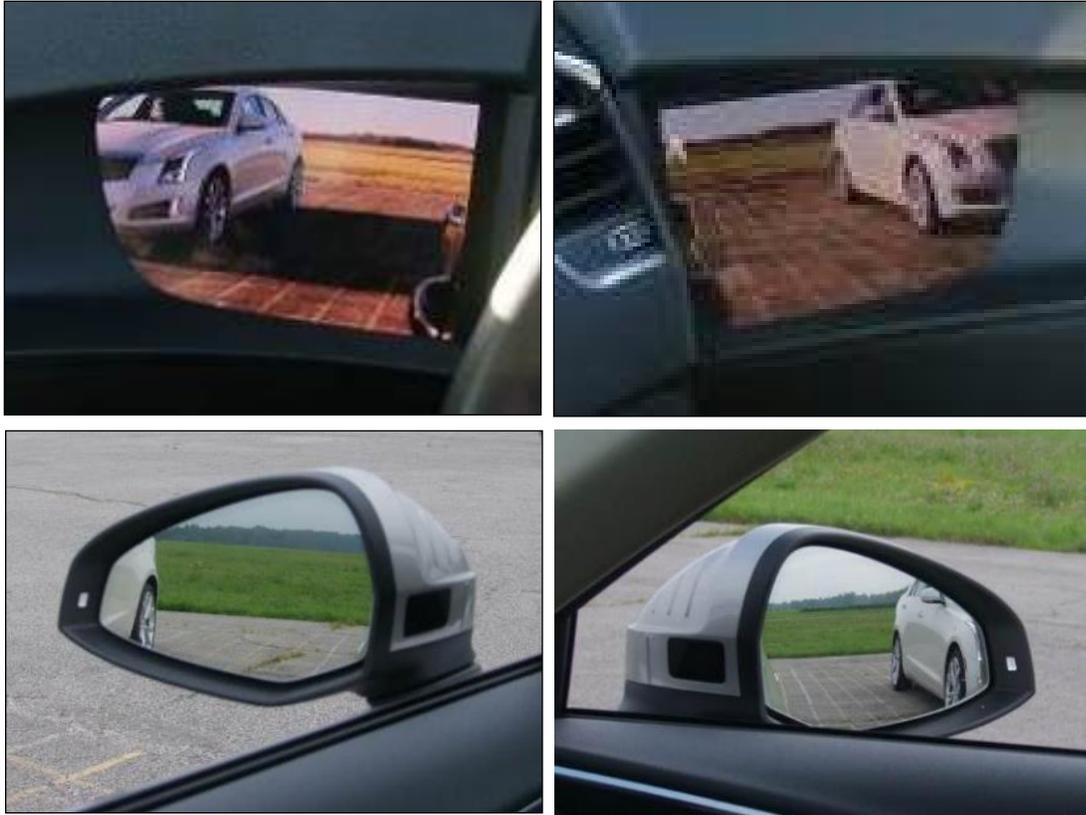
Figure 46. Sedan Positioned 5 Feet (1.52 m) Aft of Rear Bumper, as Viewed With Side CMS (top) and Mirrors (bottom) on Driver (left) and Passenger Side (right)

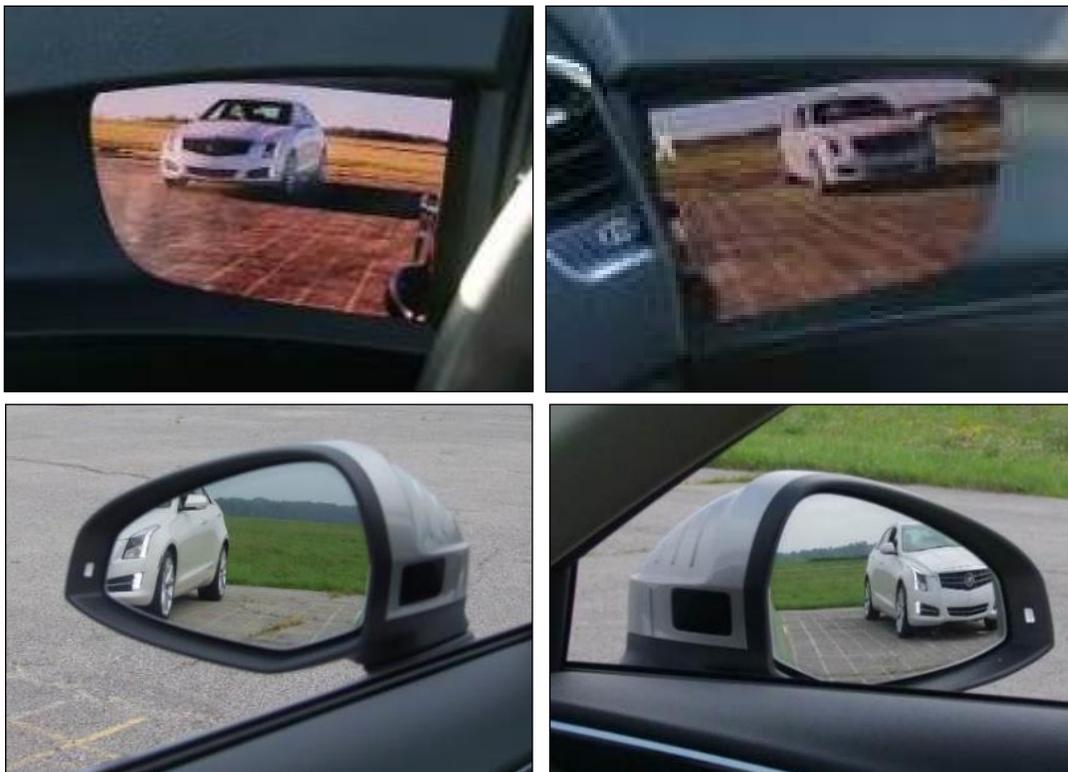
Figure 47. Sedan Positioned 16.4 Feet (5 m) Aft of Rear Bumper, as Viewed With Side CMS (top) and Mirrors (bottom) on Driver (left) and Passenger Side (right)

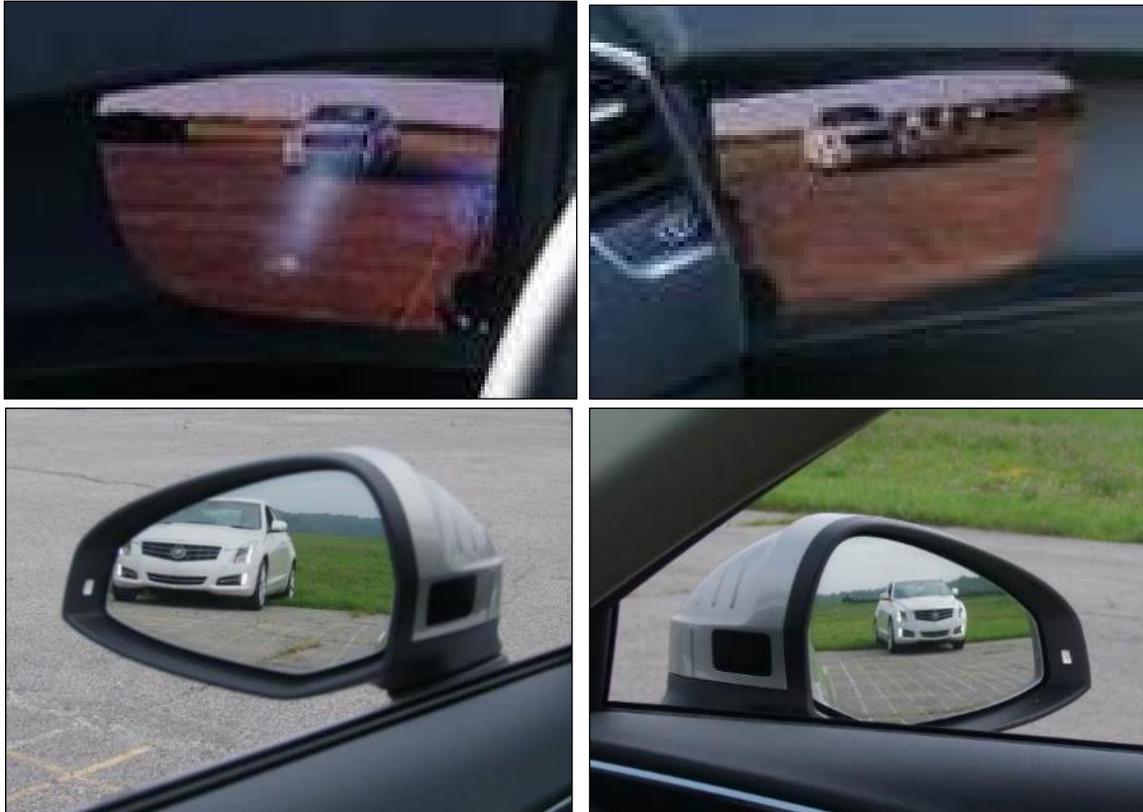
Figure 48. Sedan Positioned 32.8 Feet (10 m) Aft of Rear Bumper, as Viewed With Side CMS (top) and Mirrors (bottom) on Driver (left) and Passenger Side (right)

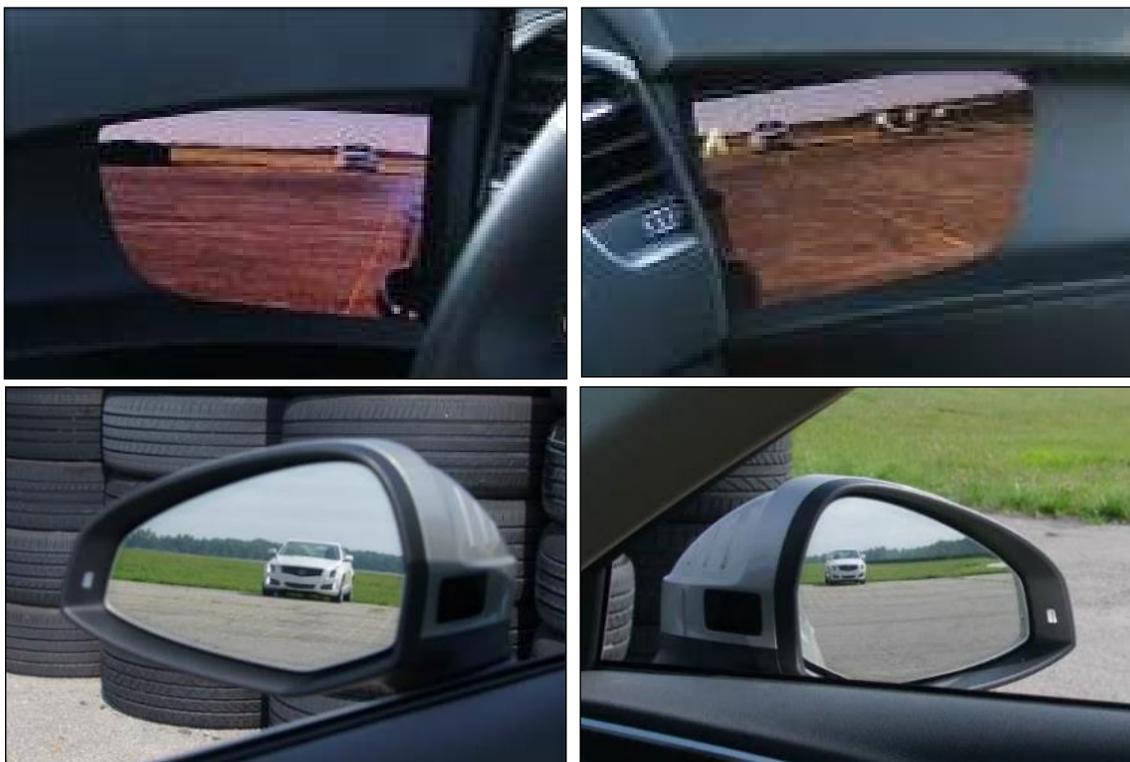
Figure 49. Sedan Positioned 82.0 Feet (25 m) Aft of Rear Bumper, as Viewed With Side CMS (top) and Mirrors (bottom) on Driver (left) and Passenger Side (right)

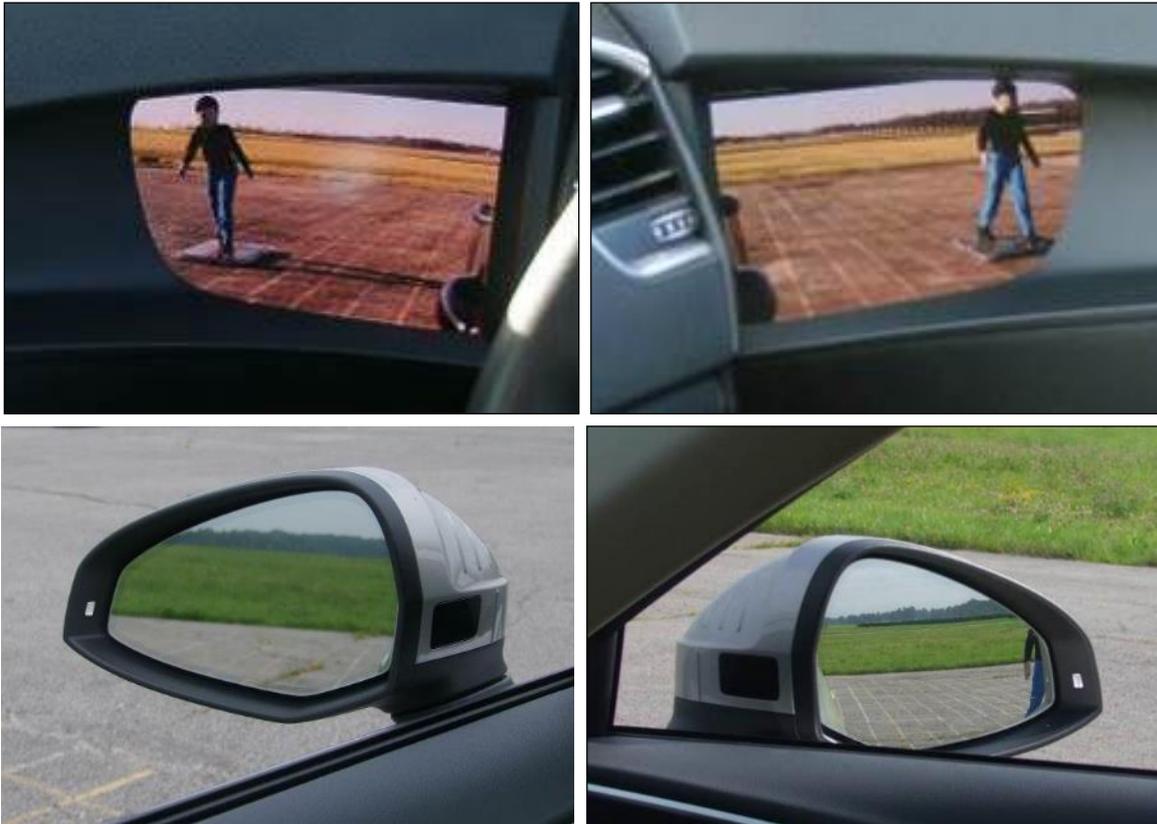
Figure 50. Child Mannequin Positioned 5 Feet (1.52 m) Aft of Rear Bumper, as Viewed With Side CMS (left) and Mirrors (right) on Passenger Side

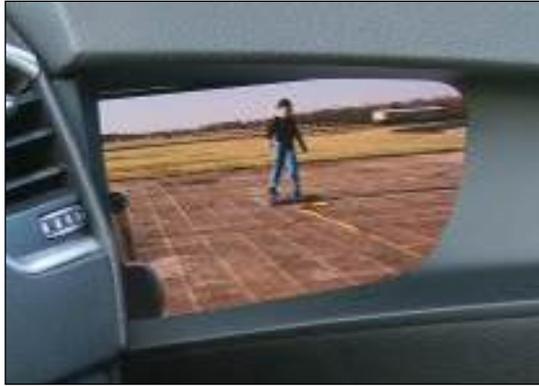
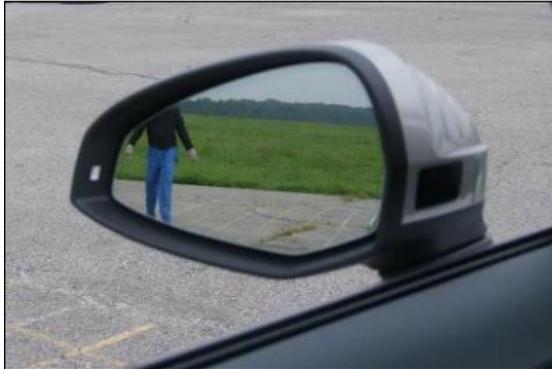
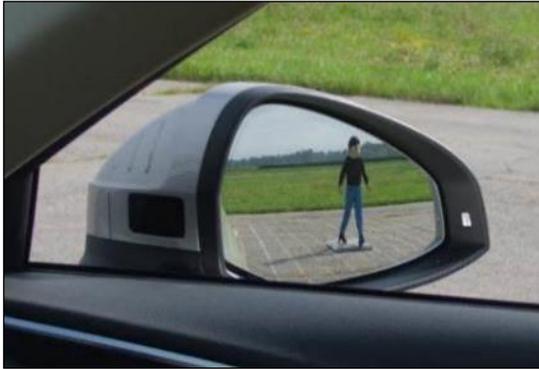
Figure 51. Child Mannequin Positioned 16.4 Feet (5 m) Aft of Rear Bumper, as Viewed With Side CMS (top) and Mirrors (bottom) on Driver (left) and Passenger Side (right)

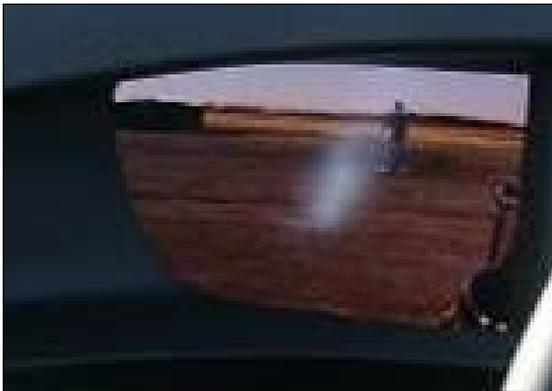
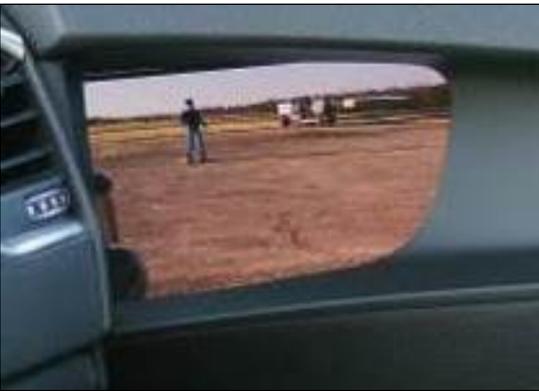
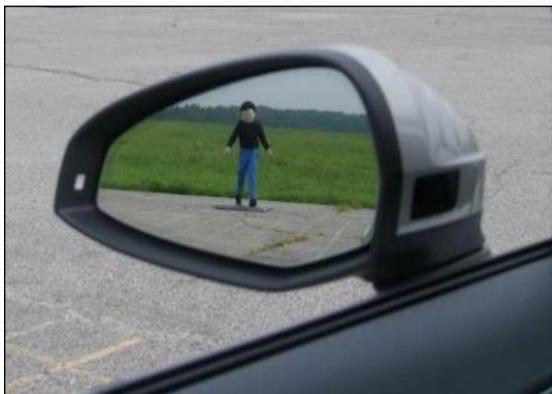
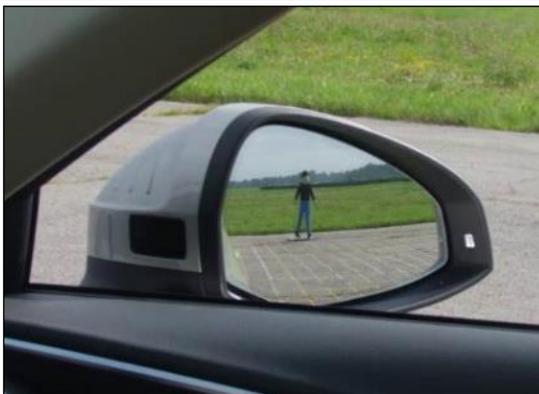
Figure 52. Child Mannequin Positioned 32.8 Feet (10 m) Aft of Rear Bumper, as Viewed With Side CMS (top) and Mirrors (bottom) on Driver (left) and Passenger Side (right)

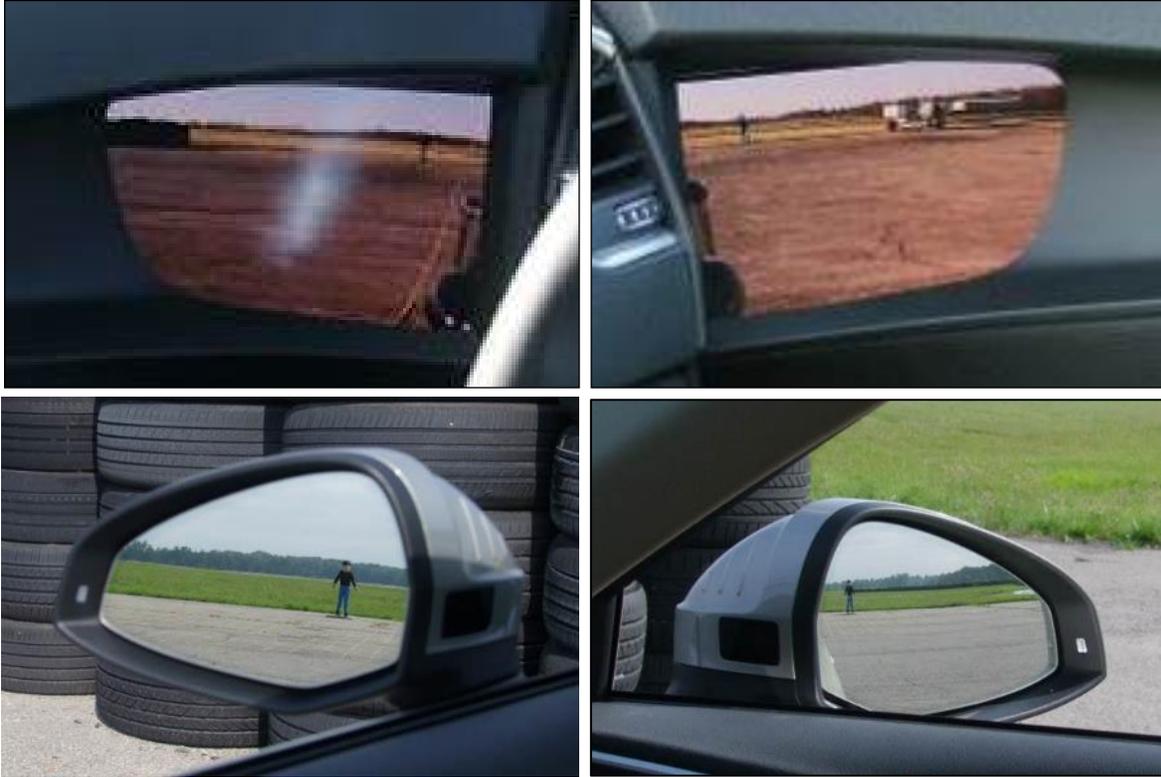
Figure 53. Child Mannequin Positioned 82.0 Feet (25 m) Aft of Rear Bumper, as Viewed With Side CMS (top) and Mirrors (bottom) on Driver (left) and Passenger Side (right)

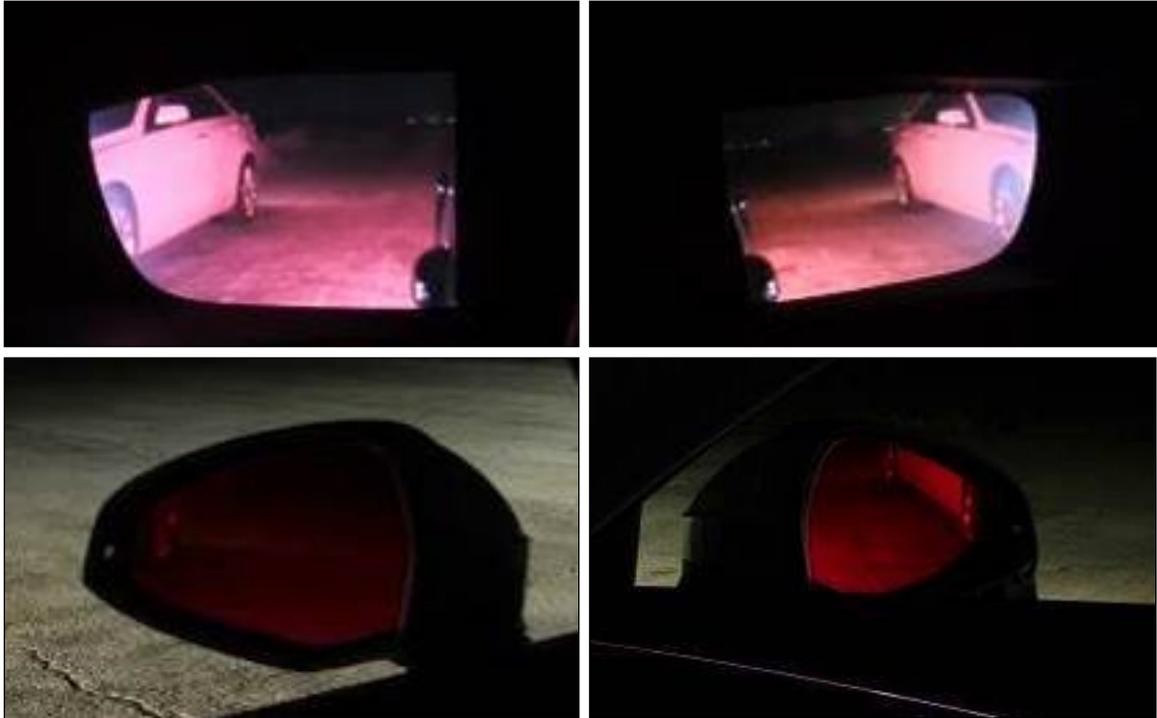
Figure 56. Sedan Positioned 15 Feet (4.57 m) Aft of Front Bumper at Night Time, as Viewed With Side CMS (top) and Mirrors (bottom) on Driver (left) and Passenger Side (right)

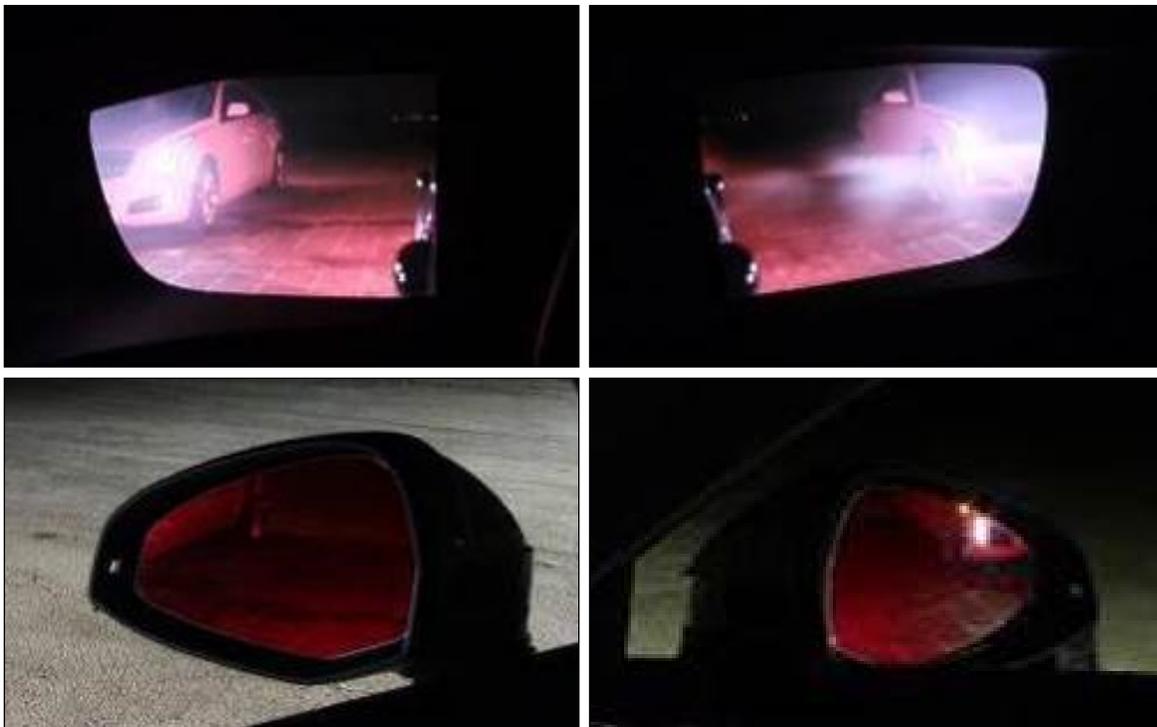
Figure 57. Sedan Positioned 5 Feet (1.52 m) Aft of Rear Bumper at Night Time, as Viewed With Side CMS (top) and Mirrors (bottom) on Driver (left) and Passenger Side (right)

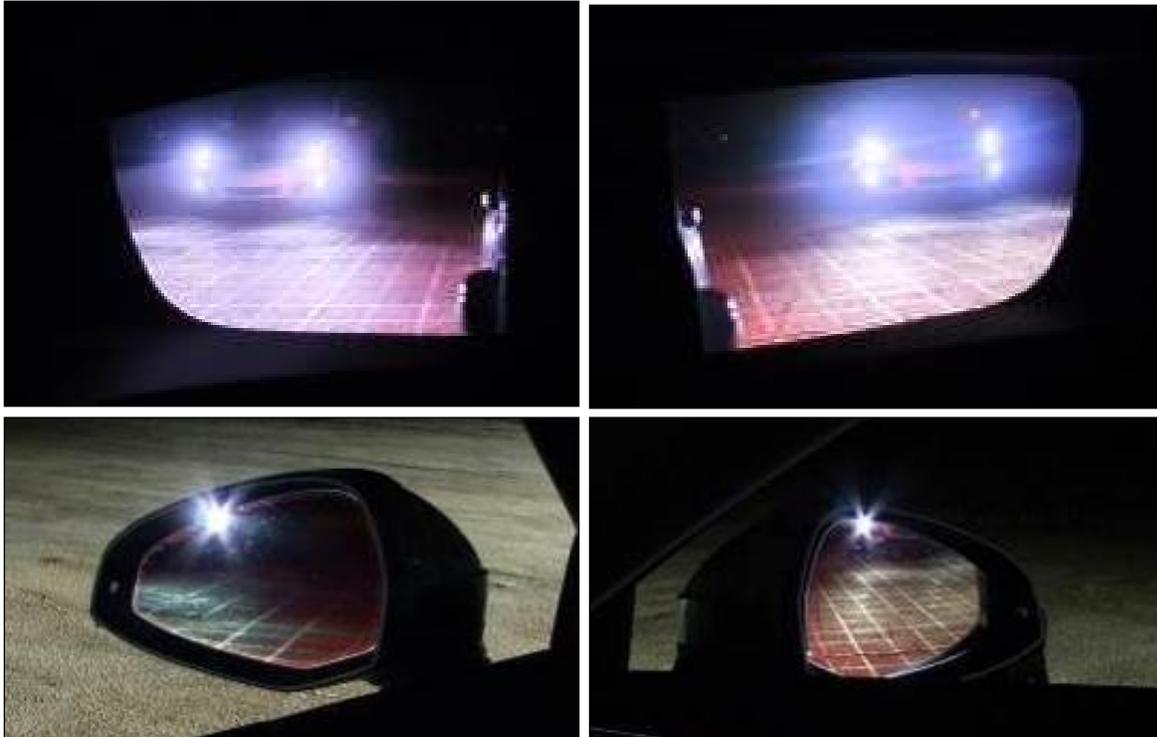
Figure 58. Sedan Positioned 16.4 Feet (5 m) Aft of Rear Bumper at Night Time, as Viewed With Side CMS (top) and Mirrors (bottom) on Driver (left) and Passenger Side (right)

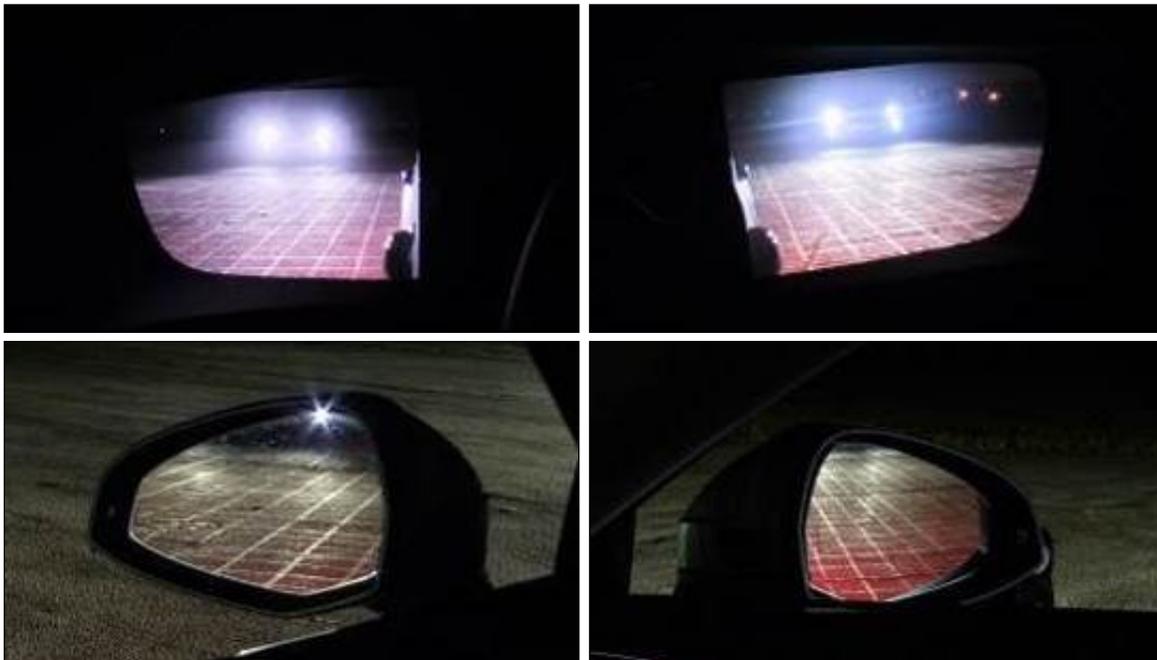
Figure 59. Sedan Positioned 32.8 Feet (10 m) Aft of Rear Bumper at Night Time, as Viewed With Side CMS (top) and Mirrors (bottom) on Driver (left) and Passenger Side (right)

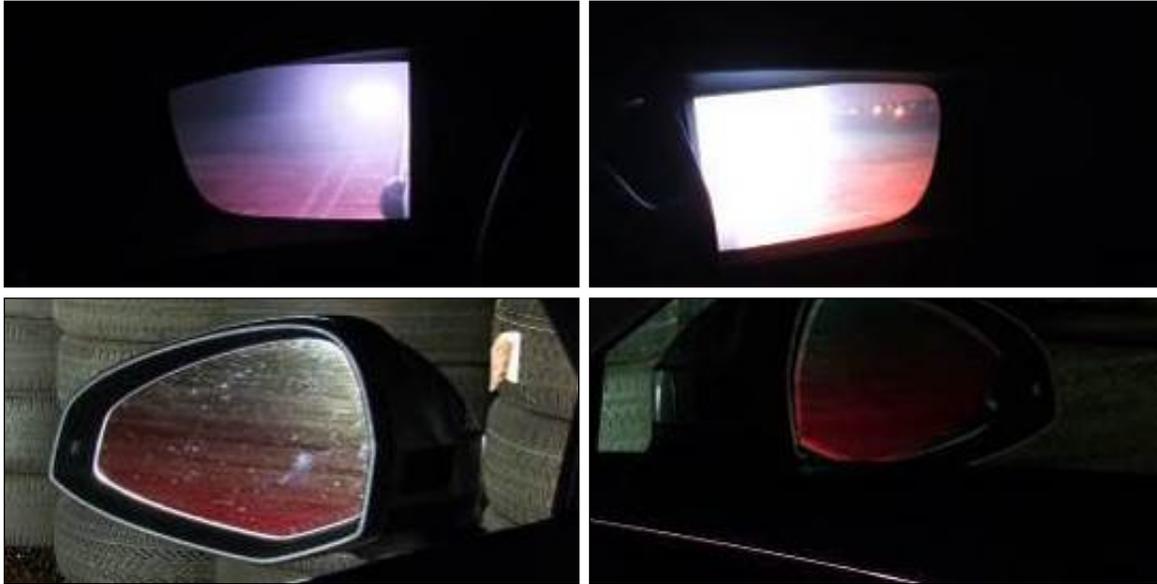
Figure 60. Sedan Positioned 82.0 Feet (25 m) Aft of Rear Bumper at Night Time, as Viewed With Side CMS (top) and Mirrors (bottom) on Driver (left) and Passenger Side (right)

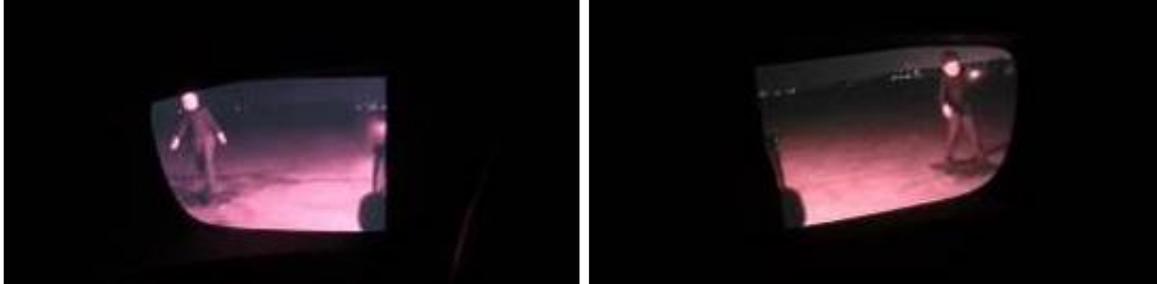
Figure 61. Child Mannequin Positioned 5 Feet (1.52 m) Aft of Rear Bumper, at Night Time as Viewed With Side CMS on Driver (left) and Passenger Side (right)

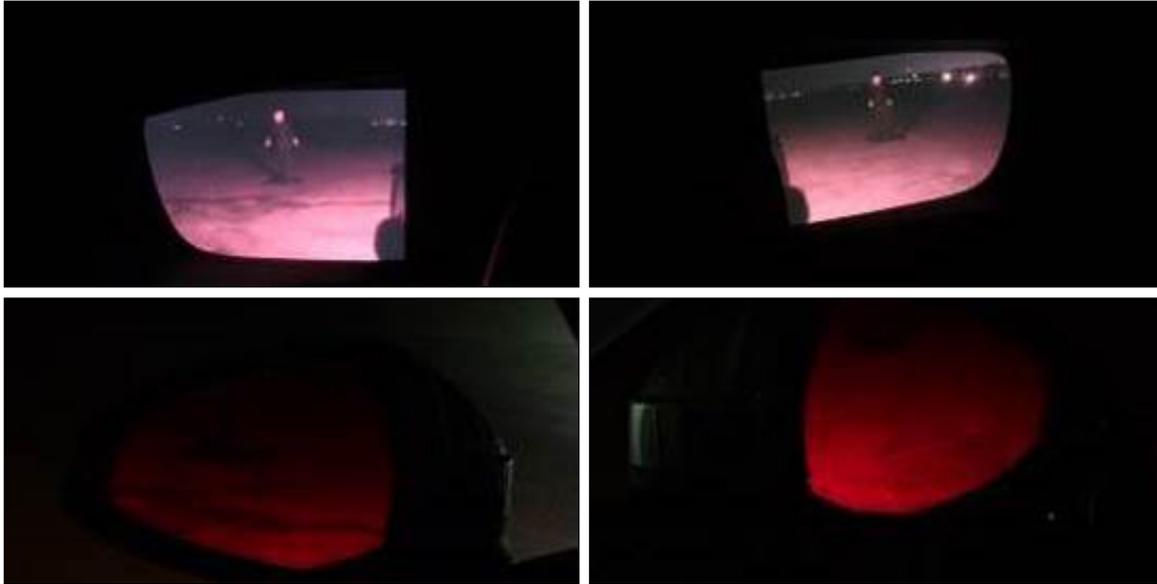
Figure 62. Child Mannequin Positioned 16.4 Feet (5 m) Aft of Rear Bumper, at Night Time as Viewed With Side CMS (top) and Mirrors (bottom) on Driver (left) and Passenger Side (right)

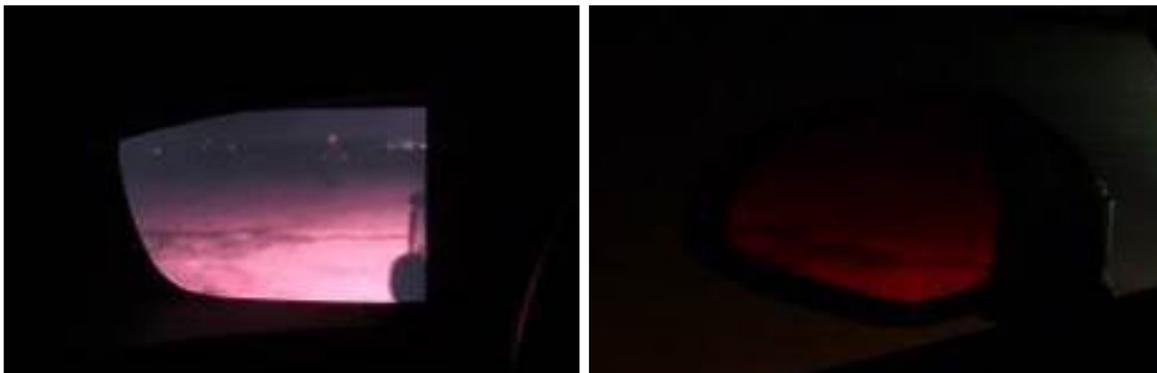
Figure 63. Child Mannequin Positioned 32.8 Feet (10 m) Aft of Rear Bumper, at Night Time as Viewed With Side CMS (left) and Mirror (right) on Driver Side
