**National Highway
Traffic Safety
Administration**

DOT HS 812 582

October 2018

Examination of a Prototype Camera Monitor System For Light Vehicle Outside Mirror Replacement

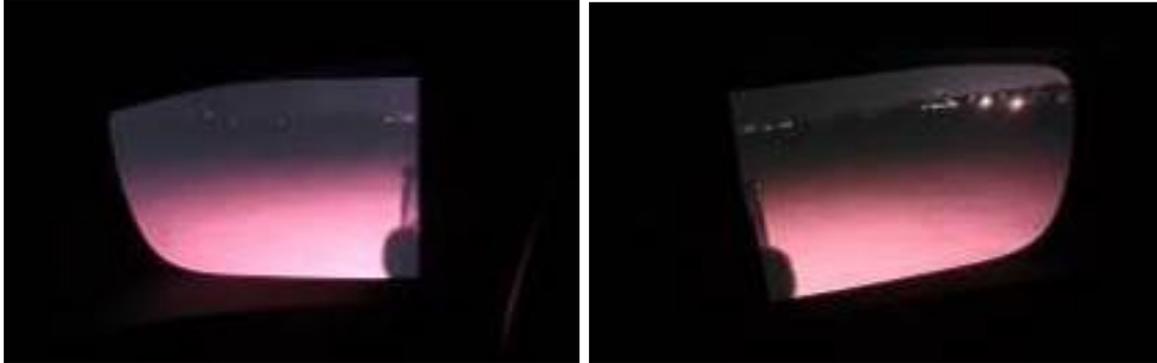
Figure 64. Child Mannequin Positioned 82.0 Feet (25 m) Aft of Rear Bumper, at Night Time as Viewed With Side CMS on Driver (left) and Passenger Side (right)
